CAHI MONTHLY NEWS

September 2011 Volume 3, Issue 9

In the Path of the Storm

A firsthand look at the damage inflicted on new wood-frame homes by the April 2011 tornadoes in North Carolina and Alabama

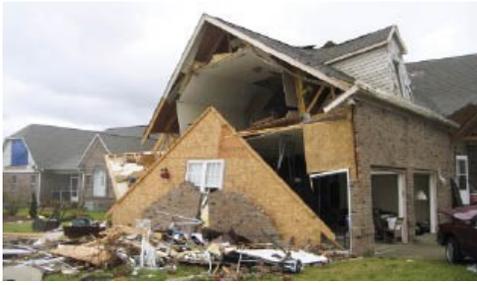
Damage to this home (1) most likely started with the failure of the garage doors. Subsequent pressurization of the garage blew out the sidewall and pushed out the back wall. A close look showed inadequate nailing of the drywall ceiling and the bonus-room floor sheathing (2) to the bottom chord of the gable-end truss, seen here from behind (3). The gable triangle was intact, with the OSB sheathing still in place - it's the connections that failed.

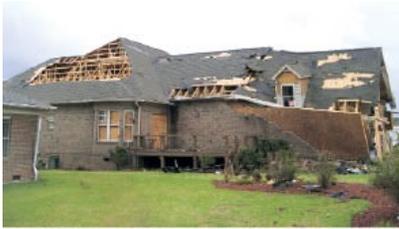
4

The same home, seen from the rear (4), also lost sheathing at the step-down trusses of the hip roof, a type of failure I observed several times. Top-chord nailing surfaces on step-down trusses do not neatly align with the roof sheathing, which makes it more difficult to attach the sheathing adequately.

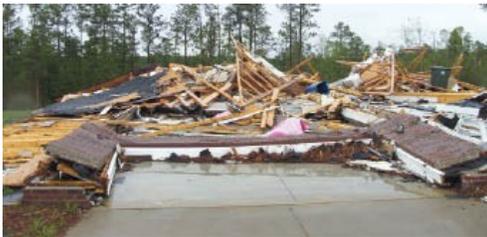
Another home in the same subdivision fared much worse **(6)**; most likely the garage walls were blown out due to pressurization through the large garage-door opening, seen in the foreground. A closer look at the left-hand garage wall **(7)** shows that the OSB sheathing was poorly attached to the bottom plate with 8-penny nails 16 inches on-center. Foundation anchor bolts with round washers were spaced 48 inches on-center along the sill plate. The home's roof trusses had been attached with toenails **(8)**.

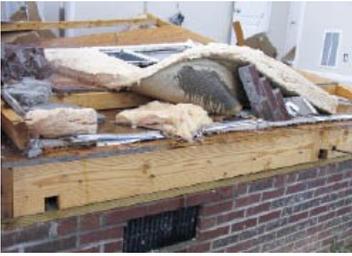
10

Another collapsed home **(10)** was fully sheathed with OSB, which lapped the rim board and sill plate but was fastened only to the rim board with 16-penny nails at approximately 16 inches on-center. I could see no nails through the sheathing into the sill plate.

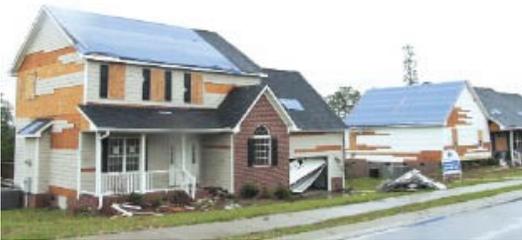
11

These two homes **(11)** lost much of their fiber-cement siding, but there were no breaches in the OSB sheathing.

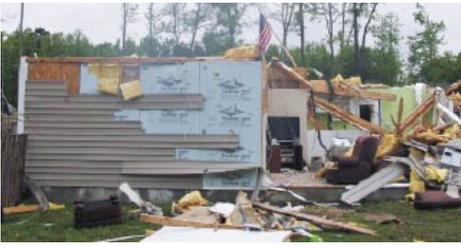
The homes I studied in Wilson were all built between 2004 and 2009. This home was almost completely destroyed **(1)**; shown here is an end wall, which was braced at the corners with OSB and had nonstructural extruded polystyrene as infill sheathing. The home's bottom plate - shown with bits of the foam sheathing still attached - was intact **(2)**; structural wall sheathing would have greatly strengthened this connection between the wall studs and the bottom plate.

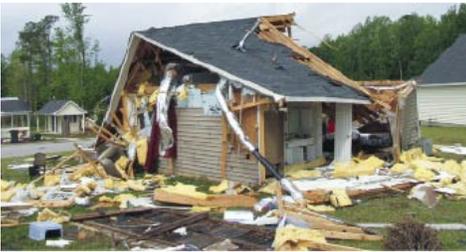
Though this home's roof remained largely intact (6), several of the exterior walls were blown out - a testament to both the tornado's lack of strength and the inability of poorly executed framing connections to maintain integrity of the building envelope. The back corner is still supported by the OSB corner bracing panel (7). A braced corner in front was pulled off when its connection to the bottom plate failed (8). On the opposite side of the house, the foam sheathing at the gable truss is almost completely stripped from the framing (9). Below, the foam-sheathed portion of the wall was lost, though the OSB corner bracing is still in place.

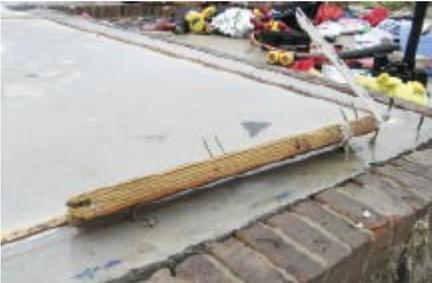
This home in western Alabama (1) was completely blown off its foundation by a tornado that came through the area around 5:30 a.m. on April 27. Remarkably, the family inside the home was swept away from the building, though no one was seriously injured. A length of sill plate was the only piece of the exterior walls that remained on the slab (2); the sills had been attached with rectangular cut nails.

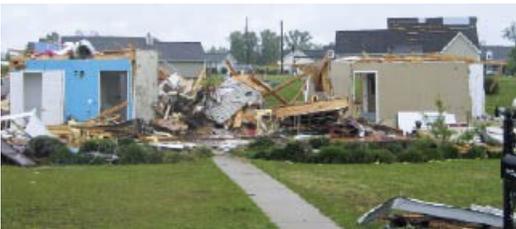
A nearby home lost all its exterior walls (3); its sill plates had been fastened with spiral shank nails 24 to 48 inches on-center (4, 5).

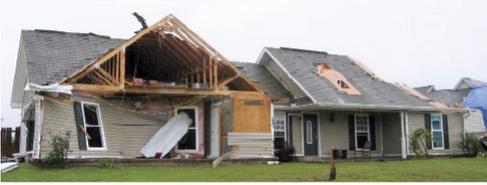
Another home in the same neighborhood lost its garage door and had its front garage wall pushed in - apparently by wind pressure, as there was no sign of impact. Gable-end failures occurred on the front and right side of the house (6). The home's masonry safe room, at the front center (7), was undamaged, and may have helped strengthen the home against the tornado's forces.

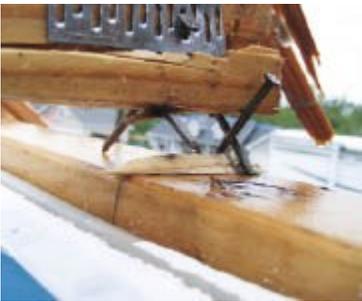
Seen here (8) is the back right corner, where the gable roof over the children's bedrooms was lost. Like most of the homes in the neighborhood, this one was fully sheathed with OSB; pink housewrap and vinyl siding covered the sheathing. A closeup (9) shows a typical truss-to-top-plate connection; the four toenails, placed in opposing pairs, caused the bottom chord to split.

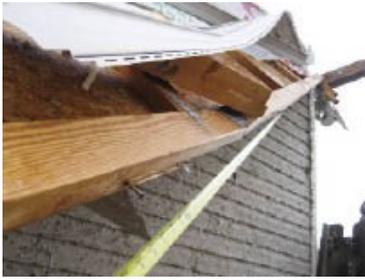
The gable end was stripped from this home (10). The bottom chord of the gable truss had been attached to the plate below with 16-penny toenails more than 2 feet on-center (11); the roof sheathing was secured with nails every 48 inches and staples every 12 inches between the nails (12).

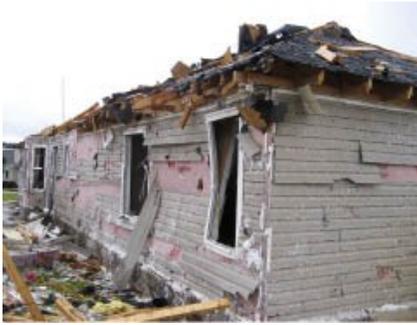
13

Though heavily damaged, this house (13) may have fared better than nearby homes because it has a hip roof, which is better than a gable roof at resisting high winds. The wall seen here was knocked in by an impact that occurred between the two windows in the middle of the photo. Though the wall was sheathed with OSB - which helped hold the framing together - the connection at the top plate failed.

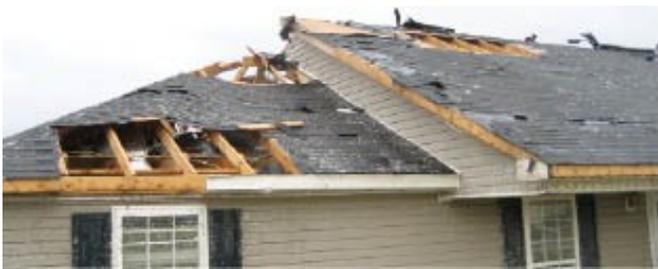
14

Another view of the same home shows missing sheathing on one section of the roof, probably related to loss of the lightweight vinyl soffit directly below (14).

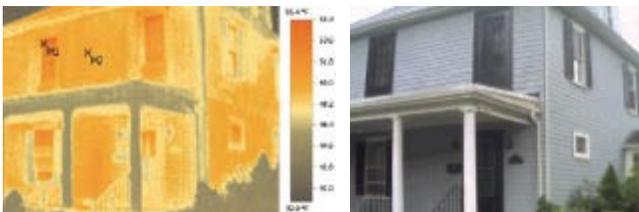
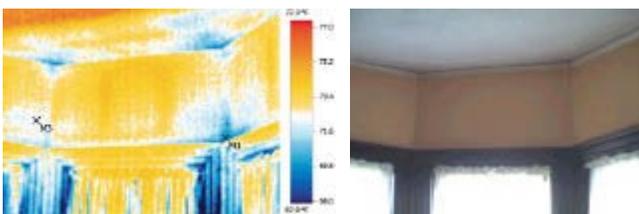
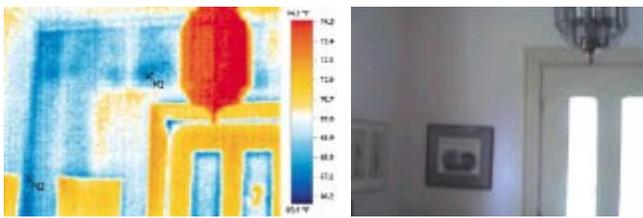
To find out just how much insulation was in the walls, I scheduled an infrared (IR) camera inspection with the insulation contractor at the beginning of the job (see **Figure 1**). I knew that the attic had only 6 to 8 inches of cellulose and blown fiberglass insulation, but I was surprised when the IR images showed that there was virtually no wall insulation in most of the house. Once I had explained the test results to the homeowner and gone over the benefits of cellulose wall insulation, convincing him to add it to the scope of work was easy.

Figure 1. Thermographic imagery revealed empty wall cavities (top), air infiltration around windows (middle), and cold spots around framing members like corners and plates (bottom).

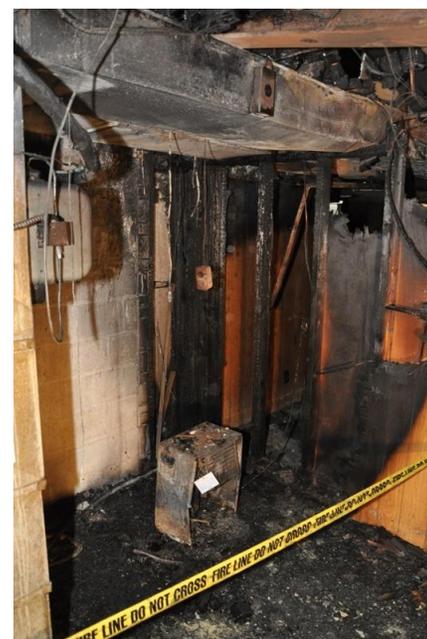
The power connector for the dehumidifier's compressor can short circuit, posing fire and burn hazards to consumers and their property.

This fire at a home in Valparaiso, Ind. involved a recalled Goldstar dehumidifier and resulted in \$192,000 in damage.

Anyone who has the recalled dehumidifiers is strongly encouraged to immediately stop using them, unplug them, and contact LG Electronics for the free repair.
