CAHI MONTHLY NEWS

July 2019 Volume 12, Issue 07

Inspecting Homes for Termites

Inspecting New Siding – Devil’s in the Details

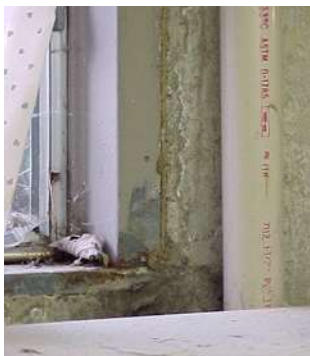
Termite shelter tubes from bottom to top corner of basement window frame.

Bottom corner. Note large accumulation of mud at lower corner, at grade elevation.

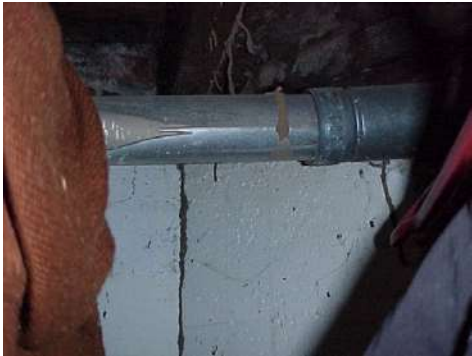
In basement water heater closet, termite shelter tube stalactites descending from overhead floor joists. Note shelter tube encircling metal water heater flue.

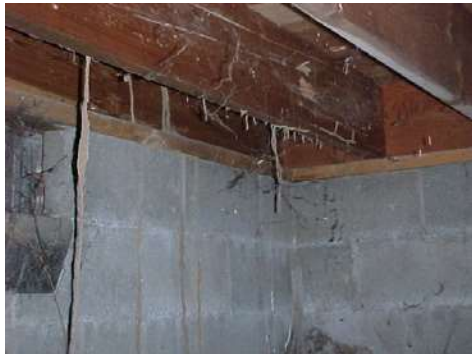
Side view of same location showing stalactites, tubes on flue and vertically on concrete wall.

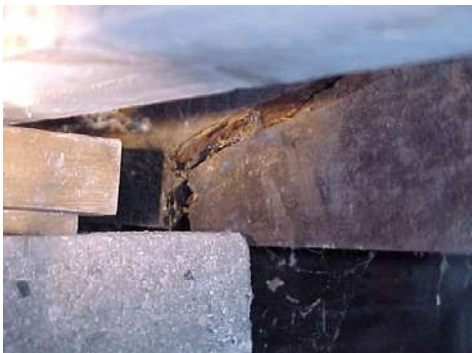
In crawl space, termite tunnels on block foundation end end joist and hanging from floor joist. Note hanging tunnel at left foreground, measuring 3' below joist, and void through joist near end, at upper right.

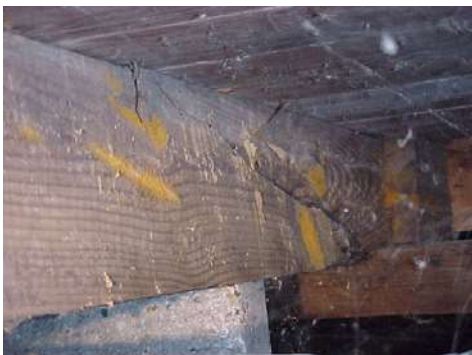
Damaged joist under LR floor, split from loading after substantial activity of powder-post beetles.

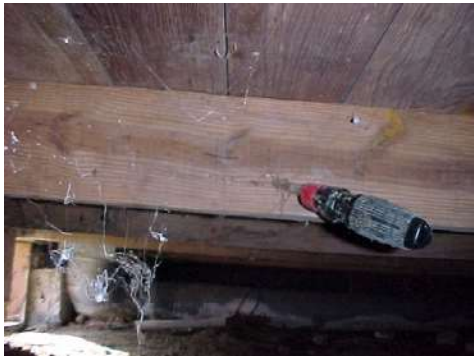
View of opposite side of split floor joist.

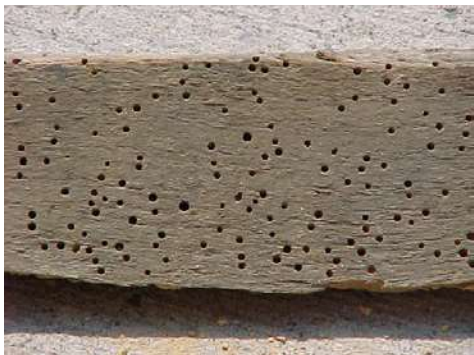
Wood from floor joist, damaged by activity of powder-post beetles. Note disintegrated condition of wood at foreground.

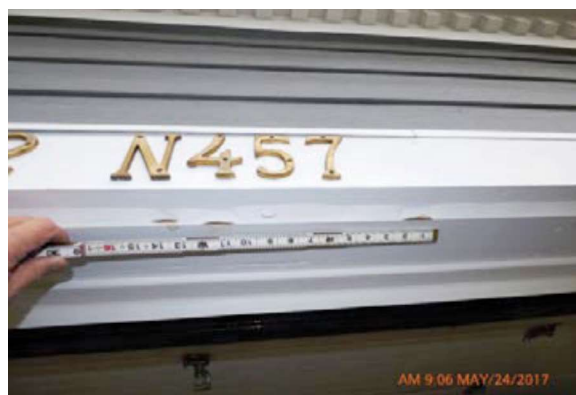
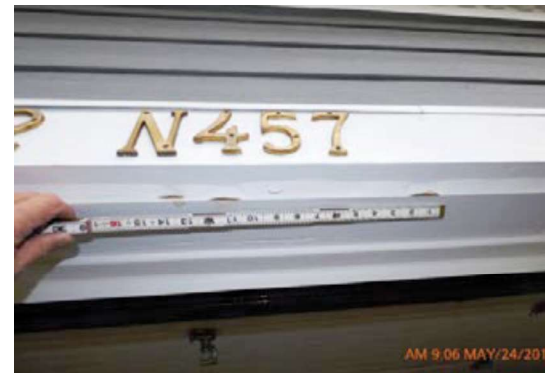
(Figure 2: Garage Door Issues)

- Above the garage door jamb, there was evidence of minor water damage and peeling paint below horizontal trim (See Figure 2: Garage Door Issues). Similar water damage was occurring below horizontal trim at the front entrance where the structure was rebuilt. Leaks should not occur in either place.

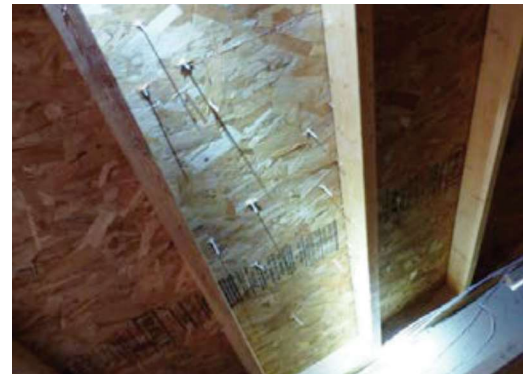
(Figure 3: Nailing Through OSB)

- In the attic above the garage, the back side of the OSB sheathing (oriented strand board) was visible. Hundreds of nails had missed studs (See Figure 3: Nailing Through OSB). Fiber cement siding must be fastened to studs.

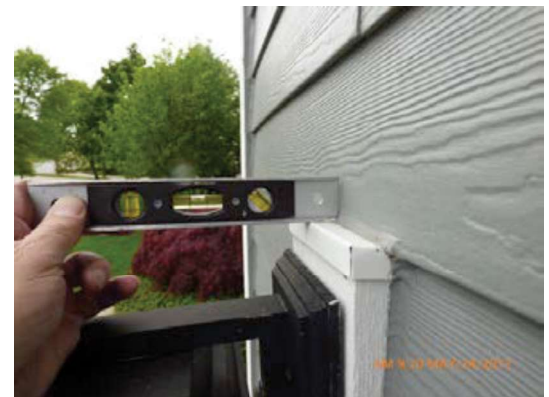
(Figure 4: Cap Siding and Caulk)

- Some cap flashings were caulked to the siding (See Figure 4: Cap Siding and Caulk). Some were pitched into the wall assembly, and some had inadequate clearance to the siding—a minimum gap of ¼ inch is required.

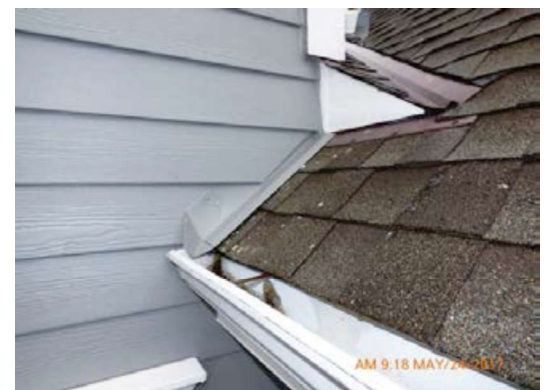
(Figure 5: Kick-Out Flashing)

- Some nails were visible even though this was a blind nailing installation. Nails were overdriven and breaking through the surface of the siding.
- Kick-out flashings were not properly installed (See Figure 5: Kick-Out Flashing).

We found some nails overdriven and puncturing the siding. We agreed that kick-out flashings were improperly installed; the clearance to the roof

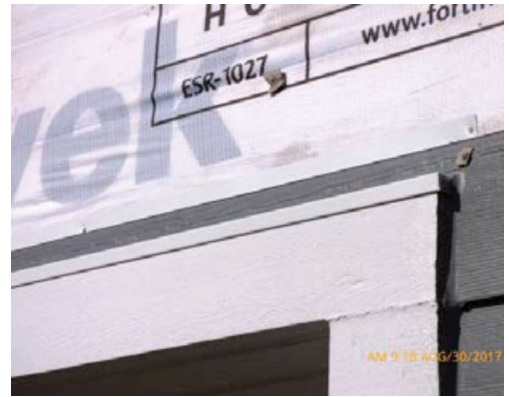
(Figure 6: Defective Layering at Garage)

During siding removal, we reviewed the installation over the garage door and found improper layering of the cap flashing and the water-resistant barrier (See Figure 6: Defective Layering at Garage). At several windows, metal cap flashings were placed over the water barrier, not tucked under the barrier

After some difficult and frank discussions with the owner and the contractor, the contractor decided to completely remove the siding and replace it with proper flashing and layering of materials. The original project had cost about \$30,000, so the contractor was making a major commitment to do the job right. This high-quality contractor unfortunately had assigned an inexperienced crew to this particular job.

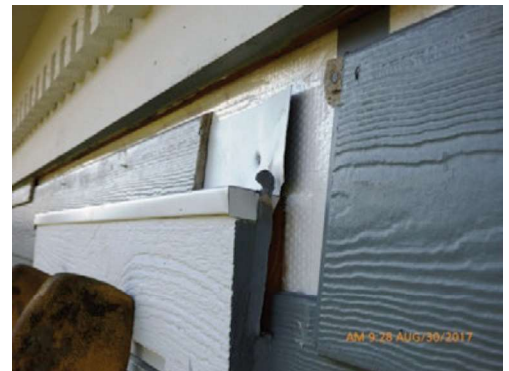
(Figure 7: Improper Layering at Window)

(See Figure 7: Improper Layering at Window). By identifying the now visible nail spacing, we also found that the siding was not nailed to studs.
