News and Views from the Connecticut Association of Home Inspectors, Inc.

June 2007

Foundation Inspection Methods - Part One

By Daniel Friedman

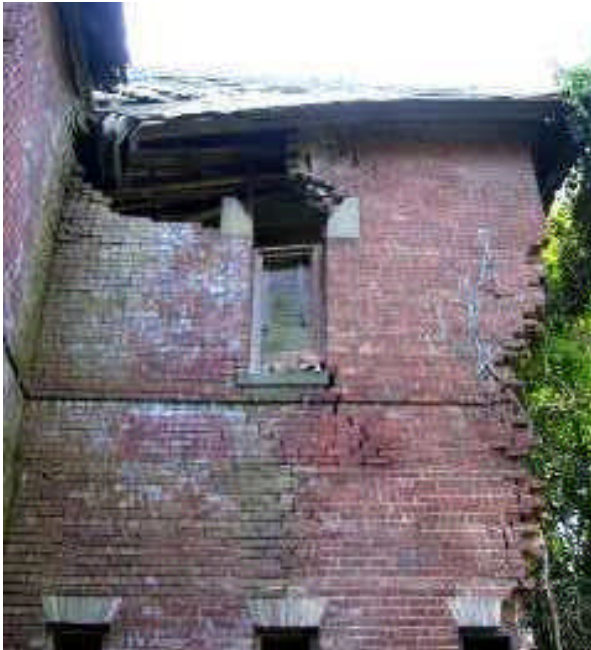
This historic brick structure had already begun to collapse when we inspected its condition. The root cause of failure was water from roof leaks and at the building right side (not visible) in-slope grade and surface runoff which soaked the structure's lower foundation walls and permitted frost

damage. As bond courses break and walls bulge, structures of this type are unstable and dangerous.

- **Bulging brick walls:** this is likely to be a bond-brick or bond-course failure - potentially extremely dangerous and very urgent - can presage sudden catastrophic building collapse!
- **Cracks and Bulges in brick walls** (such as the photo above): frost and earth loading - can push a below-grade brick foundation wall inwards. Often the wall is bulged inwards as well as showing horizontal and step cracking and loose bricks over the bulged area. Damage occurs from slightly above ground level to roughly the frost line.
- **Cracks and loose bricks:** frost, settlement, expansion, usually diagonal or stair-stepped, often at building corners where roof spillage is concentrated.
- **Loose bricks and missing or lost mortar:** and movement where mortar is severely washed-out by roof spillage or other water

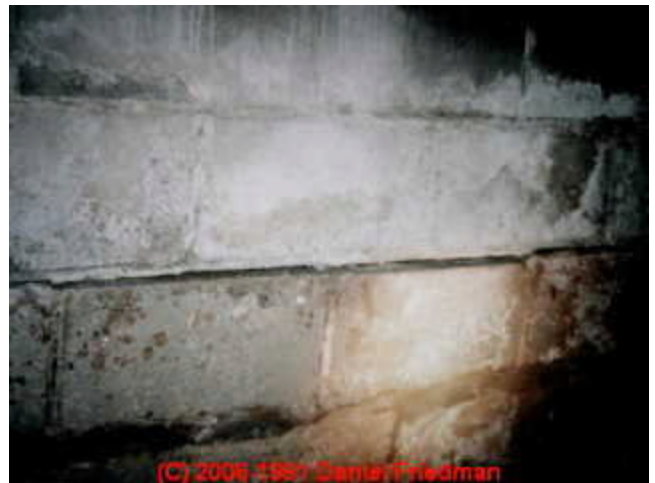
In masonry block construction, foundation or wall cracks occur more commonly in mortar joints but can also occur across blocks. Horizontal cracks are more immediately threatening of serious collapse than vertical cracks. Expansion and shrinkage cracks may occur but are less common than in some other materials. Cracks tend to be more severe in the center of walls from external loading and pressure (from any source). Cracks occurring near foundation corners are often from water and frost. In freezing climates, "frost
