CAHI MONTHLY NEWS

November 2019 Volume 12, Issue 11

Common Deck Defects

Here's a look at the framing and flashing details
that contractors keep getting wrong

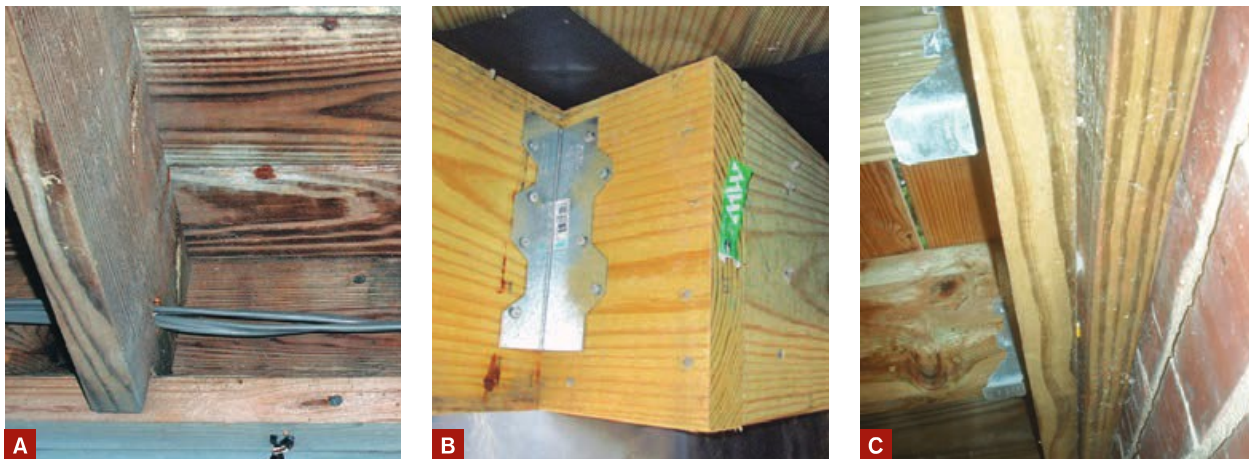
Figure 1. Older decks frequently have ledgers that have been nailed rather than screwed or bolted to the house (A), but the author sometimes finds this problem on recently built decks too (B). Note the nailed double-ledger connection, which is in the process of separating, in photo (C).

find ledgers that have been nailed to the framing, which is prohibited by both DCA 6-15 and the IRC (**Figure 1**). When I do, I complete my inspection, then explain the risks to my clients and advise them (and their real estate agent) not to walk on the deck until it is properly attached to the house. In my report, I highlight this defect in red ink to emphasize the importance of this finding and recommendation.

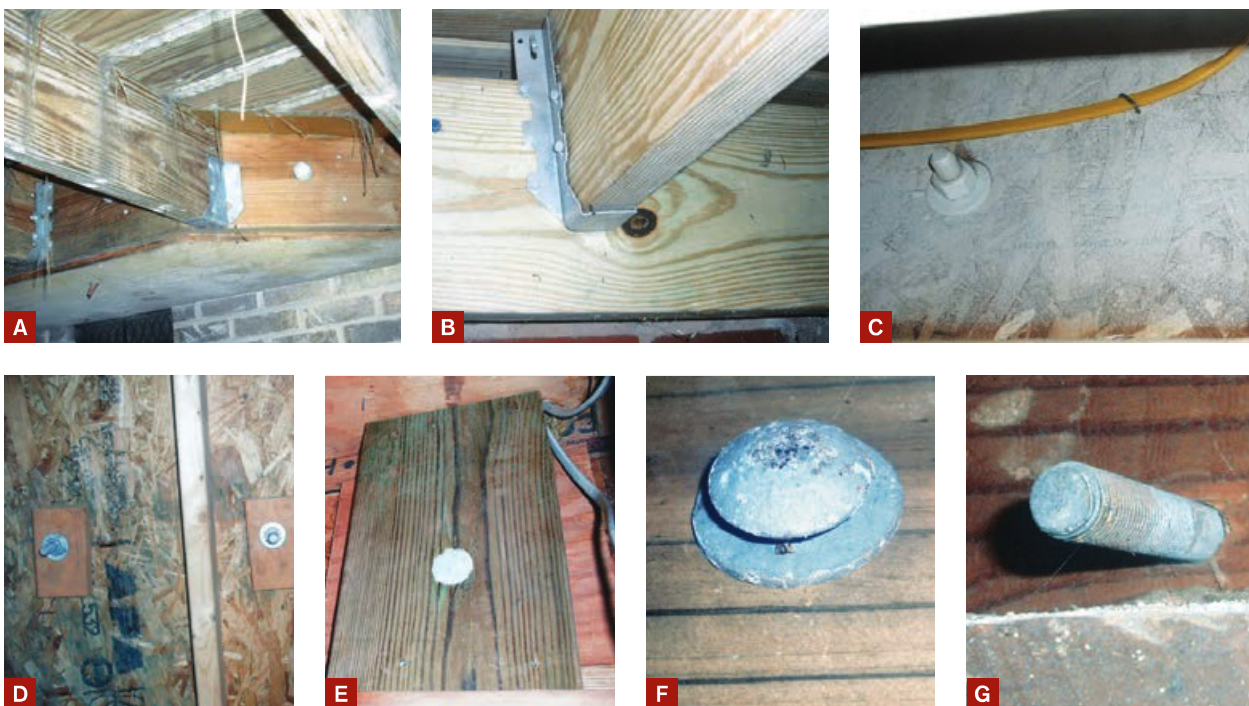
Figure 2. Ledgers shouldn't be fastened to a cantilevered projection (A), to brick veneer (especially with masonry screws) (B), to the web of an I-joist rim board (C), or to OSB sheathing (D). This ledger, on a year-old deck, was fastened to an I-joist rim board with carriage bolts; neither the fasteners nor the method are allowed by code, despite the blocking (E). Adding a washer to a carriage bolt doesn't make the connection code compliant (F), but it's better than forgetting the nut and washer (G). Also note that this bolt is too close to the edge of the rim joist and could cause it to split.

erly installed. I've seen plenty of creative—but incorrect—ways to attach a deck ledger to a building. I've discovered ledgers that have been bolted to masonry walls, to OSB sheathing, and even to the web of an I-joist rim board (**Figure 2**).

Another problem is ledgers that are attached to cantilevers. Because cantilevers aren't typically designed to support the loads from a deck, both the IRC and DCA 6 require that the band joist supporting the deck ledger be fully bearing on the structure, effectively prohibiting attachment of a deck ledger to a cantilever.

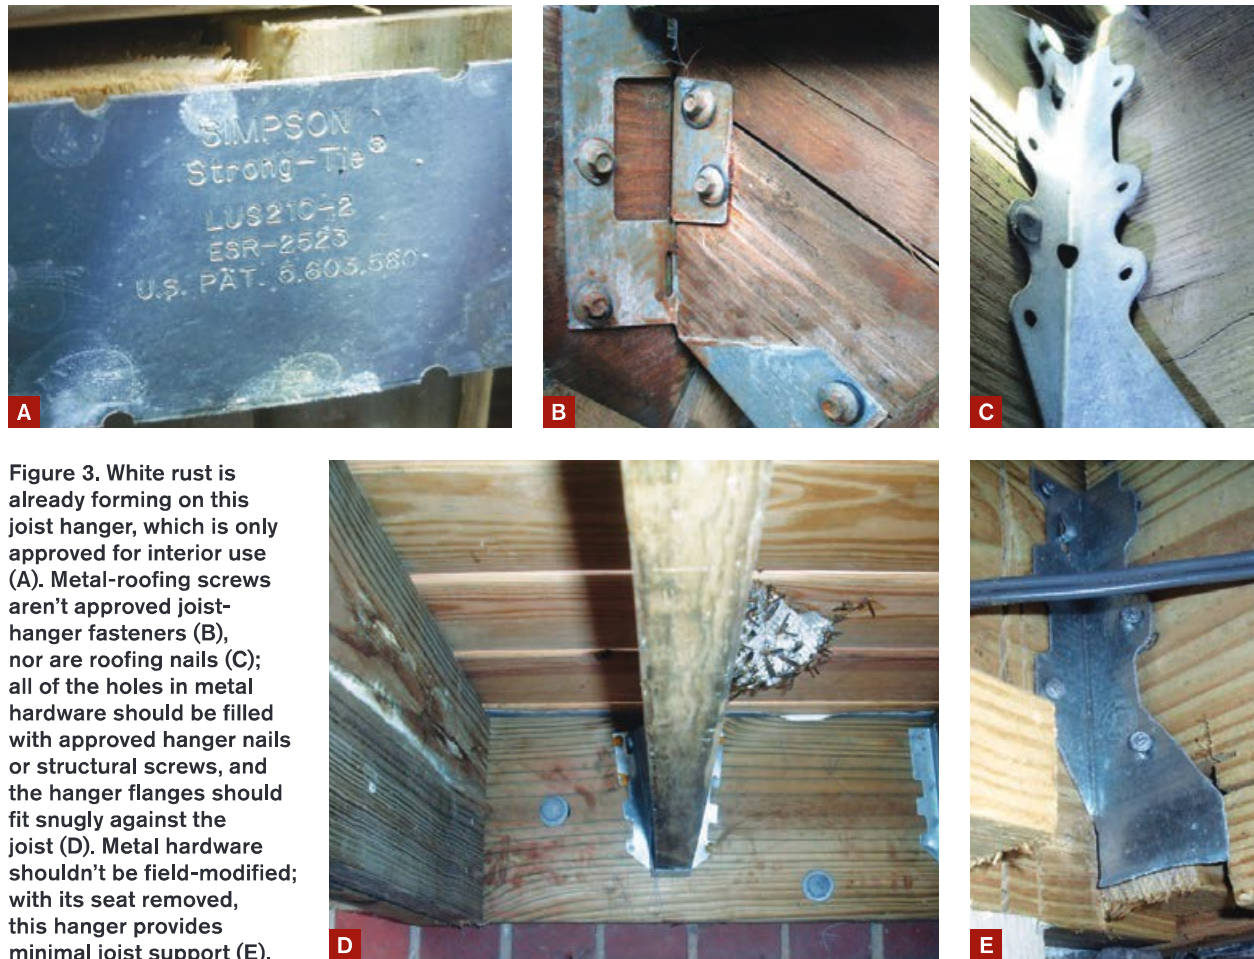
Figure 3. White rust is already forming on this joist hanger, which is only approved for interior use (A). Metal-roofing screws aren't approved joist-hanger fasteners (B), nor are roofing nails (C); all of the holes in metal hardware should be filled with approved hanger nails or structural screws, and the hanger flanges should fit snugly against the joist (D). Metal hardware shouldn't be field-modified; with its seat removed, this hanger provides minimal joist support (E).

I often find problems with joist hangers and other metal hardware. Sometimes the deck builder has used hangers intended for interior use, when he or she should have used G185 (minimum) galvanized hangers, or even stainless steel hangers in coastal areas. One way to verify that a Simpson Strong-Tie joist hanger is suitable for use on a deck is to look for a Z (galvanized) or an SS (stainless steel) at the end of the model number (**Figure 3**).

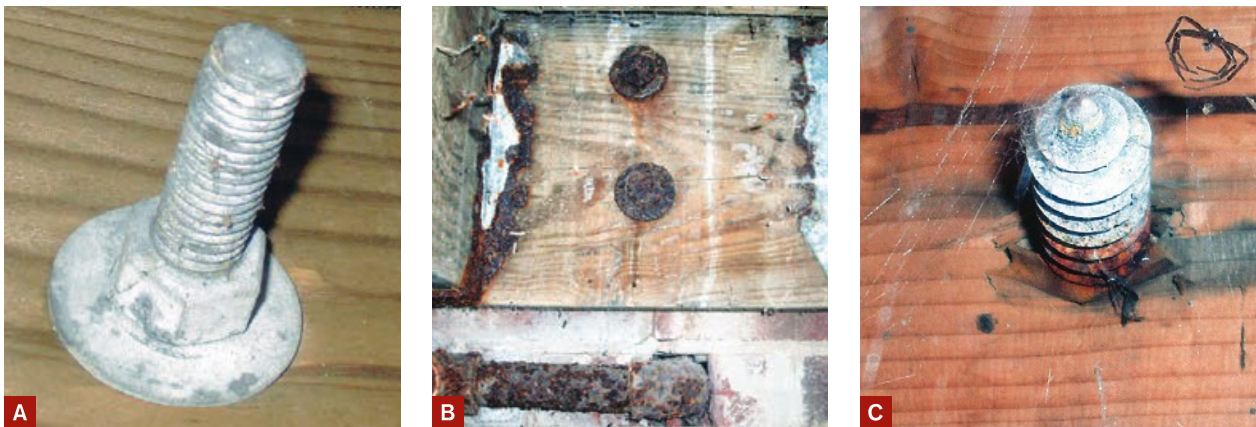
Figure 4. The white rust on this ledger bolt indicates that it is still safe but is nearing the end of its service life (A). The extensive red rust on these bolts indicates that the hardware should be replaced immediately (B). Water intrusion is causing wood rot and the red rust on this lag bolt; the connection is likely weakened (C).

One of the most important things I look for when inspecting a deck or balcony is white or red rust. White rust appears on metal hardware as white stains, indicating that the protective zinc coating (galvanization) is deteriorating. While white rust indicates that hardware is nearing the end of its service life and should be monitored regularly, significant red rust indicates that the component has reached the end of its service life and should be replaced (**Figure 4**).

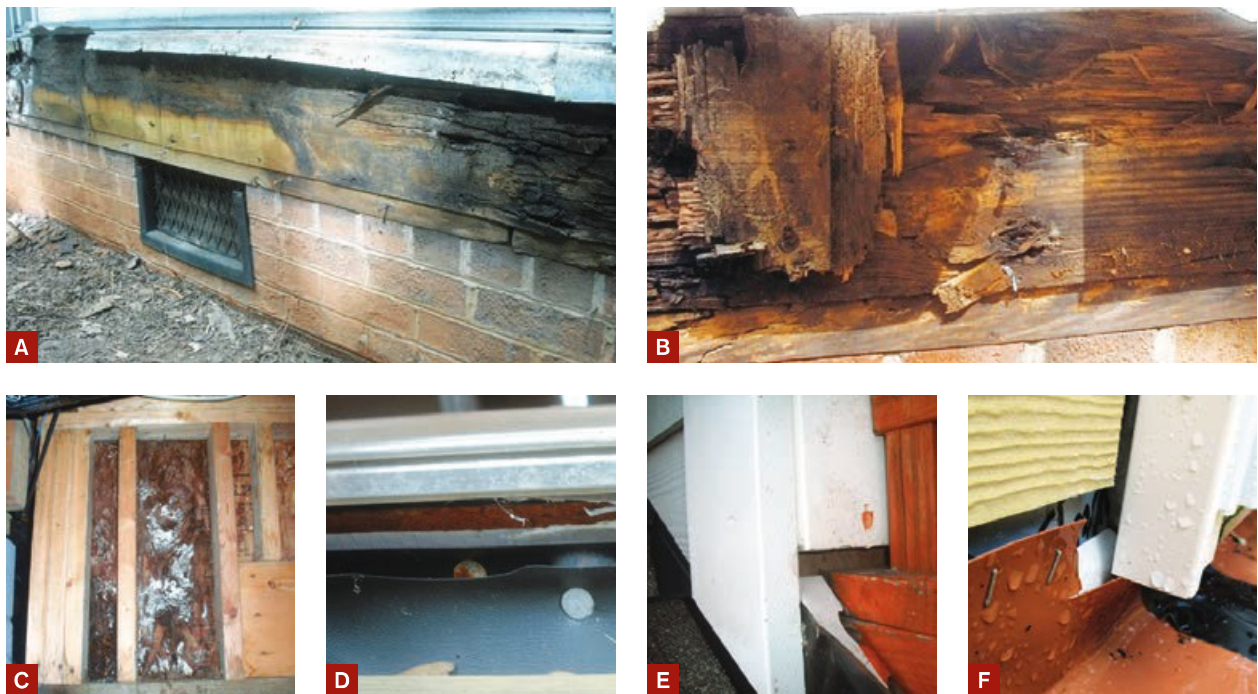
Figure 5. The sheathing and band joists on these homes (A, B) are in rough shape, thanks to moisture intrusion from their decks, and require replacement. Improperly installed ledger flashing on a one-year-old deck was the cause of this water damage (C). Flashing is often improperly installed underneath door thresholds (D) and where ledgers intersect with other building components, such as a roof (E). During a new-home inspection, the author discovered flashing that hadn't been integrated with the water-resistive barrier underneath the home's siding (F).

It won't matter how well a deck ledger is attached to a building if the band joist or rim board it's attached to is water-damaged. The bolts or screws may withdraw from water-damaged wood, and if this occurs, the deck will collapse. Even though flashing details are not spelled out in the IRC, properly installed deck flashing is essential for the long-term structural integrity of a deck (**Figure 5**).

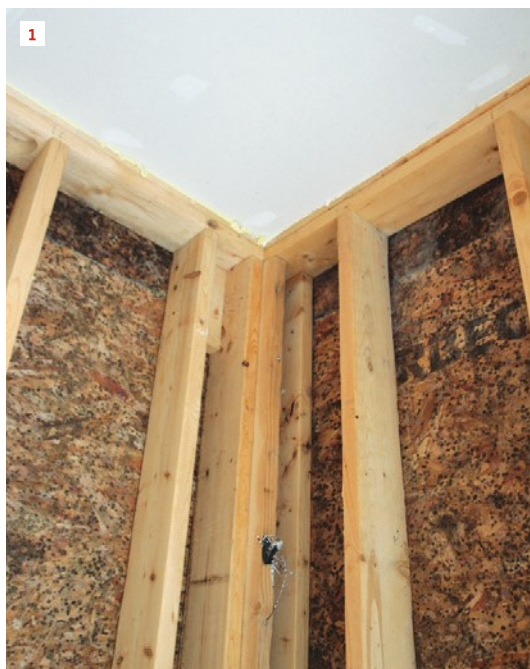
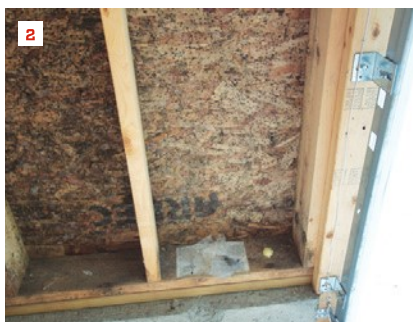
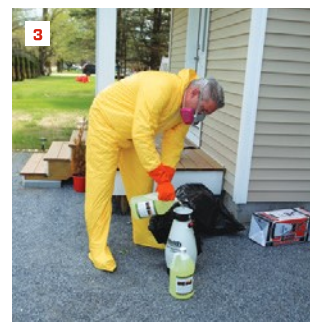
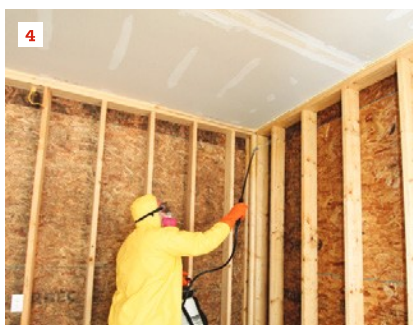
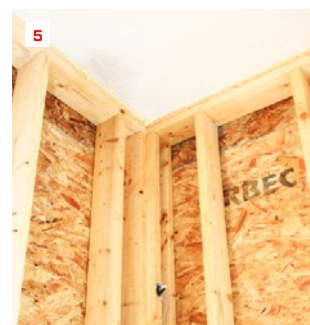
Moisture led to mold discoloration on this OSB sheathing (1, 2). After gearing up with protective equipment, the author pours mold stain remover into a hand-pump sprayer (3) and applies it to the affected areas of the OSB (4). Within minutes, the solution has eliminated the staining and restored the OSB to a like-new appearance (5).

From experience, I've learned to rely on one particular cleaning product for cleaning up moldy OSB: MMR mold stain remover from Bad Axe Products (badaxeproducts.com). The formula for MMR includes sodium hypochlorite (which bleaches the wood and cleans up the mold stains) and some proprietary surfactants (which help the formula soak into the surface).

Before you handle this powerful chemical, you should be prepared. I follow manufacturer recommendations and suit up with DuPont Tychem 2000 full-body chemical protective coveralls and a full-face respirator with a P100 organic vapor cartridge, available online from Jon-Don janitorial products (jondon.com), which also supplies MMR. I don plastic gloves and tape the gloves to the protective suit sleeves. Then I pour the MMR into a hand-pump sprayer and spray it full strength onto any surfaces I need to clean.

The product requires no scrubbing. The powerful bleach starts to work within seconds and brings the blackened wood surface back to a lumberyard-clean, bright condition in less than a minute. Once the material dries (in a day or so), it leaves no residual trace.
