CAHI MONTHLY NEWS

May 2019 Volume 12, Issue 05

Presidents Corner	1
What Home Inspectors Need to Know About Chimneys.....	2
Effective Foundation Waterproofing.....	7
Carpenter Ants.....	9
Air Sealing a Masonary Party Wall.....	17
Drinking Water Quality Awards.....	20
What a Long Strange Drip.....	21
Viessmann Boiler Recall.....	23

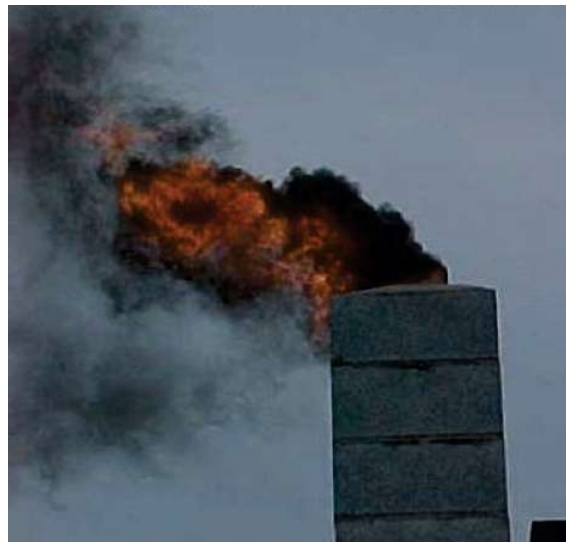
(Figure 2: Chimney Fire)

The most commonly thought of sudden occurrence is a chimney fire (See Figure 2: Chimney Fire). However there can be other thermal events that would fall into this category, as they cause the same sort of damages. Clay flue tiles function well under normal operating temperatures but can fail with sudden temperature changes. Thermal damage is most often seen on flues venting wood-fired appliances but can occur with any fuel. Flue tiles are a ceramic and a dense material. The mechanics of flue tile failure are due to temperature differences between the outer and inner surfaces of the tile.

Rapid heating of the inner surface causes expansion. While the inner surface is attempting to expand, the outer is relatively cool. This stress between the two surfaces causes a longitudinal crack to occur. The cracks may go other directions but always start longitudinally. This rapid rise in temperature may be caused by a chimney fire which can reach temperatures over 2,000 degrees Fahrenheit. A quick, hot fire can cause the same thermal expansion and crack flue tiles without a chimney fire occurring. When flue tiles are cracked they can no longer contain the products of combustion and are no longer suitable for use.

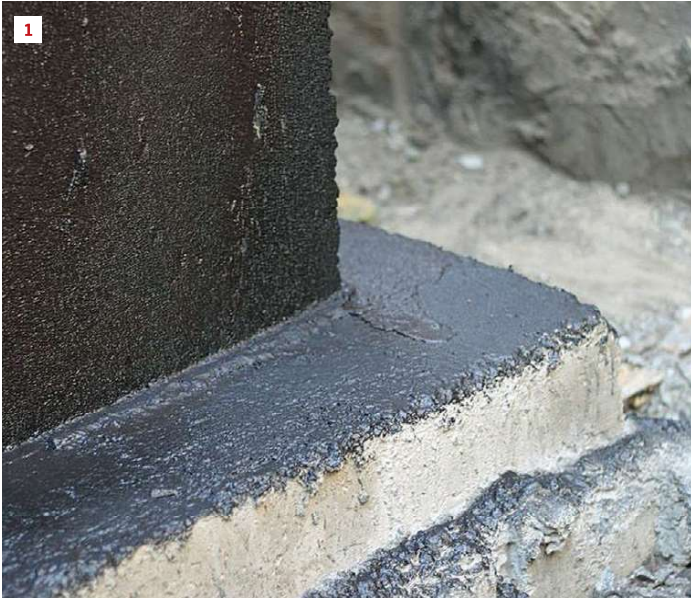
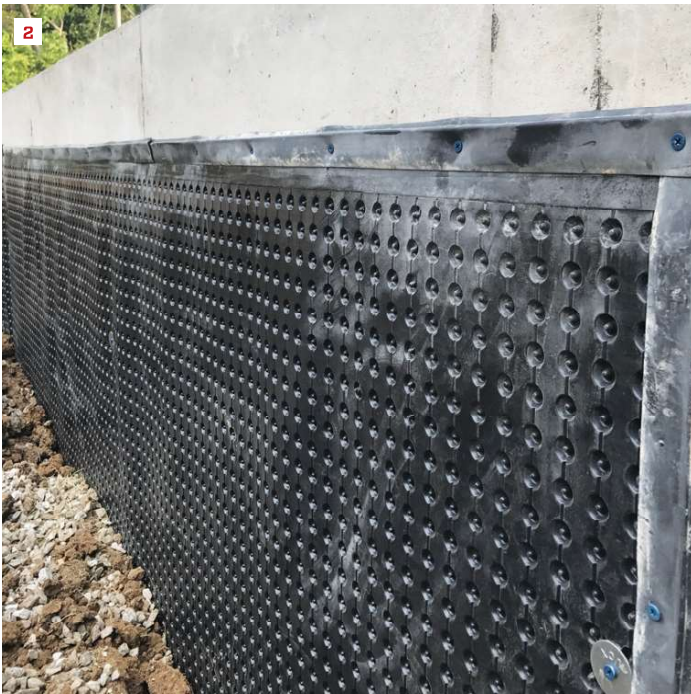
A bitumen foundation coating (1) will help to prevent water from being absorbed into concrete. But it needs a dimple mat (2) in front of it to relieve hydrostatic pressure. The dimples create a space between the soil and the concrete, allowing water to drain freely to footing drains.

The foundation waterproofing system we use is not fancy or expensive, but it works extremely well to fend off water problems. We begin by coating the foundation walls with a regular foundation dampproofing—what is called a “tar coating” around here. The guys put on the full suit, roll or spray the coating on, and use chip brushes to make sure it is worked into all the cracks and crevices on the surface of the concrete.

Bitumen-based dampproofing is a standard, traditional material for foundations, and 15 years ago, that’s all you would have gotten. Dampproofing materials have changed over the years. Most are now water-based and not as hazardous for workers, but they still perform similarly. The important thing to understand is that, by itself, this material can’t hold back pressure-driven water. Under hydrostatic pressure—the weight of water in the soil next to the foundation—water can be forced through the material. This is particularly true as the material ages, especially if cracks develop over time. The material is somewhat elastic but is limited in its crack-bridging capacity.

To prevent water from penetrating, we cover the foundation walls with a plastic dimple mat. This is typically a high-density polyethylene material that we attach to the wall with Tap-Cons and cap off along the top edge with a profiled plastic cap.

The 3/8- to 1/2-inch dimples keep the mat off the wall, creating a void behind it that allows any water that reaches the foundation to drain to the bottom. The water that finds its way past the mat is not under hydrostatic pressure that will drive it through the wall. The dampproofing is there to prevent the free-draining

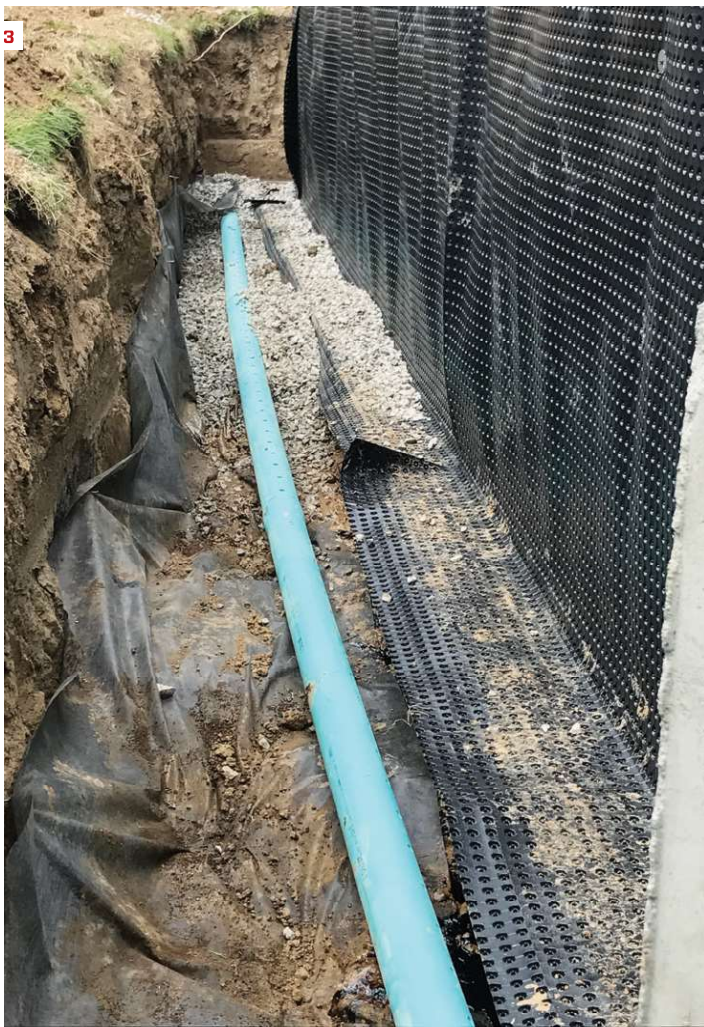
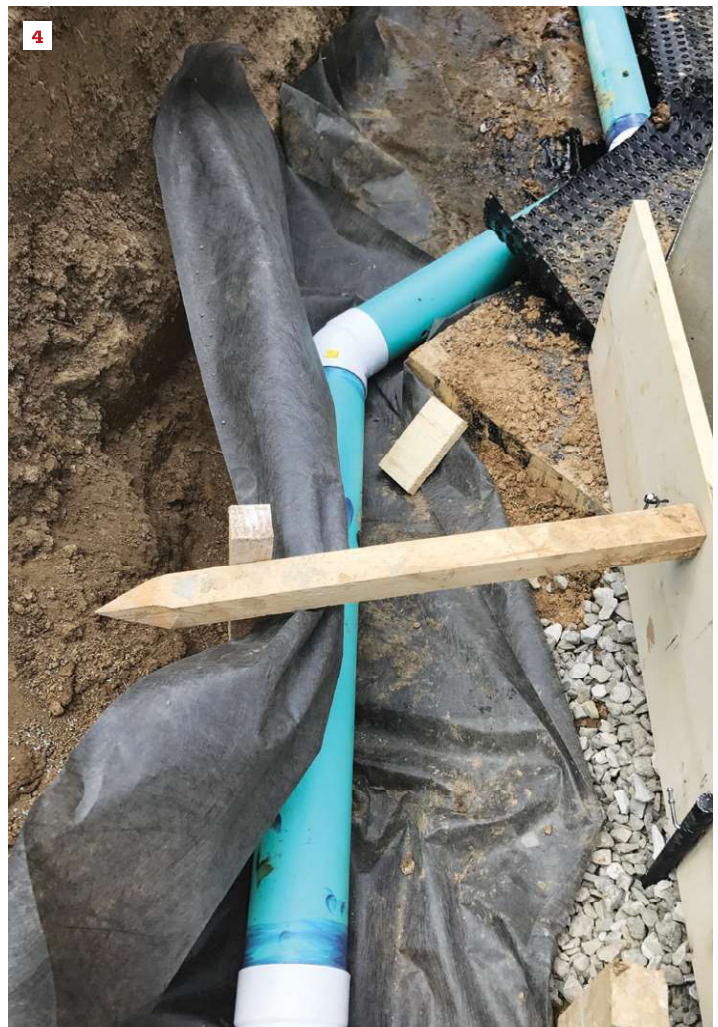
When laying down perimeter drains, the author first lays down filter fabric, then embeds the pipe in gravel. Large (1-inch) gravel creates plenty of voids through which water can freely move, but the filter fabric needs to be there so soil won't fill up the voids over time. Note that the holes in the drainpipe face down to limit the volume of water that accumulates at the footing (3, 4).

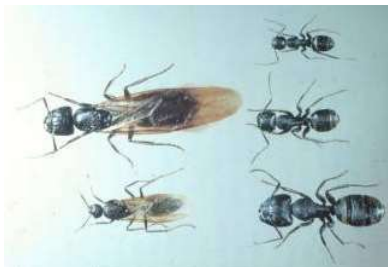
Left column: winged female (top), winged male. Right column: workers of varying sizes.

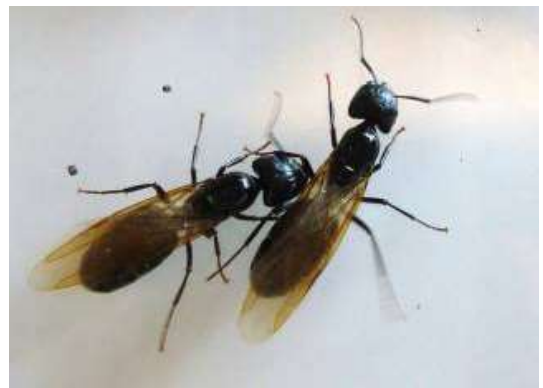
Winged carpenter ant

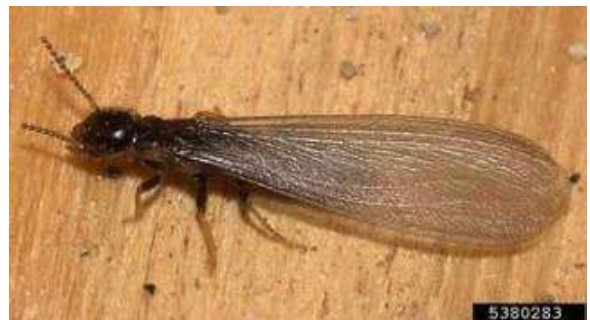
Winged termite

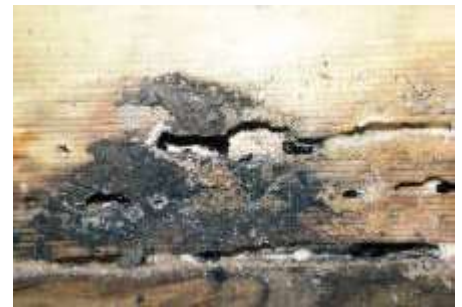
Carpenter ant damage to header board

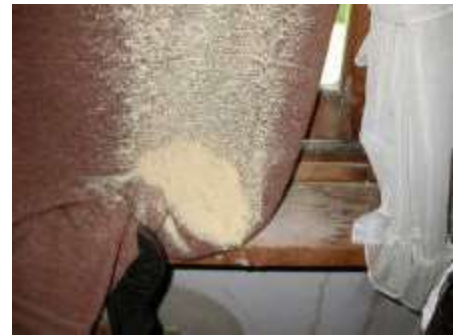
Coarse sawdust from carpenter ants

Finding coarse sawdust or consistent indoor sightings of large numbers of worker ants (20 or more) is evidence of a nest. Also, large numbers of winged ants indoors (late winter through spring) is evidence of an indoor nest.

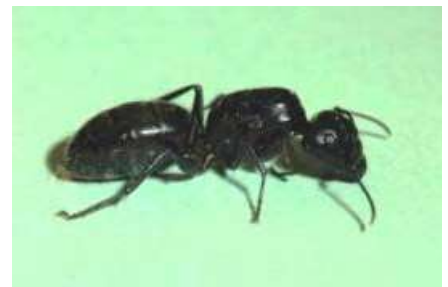
A wingless carpenter ant queen

Wingless queens found indoors are not an indication of an indoor nest. They are new queens that have recently shed their wings and are still searching for nesting sites.

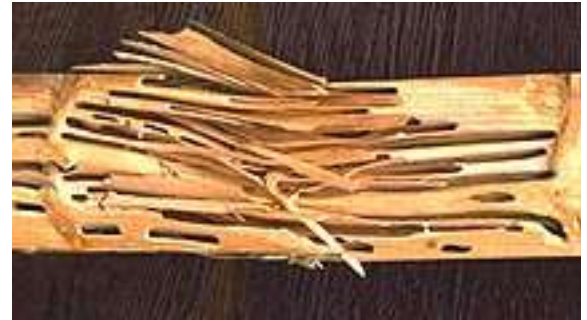
Smooth galleries of carpenter ant damage

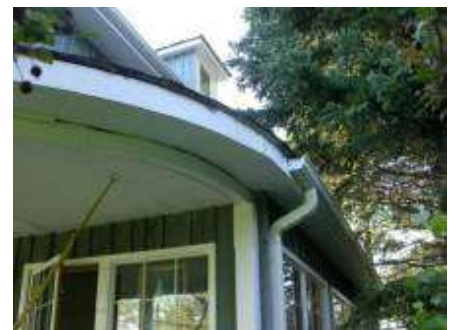
Branches touching a building allow easy access to ants

- Replace moisture-damaged wood.
- Prevent moisture from wood or lumber that is stored in a garage or near the house by elevating it to allow air circulation.
- Store firewood as far away from buildings as possible.
- Remove tree and shrub stumps and roots.
- Trim branches that overhang the home, so branches don't touch the house (including roof and eaves).
- Prune branches that touch electrical lines. Carpenter ants can travel from branches to lines and use them to get into buildings.

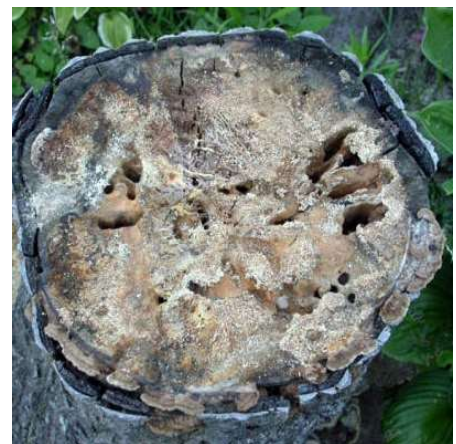
Carpenter ant nest in a tree stump

Try removing the wood with the parent colony. When that is not possible, contact a professional to treat the carpenter ant nest.

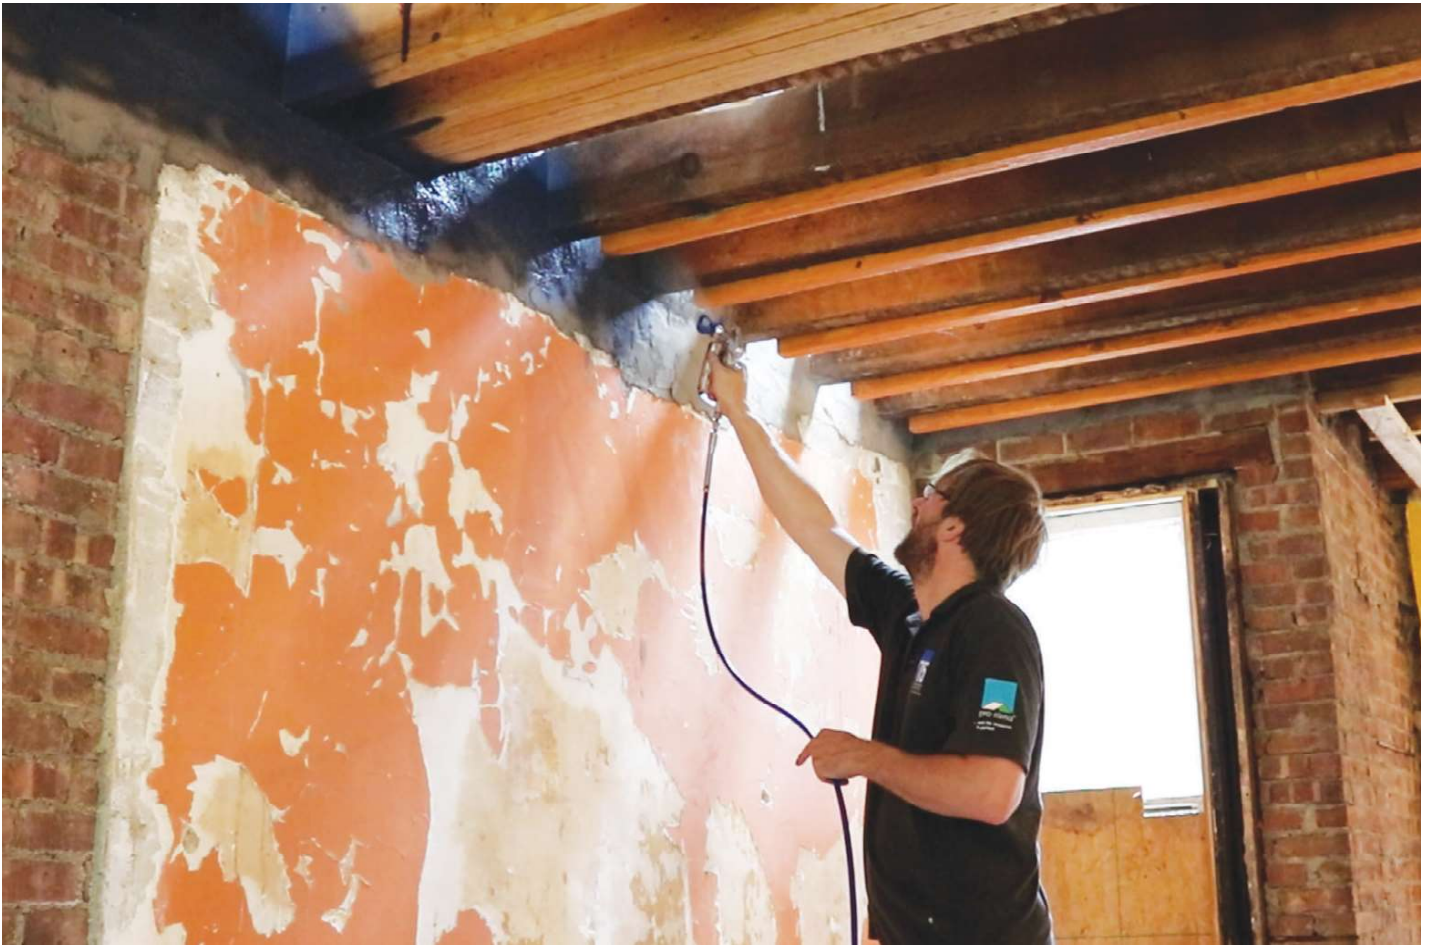
Air-Sealing a Masonry Party Wall A masonry parge and fluid-applied membrane are the keys to performance

Before the masonry parge and air-sealing fluid membrane can be applied, masonry needs to be repaired as necessary. Above, a chimney flue (1) and other irregular surfaces (2) will have to be filled before the wall can be coated. Penetrations in new and existing structural carrying members (3) also need to be filled and smoothed prior to air-sealing.

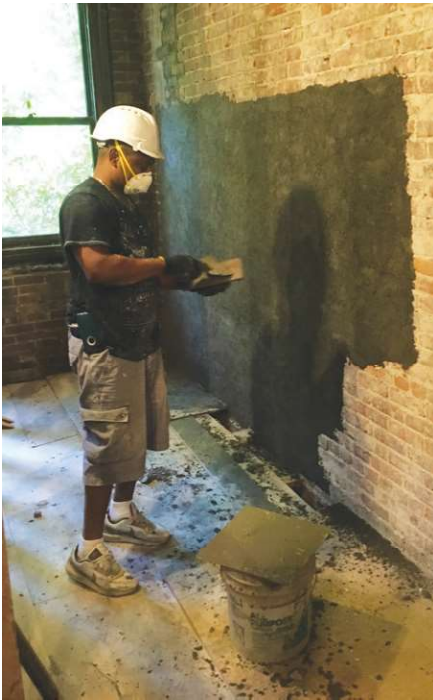
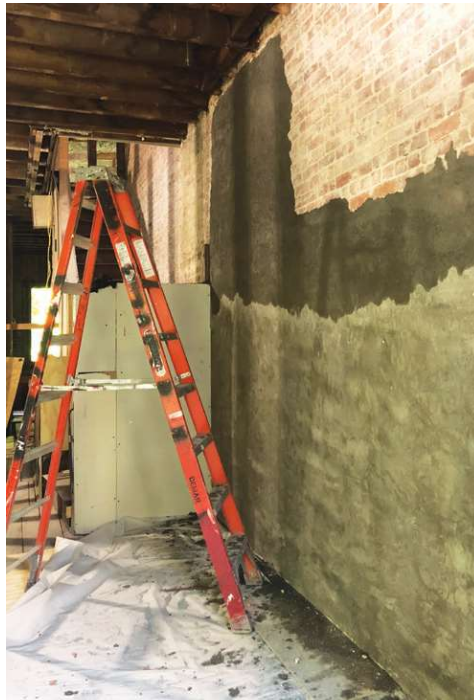
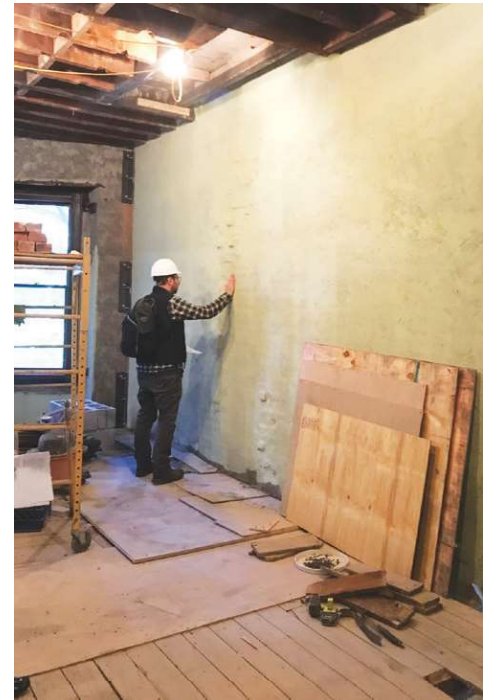
me mortar parge (4) is the first layer to be applied to the brick masonry after rough repair is completed. Next, the parge is sealed with up to three coats of fluid-applied, vapor-open airtight sealing membrane (5). The final result is a fully membrane-
 ted wall (6), ready for blower-door testing to verify airtightness levels.

Then, once the masonry itself is in good shape, we recommend a full parge coat using a lime mortar, to create a flat and level surface for later air-sealing work. This allows the masons to even out any irregular surfaces from the masonry and fill small voids or gaps where necessary.

Once the wall field is prepared and any joist replacement has been completed, a liquid-applied airtightness material is installed over the parge. This material can be any of a number of products, but we typically recommend Sto Gold Coat or Sto EmeraldCoat. These water-based acrylic coatings, typically used for exterior waterproofing under EIFS applications, are vapor permeable but airtight, and can be rolled on or spray applied. This material is installed over the field of the wall and is applied roughly around the timber joists.

We apply a minimum of two coats at 12-mil wet thickness, and sometimes as many as three coats if the substrate is very irregular. Some installers have taken to adding a small amount of different colored pigments to the material before application in order to clearly show where the various coats have been, and have not been, applied, as an aid in inspection.

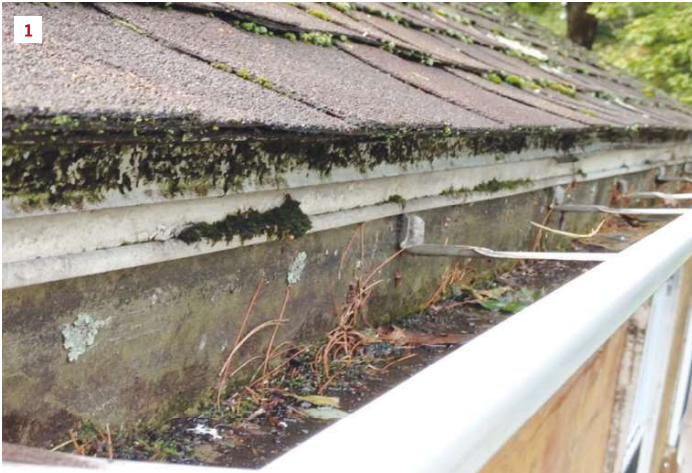
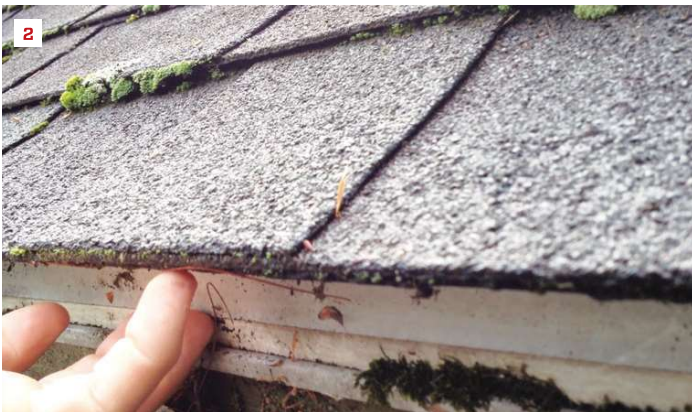
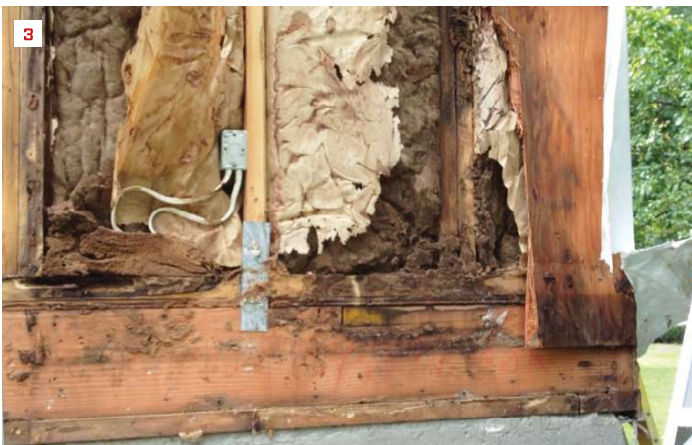
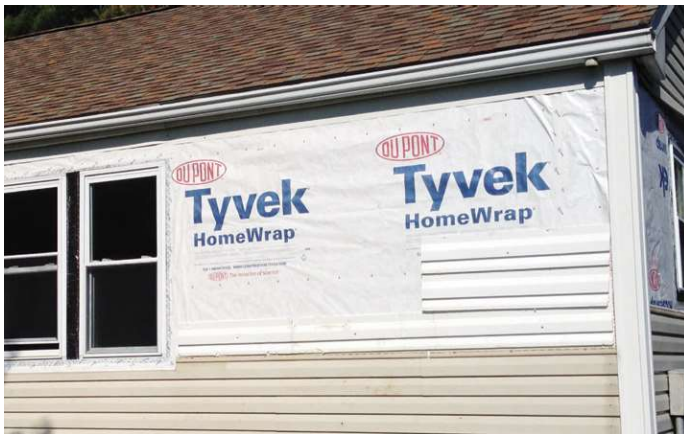
Drip edge installed tight to the fascia was directing water behind the gutters (1, 2), causing saturation and major damage in the house walls (3). To fix the problem, the author first had to strip away and replace the siding and sheathing.

author installed a working drainage plane using taped housewrap to keep the house walls dry, flashing below fascia trim and pulling the roof drip edge away from the to direct rainwater into the gutters.

What we found when we inspected the roof was not a roof leak. Instead, the trouble had begun with the installation of the drip edge and gutters. One simple oversight started the entire problem: The drip edge was applied too tight to the fascia trim. I couldn't even fit a fingernail between the drip edge and the fascia board. That meant that the water would run straight down off the roof, wrap around the drip edge and onto the coil-wrapped fascia, and run down behind the gutter instead of falling into the gutter where it was supposed to go.

Water soaked the sheathing. Over the years, the water rotted the sheathing in multiple places. When we removed the sheathing, we found rot around all the windows below the eaves, and some even on the gable-end windows. Housewrap on the walls stopped short of the windows, and wasn't integrated into any kind of tape or flashing. The window trim was installed in a way that let water penetrate to the sheathing and the window openings.

But our main project was to remove all the siding and sheathing, repair rot (including reframing windows), replace the bug- and mold-infested insulation, resheath the building, construct a working drainage plane, and flash all the windows correctly into the housewrap.

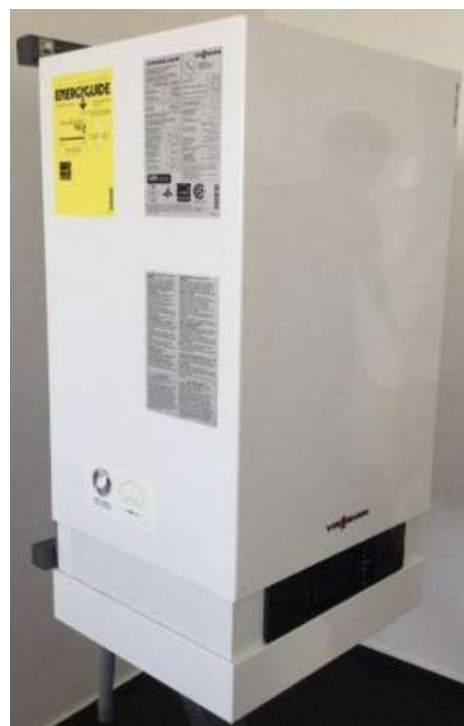
The boiler heat exchanger back plate can corrode and leak flue gases, allowing the boiler to emit excessive amounts of carbon monoxide, posing a CO poisoning hazard to consumers.

Recalled Viessmann Vitodens 200-W wall mount boiler
