# CAHI MONTHLY NEWS

October 2014 Volume 7, Issue 10

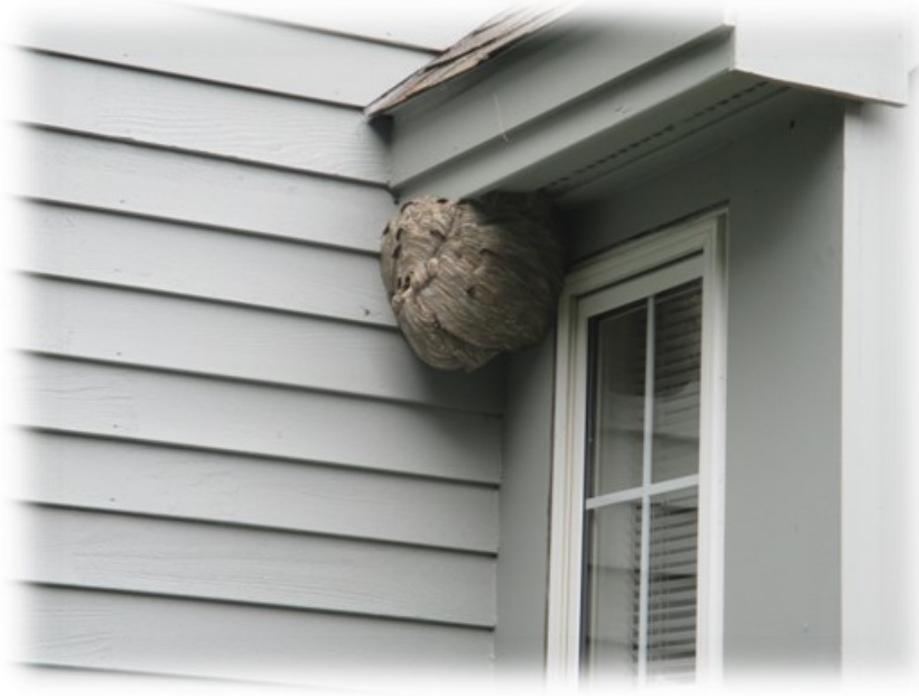
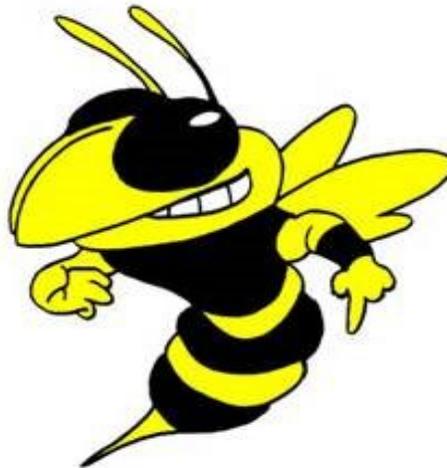
Sometimes when you are wondering around just minding your own business, you find the most interesting things. On a recent inspection I was looking for the electrical meter and main breaker for a condo unit I was inspecting. When I turned the corner past the end unit I found this...the biggest bee or wasps nest I think I have ever seen!

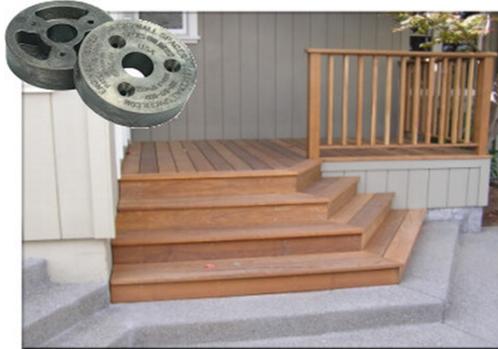
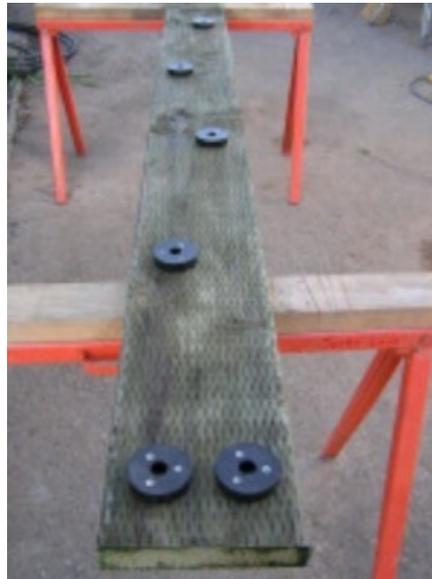
Deck2Wall Spacers™ were tested at ICC-IAS accredited Washington State University. The testing was performed following the methods used which established the deck ledger connection provisions in Table R502.2.2.1 of the 2009 International Residential Code (IRC). The prescriptive IRC table is a valuable guide for ledger connections, but it is restricted to the test configurations that were used to develop to table. The IRC table does not prohibit other designs, as indicated in “R502.2.2.2 Alternate deck ledger connections. Deck ledger connections not conforming to table R502.2.2.1 shall be designed in accordance with accepted engineering practice....”

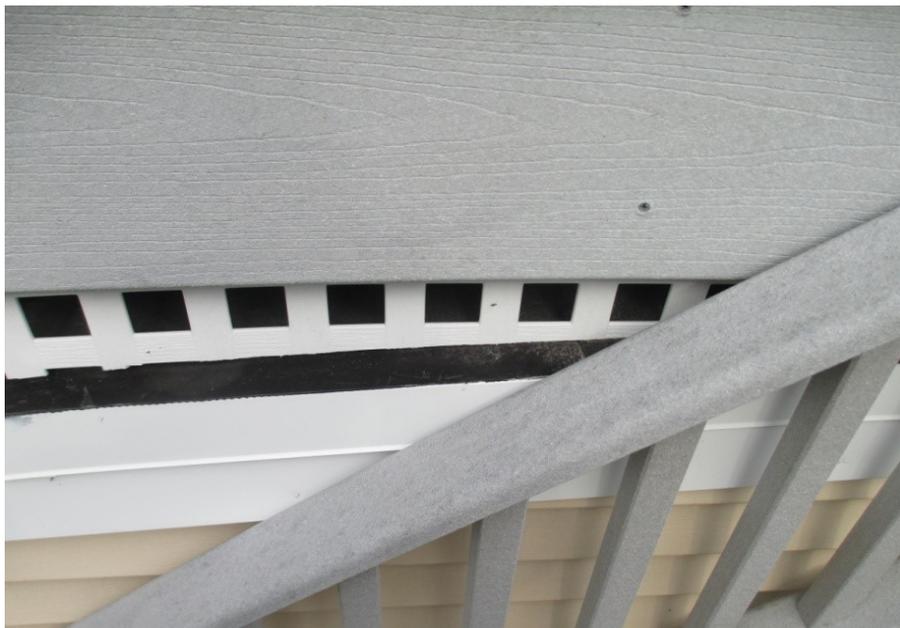
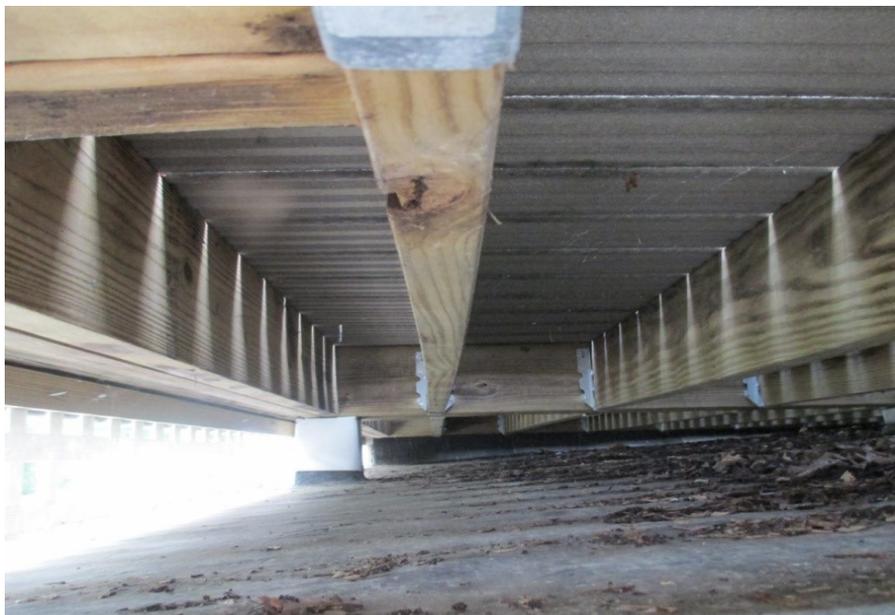
I understand that the roofing material has a useful life of twenty years when installed exposed to the weather. Won't it last longer when it is covered by a deck? Yes, but that does not mean it cannot leak in the interim. We are relying on the integrity of the builder and his or her sub to ensure that this roof was installed carefully so that does not happen. However, there are usually points where posts penetrate the roof to support the deck structure that have a higher potential leakage rate. They must be treated in a manner that will provide a water tight seal. BUT...if they leak what happens?

I just want to bring reality to the fore front when I see things of this nature. There is living space under these decks, and if the roof leaks...for whatever reason...I do not want to be part of the chain of custody...Know what I mean?

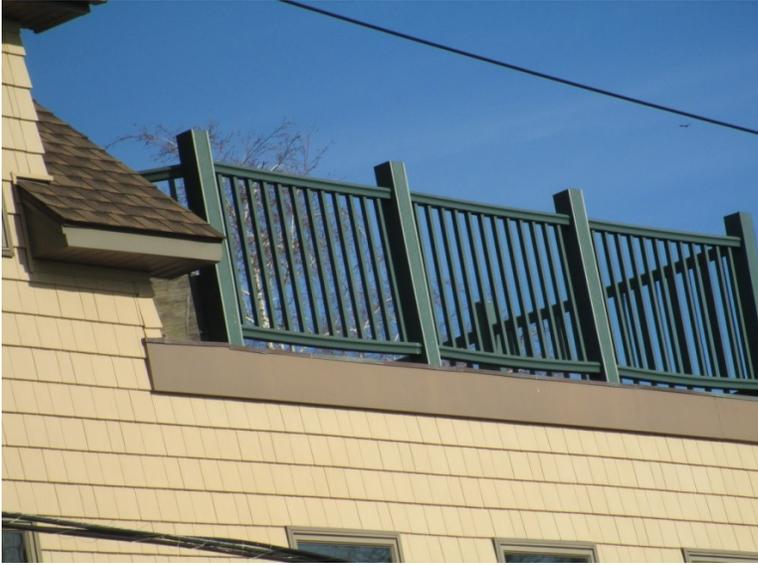
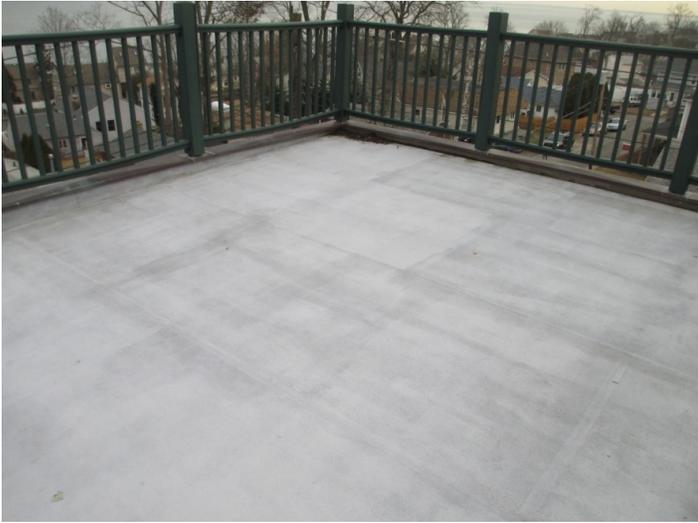
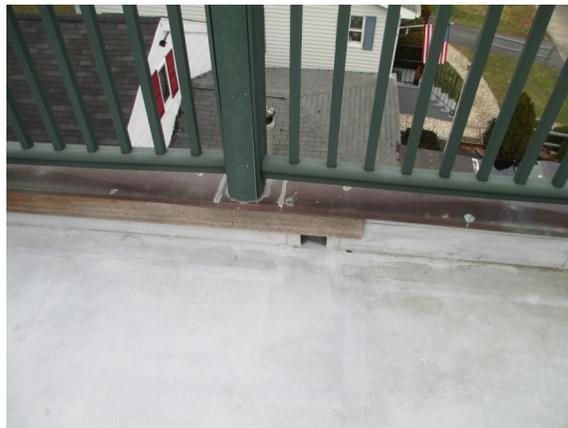
Or what about using the roof as the floor?

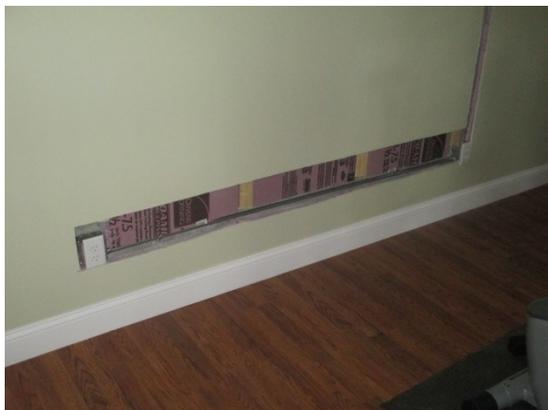
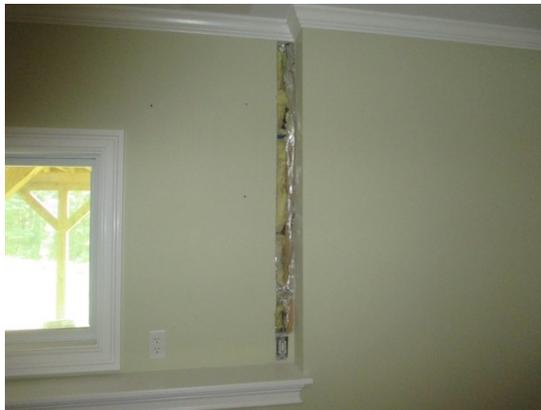
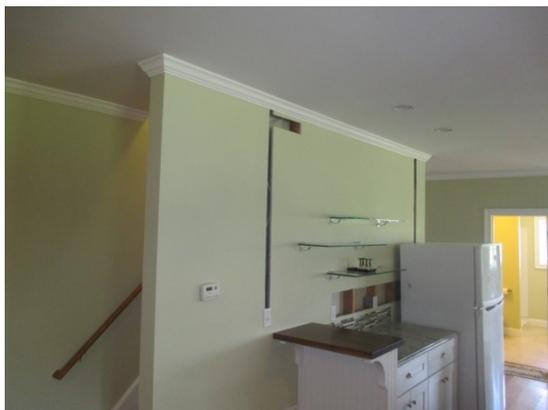
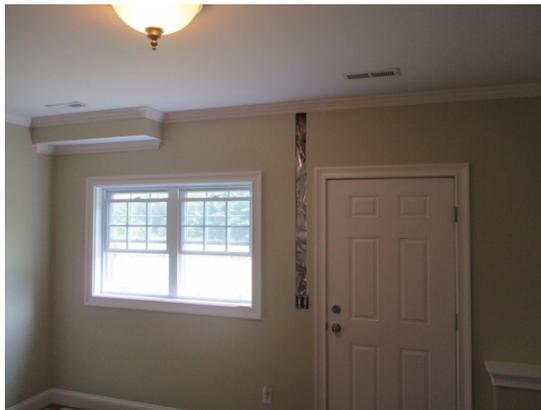
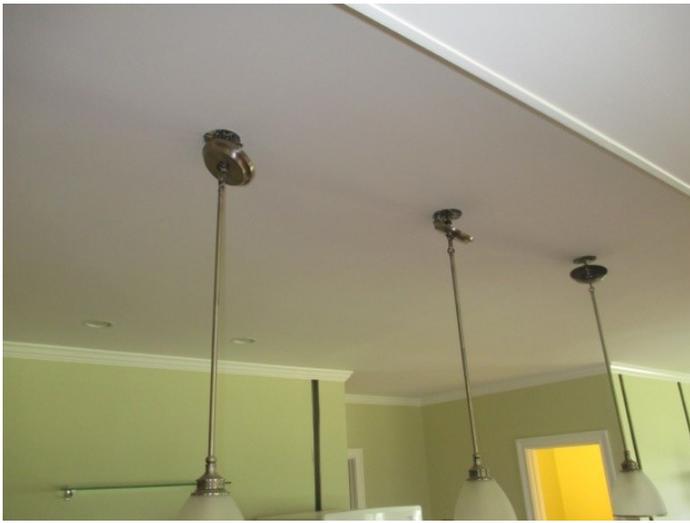
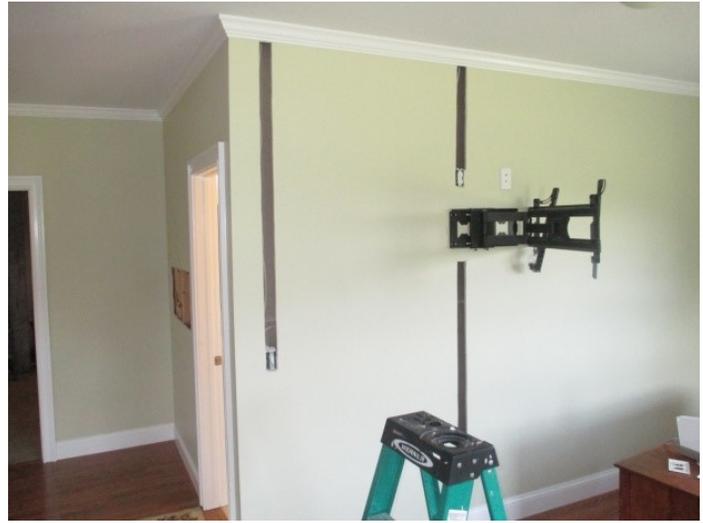
I have had my fair share of finished basements lousing up deals. I bring up the "P" work all the time. I also have a blanket statement in my report regarding permits and work performed in the home. But my question here is...which inspector is right, the one that mention the P work, or the one that did not. The following pictures portray what can happen when you must have an unpermitted basement permitted.

Back to the question of who was right and who was wrong. Technically, because we are not performing a code inspection, we do not have to mention the need for permits. We do not have to mention that an attached garage may not be protected from fires. We do not have to state that an exposed wire splice should be installed in a secured and covered junction box. We do not need to point out the absence of hand railings on stoops and in stairways. I can go on and on. And even if you can squirm out of something like this because of the standards...somebody's gotta pay for this!

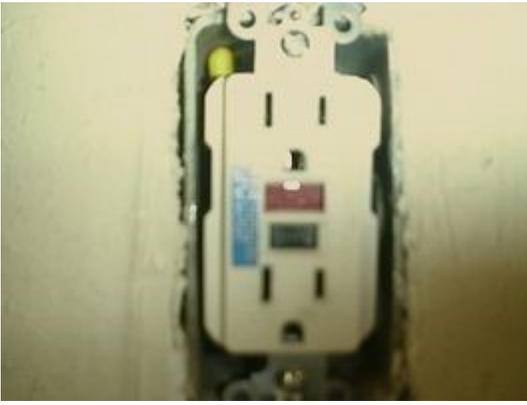
Ground an Electrical Outlet With No Grounding Wire

Ground an electrical outlet with no grounding wire by installing a Ground Fault Circuit Interrupter (GFCI) receptacle. The National Electric Code (NEC) allows three prong GFCI outlets to exclude ground wires due to the built-in breaker switch that trips at the indication of a short. An electrician may insist on grounding a GFCI during installation, but it is not required for most applications. A GFCI without ground wiring is not considered safe for computers or microwave ovens, but it will accommodate all other household electrical items.

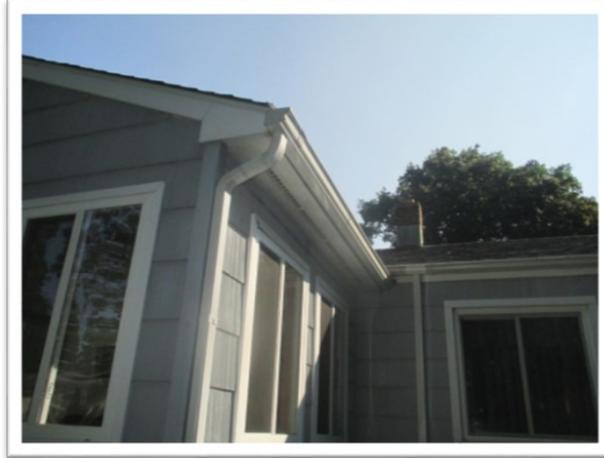
It was a Monday. The inspection started like just about any other inspection...on the outside. Everything looked normally. Typical routine maintenance stuff.

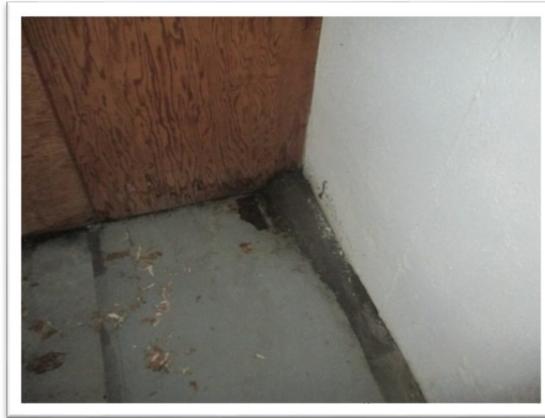
But on the inside trouble was brewing. My inspection of the basement turned up some dampness on the floor and some water stains on installed plywood. Hmm, hasn't rained in a long while.

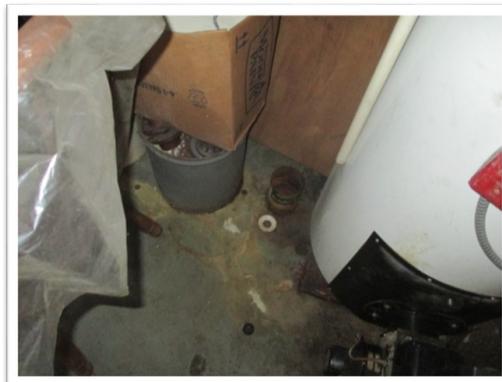
There was water near the water heater as well. A closer on the knees inspection of the base of the water heater did not find water dripping from the tank itself. Must be the relief valve...and it appears that it has been dripping for some time.

Even though it was dry between the two wet areas, the dry space may be a high spot and the water probably just evaporated in this area. Metal cans were rusted in the same area.

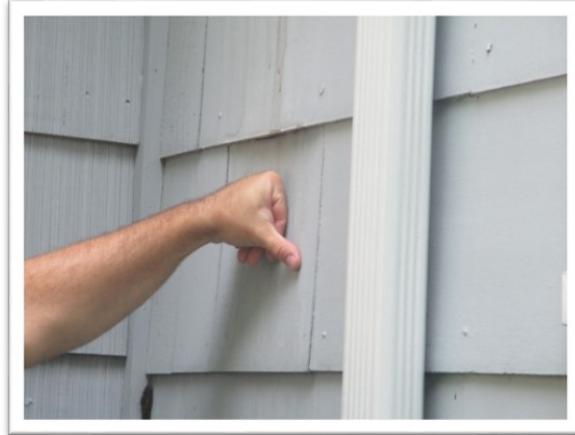
First thought...TERMITES! But after closer investigation, it was not. I looked up and I saw water stains running down the wall as well. So I went back outside and looked at the siding, gutters and roofing in this area. A low and behold, water stains on the siding as well. Pushing on the area, it was clear that the sheathing was soft and water damaged.

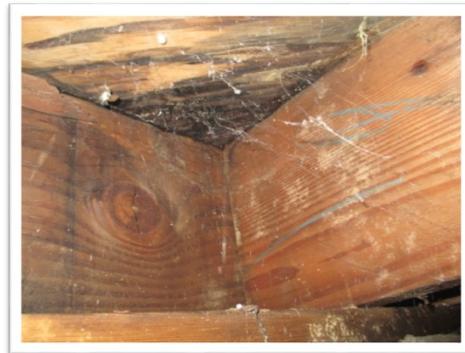
I returned to the basement and examined the area below this area and found discolored floor sheathing... right below the flaking paint and above the standing water and water stained plywood in the basement.

So I surmised that the gutter for the addition was improperly pitched or overflowing, causing the water to run down the exterior and the interior of the exterior wall, damaging the wall sheathing and causing the paint to fail on the interior wall. The water was also running through the base of the wall, into the basement and under the water heater.

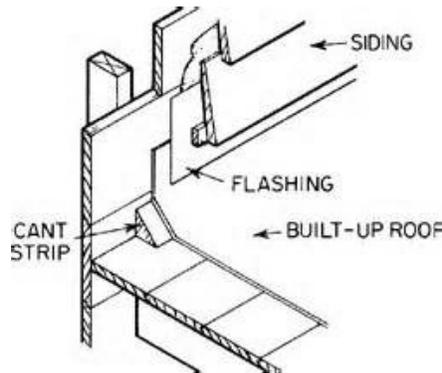
Cants, or cant strips, are components of built-up roofing. A cant strip is a small strip or block of material, usually triangularly shaped, placed at the point where a roof deck intersects with a parapet wall that rises higher than the roof. Cant strips are used to support roofing material and prevent gaps or voids. They are most commonly installed in asphalt roofing systems and modified bitumen membrane systems.

When not using roofing cants, an asphalt roof can have a 90-degree angle between the roof surface and the wall it intersects. The sharp bend places stress on the felts used to support the roof. They can pull away from the angle, trying to straighten out. This can crack the roofing surface and creates gaps that allow moisture to get under the roof. A cant strip creates a gentler angle, closer to 135 degrees than 90. This reduces stress on support felts and provides an extra layer of protection for the flashings that line the edges of the roof.
