# **CAHI MONTHLY NEWS**

**November 2015 Volume 8, Issue 10**

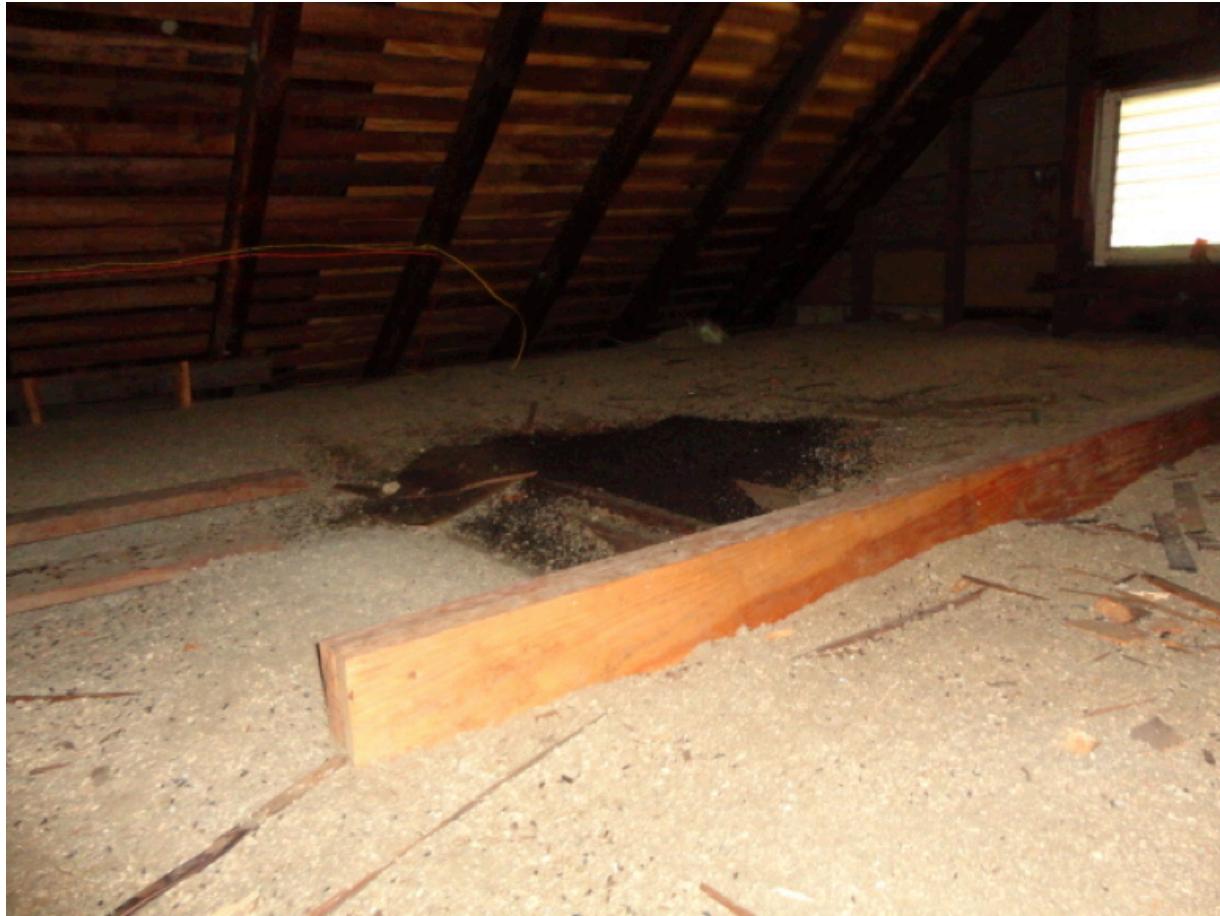
As stated last month, the picture below was taken while inspecting the attic of an old three family house in Seymour. My photographer missed the opening in the screen over the gable vent. There was also an open gap in the ridge vent material that was above this picture.

**What self-invited critter(s) caused this mess?**

**Bats.**

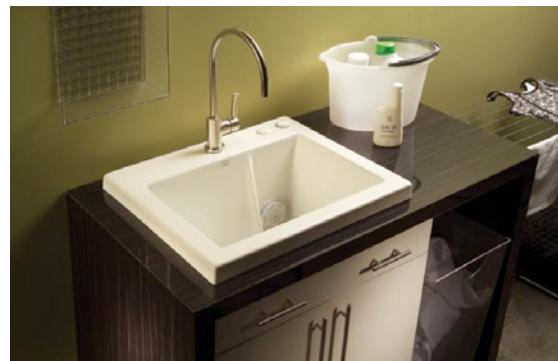
*The MTI Gentle Jet Laundry Sink is perfect for washing delicates. It features a jet system that recirculates the water, similar to a jetted bathtub.*

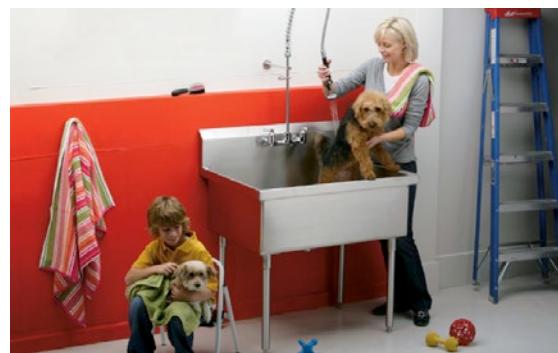
*Tough jobs call for a sink and faucet with industrial utility and durability. The Elkay Pursuit Sink is made from 14-gauge stainless steel, and the Elkay Commercial Faucet has a flexible hose that extends 30 in.*

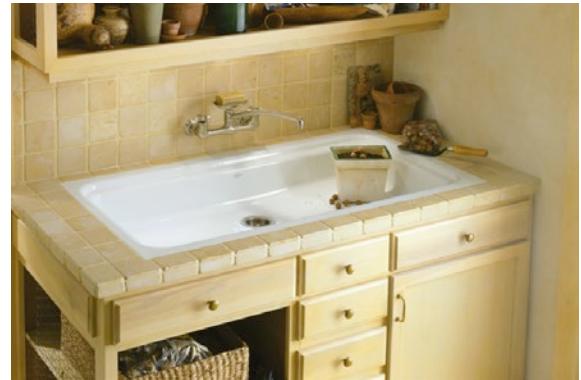
*Most utility sinks are defined by their deep basins, but in some cases a wide, shallow basin is more suitable. The Kohler Oceanview is 48 in. wide and only 6-3/8 in. deep. This sink would also work well installed on the floor.*

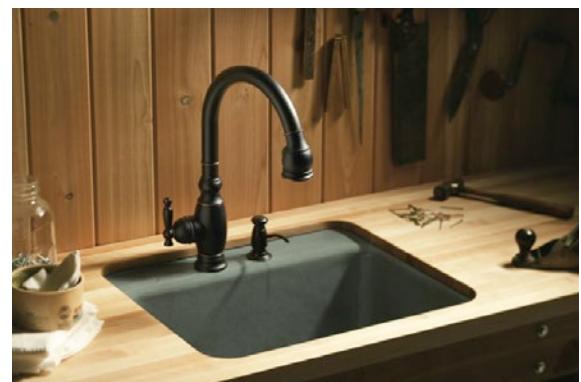
*Just because it's functional doesn't mean a utility sink can't have style. An undermount model, such as this Kohler Glen Falls Utility Sink, paired with a kitchen faucet can give your utility or laundry room a more refined appearance.*

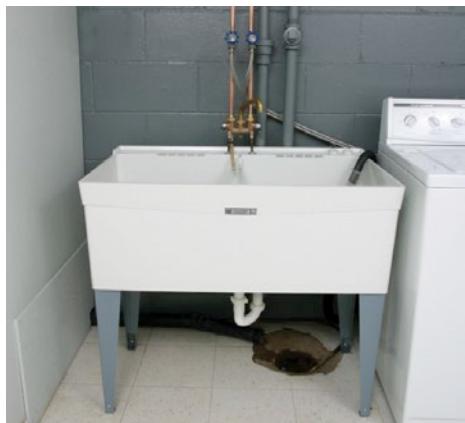
## Sink Installation

Installing a new laundry sink or upgrading to a larger tub is not difficult if you have some basic plumbing skills. Here's how we upgraded from a single-bowl to a double-bowl model.

4. Connect the supply pipes to the faucet; then install the new washing machine shut-off valves and braided stainless steel lines.

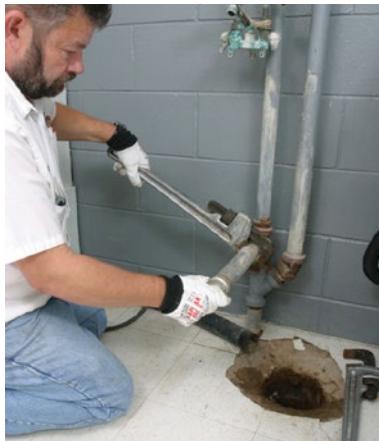
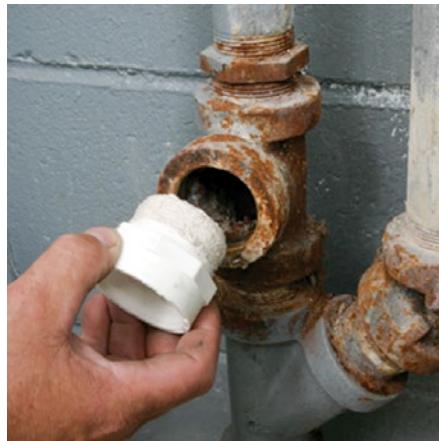
1. Disconnect the old drain and supply lines and remove the existing sink. If necessary, rotate the waste stub-out to realign with the new drain location. In this case the stub-out was rotated and the galvanized extension was removed. Note: Use caution when rotating an old fitting — you run the risk of breaking the old pipe. Thread a new PVC trap adapter onto the waste stub-out (*photos below*)

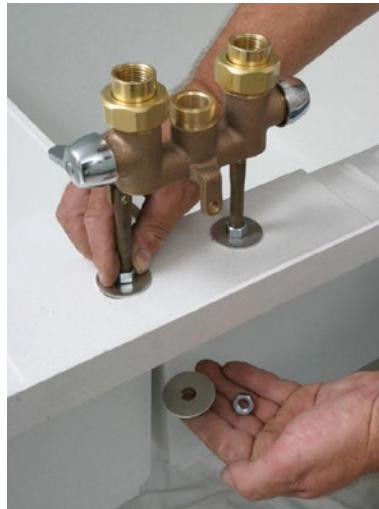
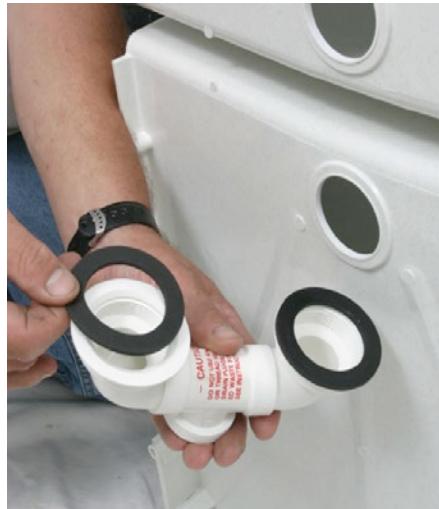
2. Assemble the faucet and attach it to the sink. We installed a brass utility faucet. This tried-and-true design isn't fancy, but it's reliable and easy to service. The faucet mounts on riser posts that are secured with washers and nuts in the faucet-mounting holes. Follow the manufacturer's instructions to assemble the new sink's double-outlet drain (*photos below*).

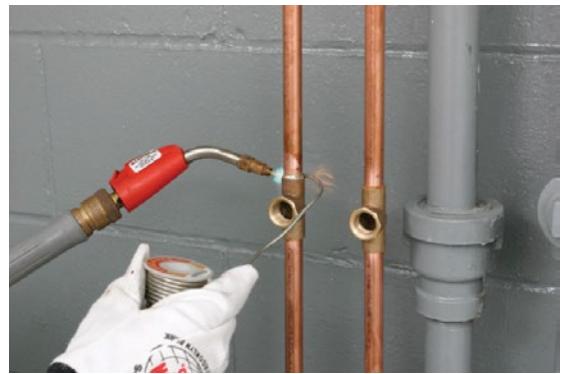
3. If necessary, reroute the supply lines to align with the new faucet location. We also installed new threaded tees for washing-machine shut-off valves.

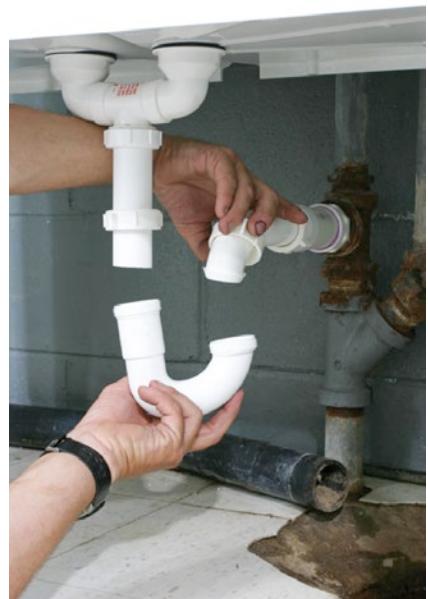
5. Finally, connect the new drain-trap assembly to the sink and stub-out. Then anchor the sink legs to the floor with masonry screws.

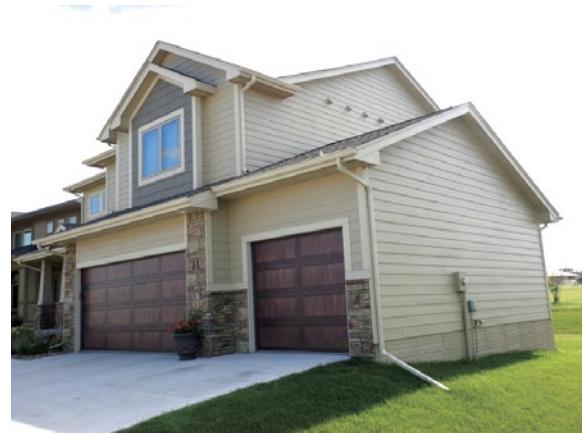
Many fiber-cement siding jobs that look fine from a distance actually have serious installation defects.

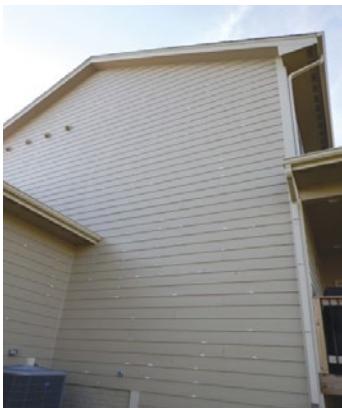
An attempt to repair poorly attached fiber-cement siding by face-nailing it still didn't conform to manufacturer specifications.

I didn't think the work could be salvaged, and I recommended tearing off all the siding and starting over. However, because the initial complaint was about the vibration of the loose boards, the builder thought he could fix the job by face-nailing the siding. But his "fix," along with his attempts to correct the water detailing, still didn't conform to the specifications of the manufacturer's instructions or those codified in the product's Evaluation Service Report (ESR).

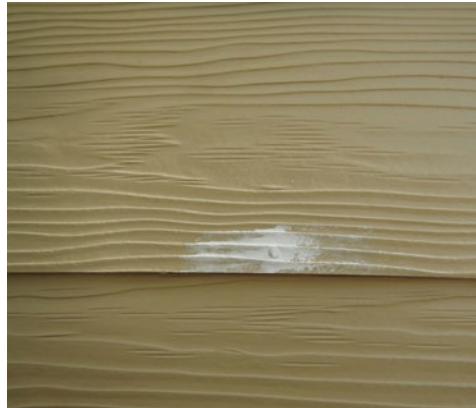
Not only were the face nails too close to the edge, but they were also overdriven.

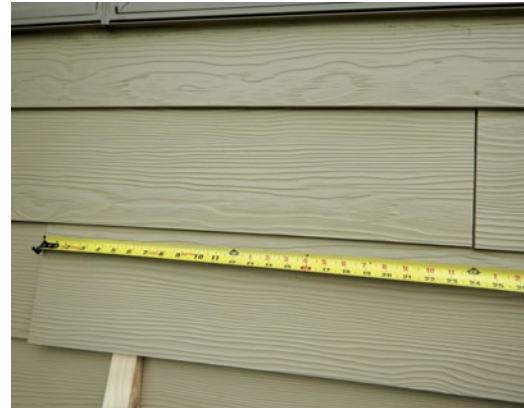
Butt joints should land over studs, but these were offset 24 inches over 16-inch on-center framing, so many of the ends were inadequately supported.

placement for exposed fasteners at butt joints: Butt joints must be located over studs (or a metal plate must be used for butt joints between studs, but none were in evidence on this job), and the nails placed 3/4 inch up from the bottom edge and 3/8 inch from the ends.

On this job, however, the butt joints were not located over the studs. The house was framed on 16-inch centers, while many of the butt joints were offset by 24 inches. At the butt joints, the builder had initially made an attempt to hold the ends down with a single nail strategically placed to hold both ends—an incorrect detail that I see all the time. I have also seen installers try to pin the ends down. Neither solution will provide enough holding power to secure the siding.

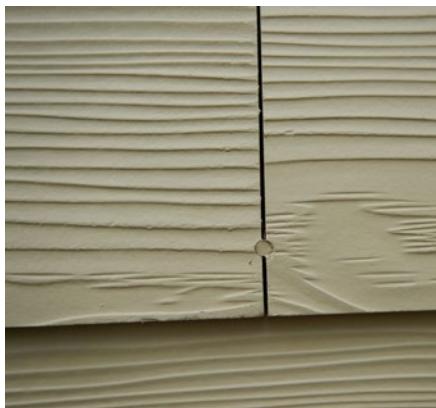
single nail placed in a butt joint is not enough to secure the siding.

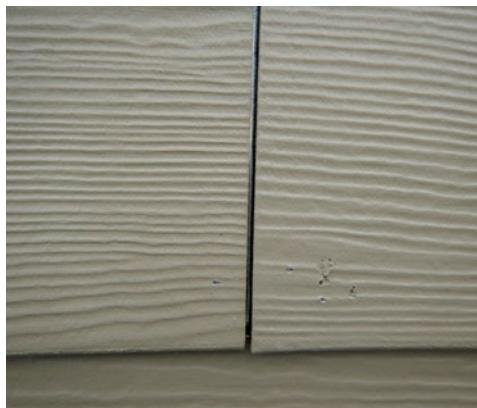
Pinning down butt ends does not provide enough holding power to secure fiber-cement siding.

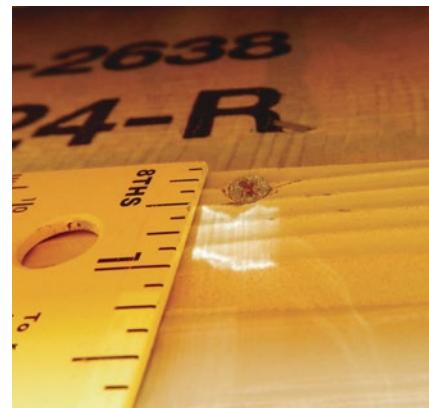
For this siding product, blind nails must be at least 1 inch from the top edge. This one was not even close.

For blind nailing, the ESR specifies that fasteners must be placed a minimum of 1 inch down from the top edge of the board, and a minimum of 3/8 inch from the ends. My inspection showed that a majority of the nails were much closer to the top edge and many were overdriven. The reason for requiring a minimum distance from board edges and ends is clear: When a fastener is placed too close to an edge, the material tends to break around the fastener when boards expand and contract with changes in temperature, or when wind forces push and pull on the material. The vibration caused by loose boards fluttering in the wind no doubt accelerated this failure and is why so many of the fasteners on this job had completely failed.

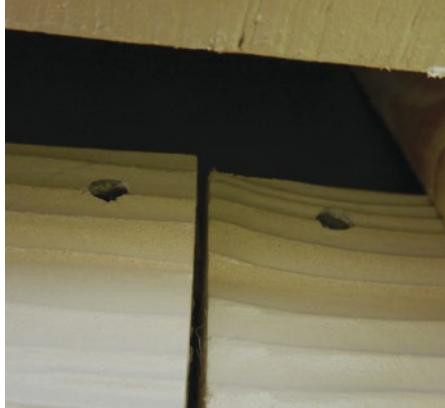
Many of the blind nails, like the ones in the photo, were overdriven.

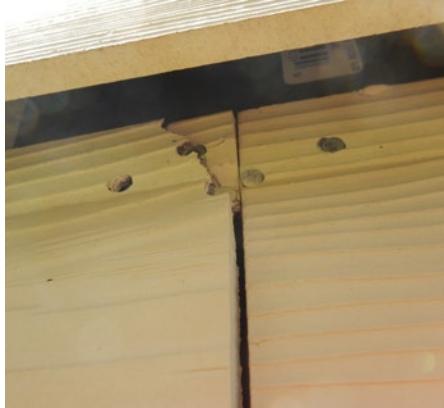
When a fastener is placed too close to an edge, the material tends to break around the fastener

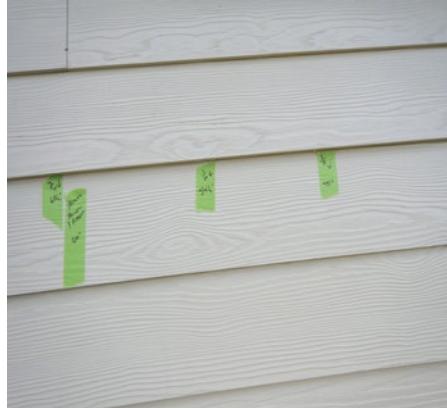
The nailing pattern was random, clearly not lined up with the studs.

Like a lot of the homes in this part of the country, the house had been sheathed with a fiber-board sheathing, which has no nail holding strength. With this material, it is especially important to drive the siding nails into the studs. But that clearly didn't happen. An analysis of the fastener spacing showed that the nailing was fairly random—likely a symptom of a zealous installer firing rapidly across each board with a pneumatic nailer.

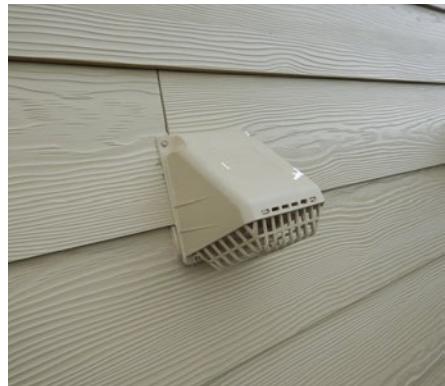
Siding breaks above penetrations like this dryer vent invite water right into the penetration hole and could allow water to leak inside the house.

There were a number of egregious water-detailing problems too. One of the worst was a siding break made directly above a dryer vent. Water leaking through this joint hit the vent pipe and followed it to the interior, where, not surprisingly, we found water marks. At all the other penetrations—at the gas line near the meter and the hose bib—the siding had simply been slotted around the pipe or vent, which not only looks bad, but also leaves the wall open to serious water and air leaks.

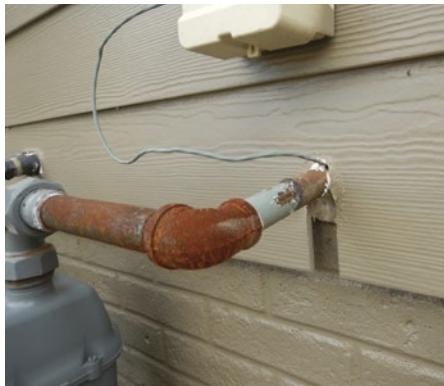
This detail looks bad and makes the wall vulnerable to air and water leaks

The correct way to detail an existing pipe or vent penetration is to use a split mounting block. When one of these is used, a hole saw is centered along the split, and half the block is slid over, and the other half under, the pipe or vent. The split, which is beveled so it drains downward, is tightly sealed with caulk.

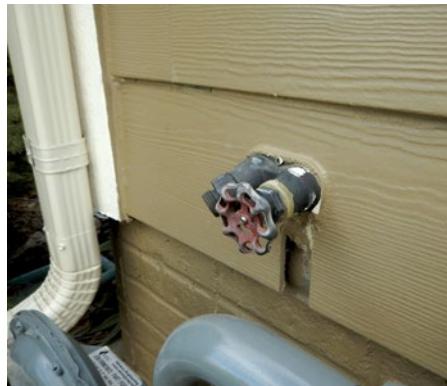
Again, the siding is simply slotted around the hose bib, inviting water and air leaks.

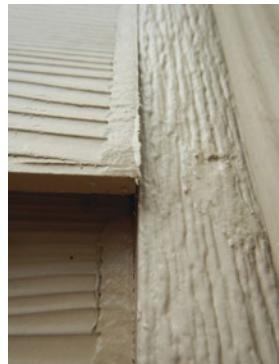
Fiber-cement boards shouldn't be butted up against the trim, but should be left 1/8 inch short to allow for expansion. The gap will allow for a caulk joint that will expand and contract with dimensional changes in the siding boards. Without the gap, you get a flat strip of caulk that is prone to peeling off.

It's critical that board ends butting against window and door openings, or against corner boards, be cut at least 1/8 inch short to accommodate expansion. On this job, the boards were frequently butted hard against the trim. This left no room for the material to expand, and it also created an inferior caulk fillet that failed quickly and allowed water to seep into the joint when the siding boards contracted.

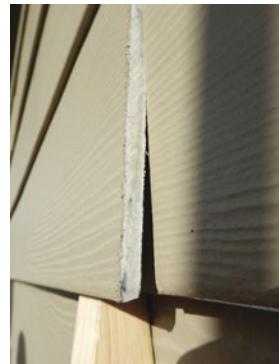
Whoever installed this siding neglected to prime the cut ends - a requirement of the manufacturer's installation instructions, which building codes mandate must be followed.

**Cut edges.** The installers on this job also failed to prime the cut ends of siding and trim boards, as specified in the manufacturer's instructions to protect the material from water. This is particularly important for exposed edges at the base of the wall. Water running down the face of the wall can turn under that lower edge, and splash-back will further wet this area.

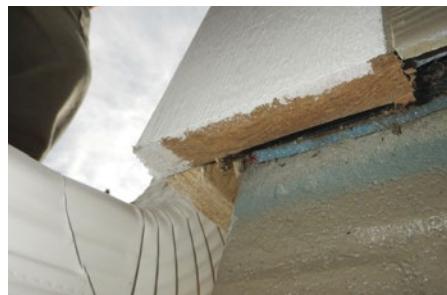
Exposed edges near the base of a wall particularly need to be primed to protect them from water that runs down the face or that splashes up.

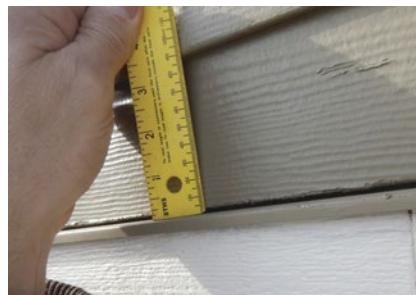
Per the manufacturer's installation instructions and the Evaluation Services Report (*which take precedence over prescriptive building codes*), there should be at least 1 inch to 2 inches of clearance between the siding boards and the porch surface.

The clearance between the siding and a deck, porch, or hardscape surface, or along the rake of a roof, is much greater. For MaxiPlank, this clearance is supposed to be at least 1 inch to 2 inches. (But Hardie, for example, requires at least 2 inches in our climate zone. Don't assume all fiber-cement details are the same.) On this job, the installers brought the siding right down to the porch floor and to the sidewalks.

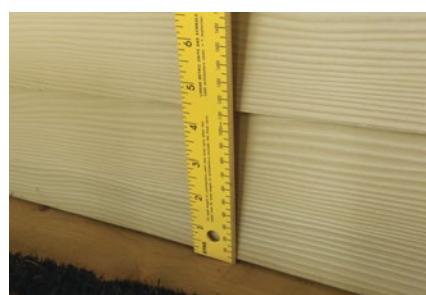
Again, MaxiPlank calls for 1 inch to 2 inches of clearance between siding and a sidewalk.

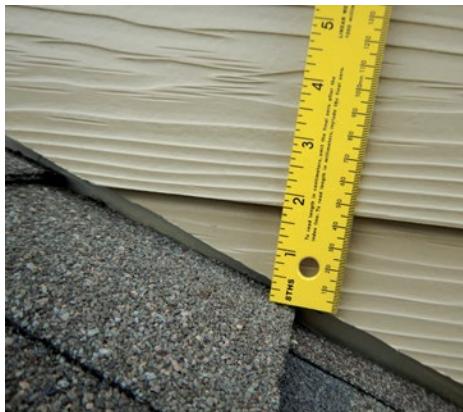
The installers brought the siding down onto the roof surface, though there should be 1 inch to 2 inches of clearance for this brand of siding.

**Sidewalls.** The installers also brought the siding down onto the roof surface where sidewalls intersected a roof. And they left out any kind of kick-out flashing where the bottom edge intersected with the wall. When this was called out on my initial report, they cut back the siding and smeared a lot of caulk into the corner in lieu of a kick-out flashing.

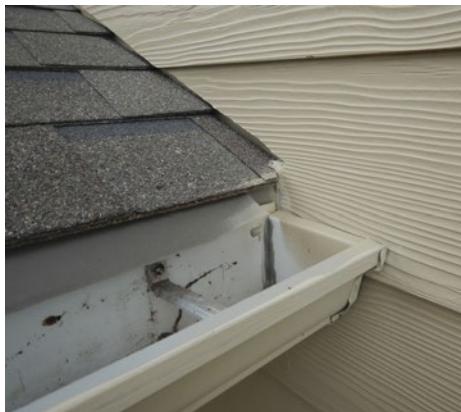
Note the absence of kick-out flashing.

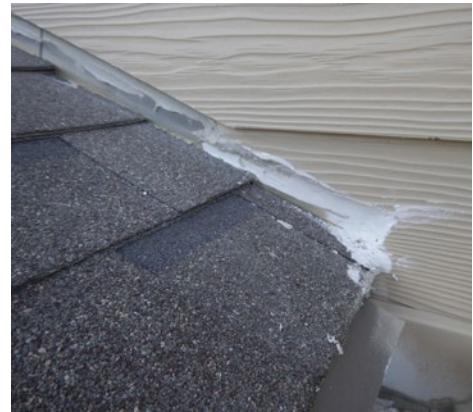
Caulking is not a good substitute for flashing.

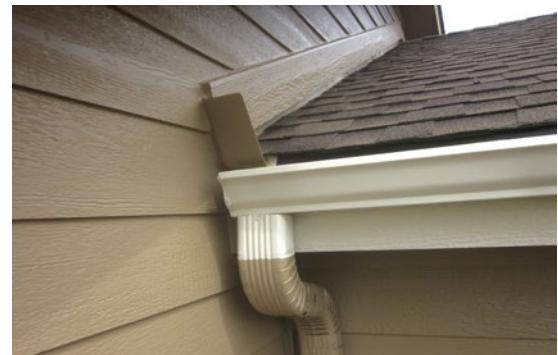
A true kick-out flashing, like this one, gathers water and directs it into the gutter. Note also the wide gap above the trim board following the rake. This allows any water flowing down the roof to be directed by the step flashing to the gutter, instead of wicking into the sidewall siding boards.

A true kick-out flashing, as shown in this photo of one of my siding jobs, is a large flashing that gathers water and directs it into the gutter. Note, too, how I detail the rake: I run a trim board along the rake, keeping this the required distance above the roof surface, and bring my siding board down to the trim, maintaining a 1/4-inch gap that gets caulked. Details like this let me stay profitable and allow me to sleep at night.

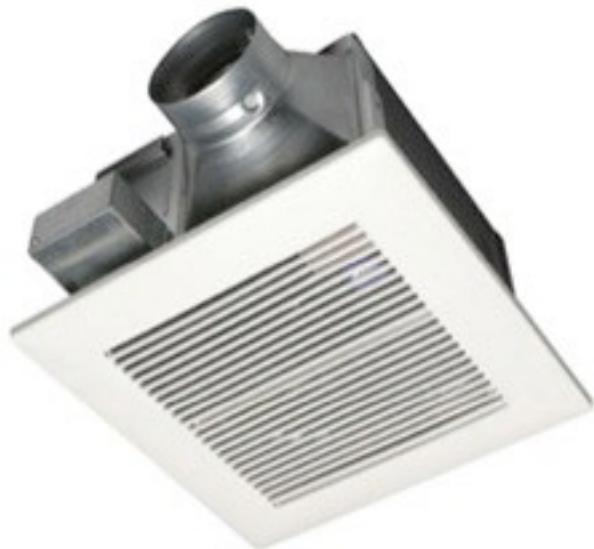
Bathroom ventilation fans should be inspected for dust buildup that can impede air flow. Particles of moisture-laden animal dander and lint are attracted to the fan because of its static charge. Inspectors should comment on dirty fan covers.

Ventilation systems should be installed in all bathrooms. This includes bathrooms with windows, since windows will not be opened during the winter in cold climates.
