# CAHI MONTHLY NEWS

October 2016 Volume 9, Issue 10

## Premature Trim Failure

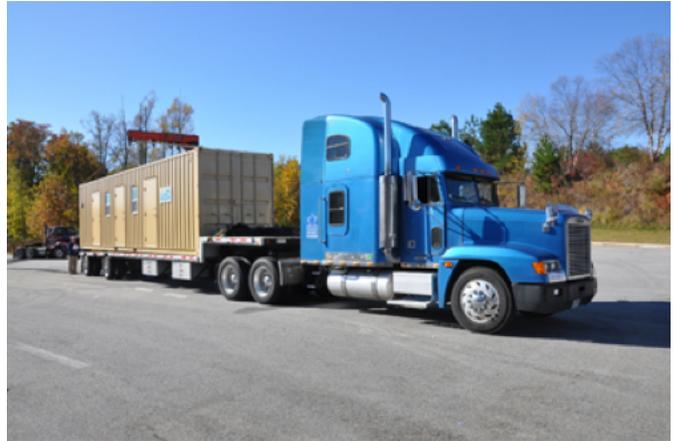
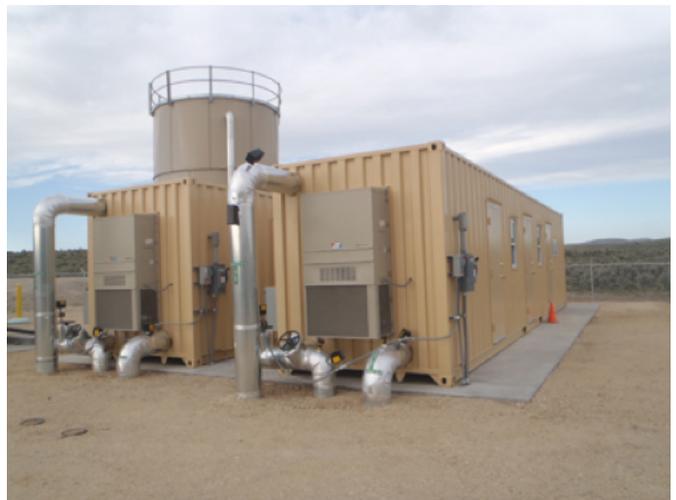
AdEdge provided five 40-ft.-long **WaterPOD containerized units**: one custom-designed unit for well #1, and two each for wells #3 and #11. Each unit includes HVAC, pedestrian doors, vents, windows and lighting—and, most importantly, an AdEdge GS+ coagulation/filtration package that is sized for the well's maximum flow. These units sit on concrete slab bases and are pre-designed and pre-piped, ready for “plug and play” use.

The treatment process begins in the well house, where a chlorine module injects liquid sodium hypochlorite into the water. This oxidizes arsenic (III) to arsenic (V) to aid in its removal. The water is then injected with ferric chloride to supplement the raw water iron concentration in order to further assist in arsenic removal. From there, the water is treated with CO<sub>2</sub> to reduce its pH level to approximately 7, as adsorbent media and coagulation/filtration processes are typically more effective in waters with pH levels of 6.8 to 7.3.

After pH level is reduced, the water is introduced to the WaterPOD and treated using 26 cu ft of AdEdge GS+ coagulation/ filtration media, housed in carbon-steel vessels (seven at well #1's Water-POD, and six each at the other two wells) in a parallel configuration. AdEdge GS+ is an NSF 61-certified black filter media used for arsenic, iron and manganese removal. Its surface is coated with manganese dioxide, which acts as a catalyst in the oxidation-reduction reaction of iron, arsenic and manganese. The treated water is then stored in an atmospheric tank.

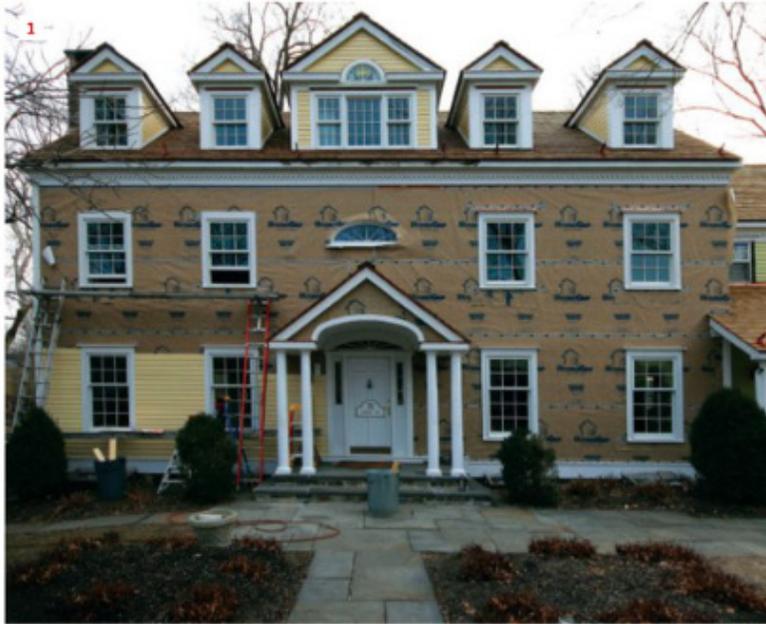
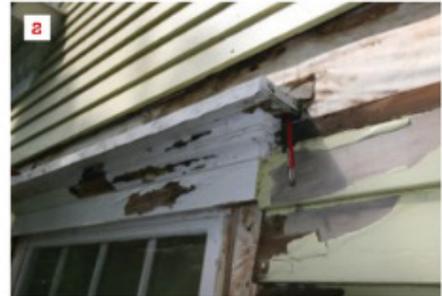
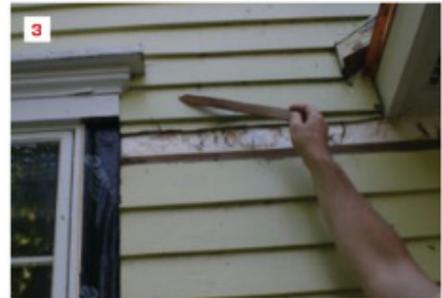
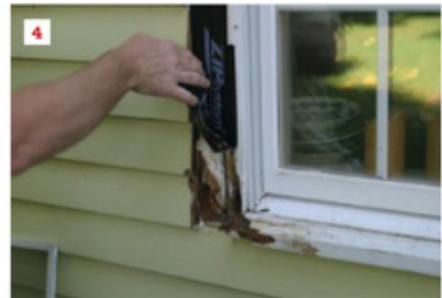
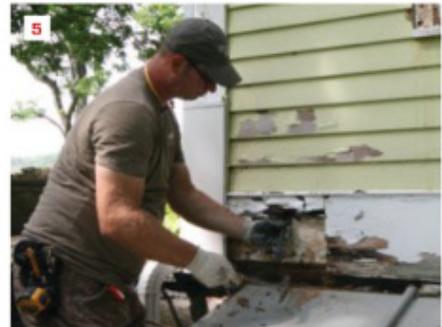
To begin with, on the windows, the metal cap flashing at the head was not sloped properly and the wood cap trim was not kerf cut (2). This caused water to pond, then run off the ends of metal flashing and behind the siding (3). The siding was scribed around decorative head trim and no thought was given to directing water outwards from the WRB, so it ran down the factory-applied pine trim, collecting at the sills. Roughly half of the home's 30 windows exhibited the level of sill rot shown in photo (4).

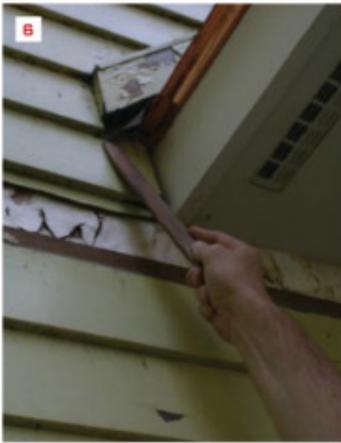
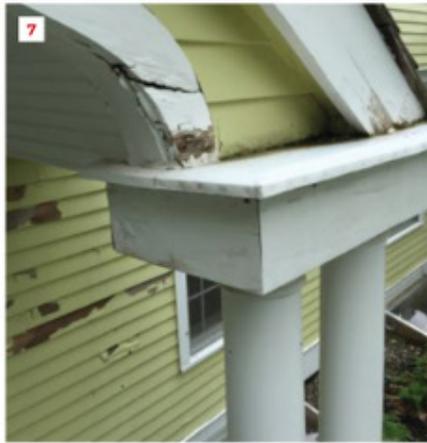
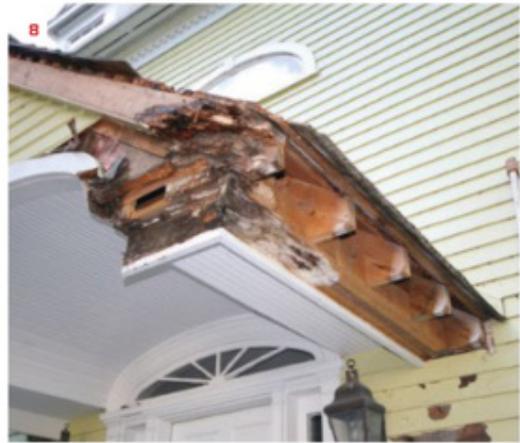
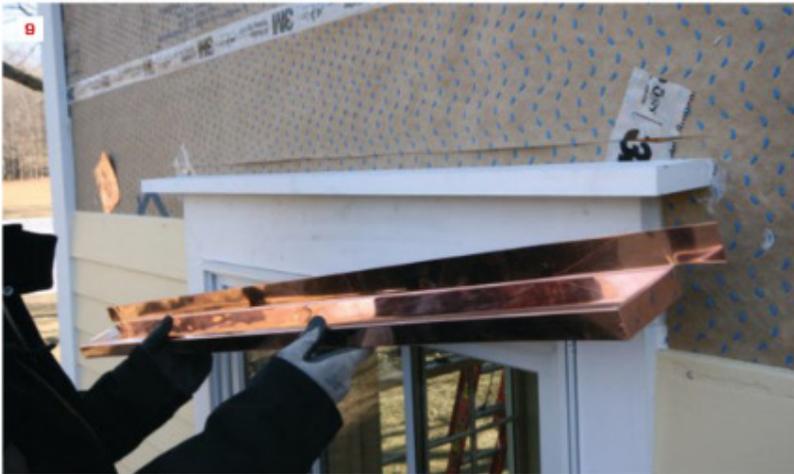
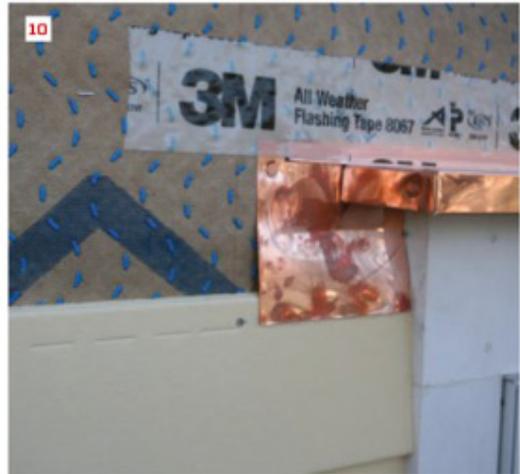
Also, the cedar water table trim was rotted throughout the house (5). Traditionally, water table trim was topped off with a wood drip cap, which makes it prone

to rotting if regular maintenance painting is not kept up. And if, as was the case here, it has no metal flashing installed over the wood drip cap, it's doomed to failure.

Another problem was at the entry portico, where kickout flashing had not been installed. Here, trim was placed over the step flashing, but no attempt was made to direct water running down the step flashing outward at the bottom (6)—water was allowed to flow behind the siding. This problematic detail also occurred in a couple of other locations, higher up on the roof.

Finally, at the rake returns, the aluminum cap flashing sloped the wrong way, which caused water to pond against the trim and siding (7). The returns were probably built with too little slope to begin with, and over the years, settling caused them to reverse slope. Eventually, the silicone caulk sealing the aluminum cap flashing failed. When we started our repairs, we found the underlying rake-return boxes, adjacent trim, and framing had turned into compost (8).

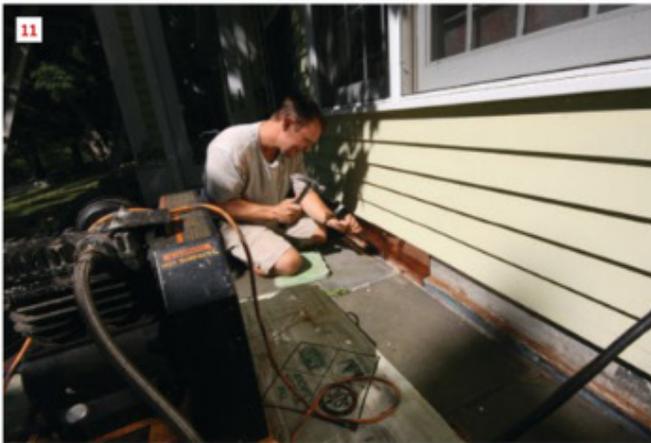
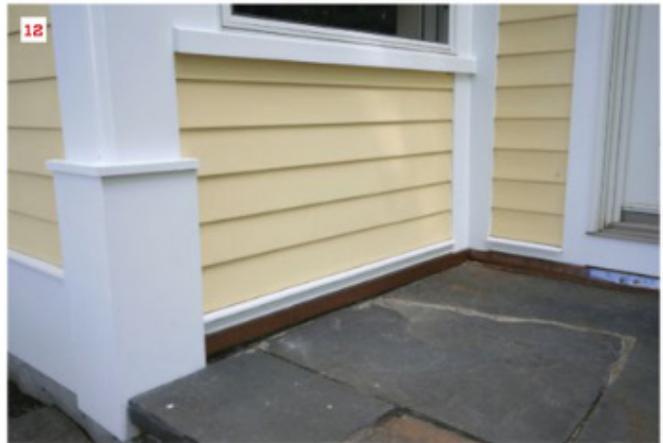
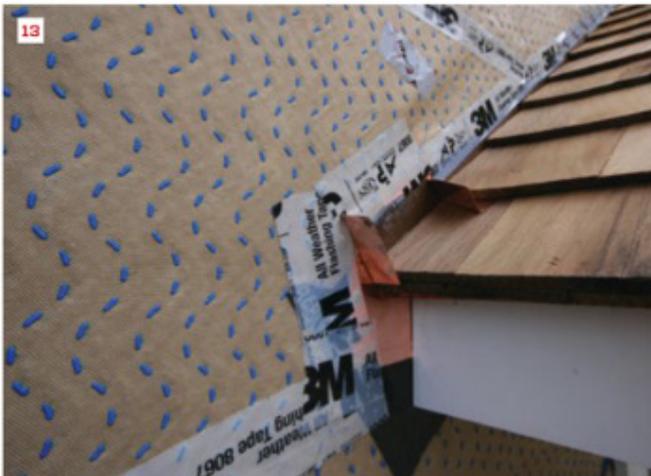
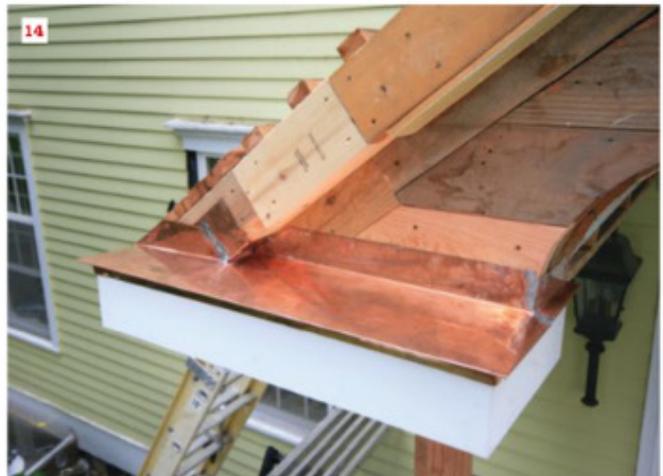
WRB and slid the vertical leg of the cap flashing into the cut opening (9). To direct water outward from the head flashing, we slipped square copper flashing under the cap flashing on both sides of the head trim; the bottom of square flashing was lapped onto the fiber-cement siding. The slit in the WRB was sealed with 3M all-weather flashing tape (10).

Later on, the siding was butted to the head trim and then the decorative trim (with mitered returns glued up) was installed. This avoided the need to scribe the fiber-cement siding around a decorative molding, eliminating a potential water entry point, as was the case with previous head flashing.
