# CAHI MONTHLY NEWS

April 2019 Volume 12, Issue 04

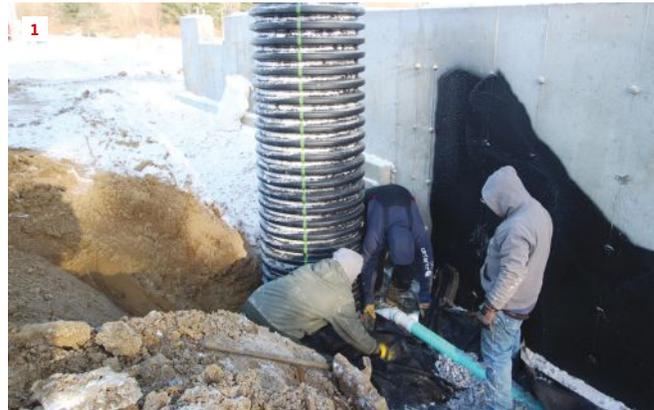
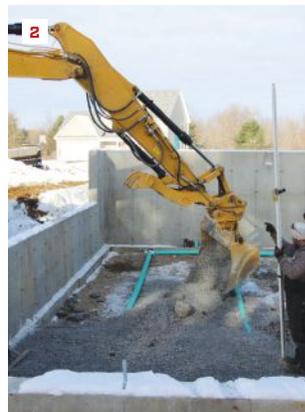
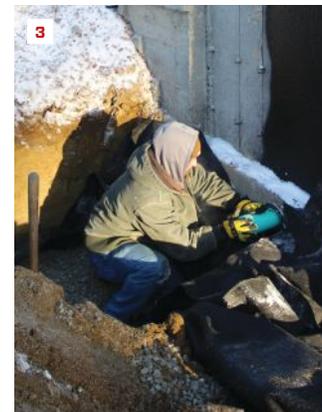
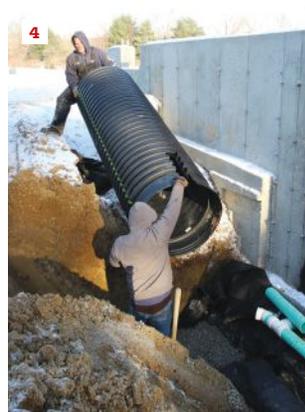
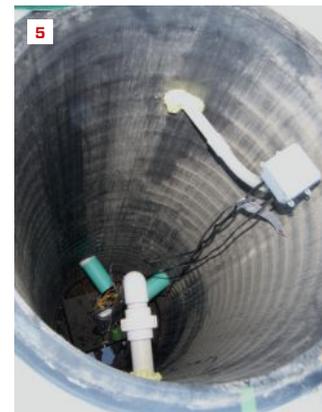
The author and crew install a 30-inch-diameter culvert vertically to act as a sump pit well next to the home's foundation (1). The under-slab drainage (2) is connected to the perimeter drains through sleeves cast into the footing (3). The culvert is muscled into place (4). In this completed home's sump, the pump-to-house wiring connections are made at a wall-mounted junction box (5).

largely due to an unusually wet late summer and fall. So we adjusted the basement hole depth to 3 feet (2 feet above the high-water line), then put in a 6-inch layer of clean stone. I like to pour footings on a stone base rather than on undisturbed soils to help level the formwork and provide drainage. As to pump placement, we generally set the bottom of the sump pit 18 inches below the top of the footing (see Exterior Sump Pit, right).

**Sump-pit install.** With the perimeter and under-slab drains joined, we excavated the sump-pit area. We dug beyond our planned sump-pit depth to first install a 12-inch lift of gravel wrapped in filter fabric. Next, we ran a short length of pipe from the drains to our sump location and then moved the 30-inch-diameter high-density-plastic culvert into place, first cutting a slot in its bottom edge in order to slip it over the drain pipe (4). We wrapped the cut slot in filter fabric, then installed a second lift of gravel 18 inches deep to help stabilize the vertically installed culvert until it was backfilled with sand.

**Connecting the pump.** After backfilling and running a 2-inch PVC discharge pipe and electrical conduit to the sump, my crew hoisted me into the culvert. I’m a big guy and a 30-inch-diameter space is a tight fit, but I managed to set our 3/4-hp sump pump on a concrete paver to elevate it above the gravel, and then connect the pump’s discharge pipe, which leads to a roadside ditch roughly 75 feet away. Working from above, a crew member screwed a junction box near the top of the culvert (5), while I set the pump’s control- and overflow-alarm float lengths. We made our power and control connections from the pump and house at the box, then fastened a 30-inch-diameter hard plastic lid to the culvert.

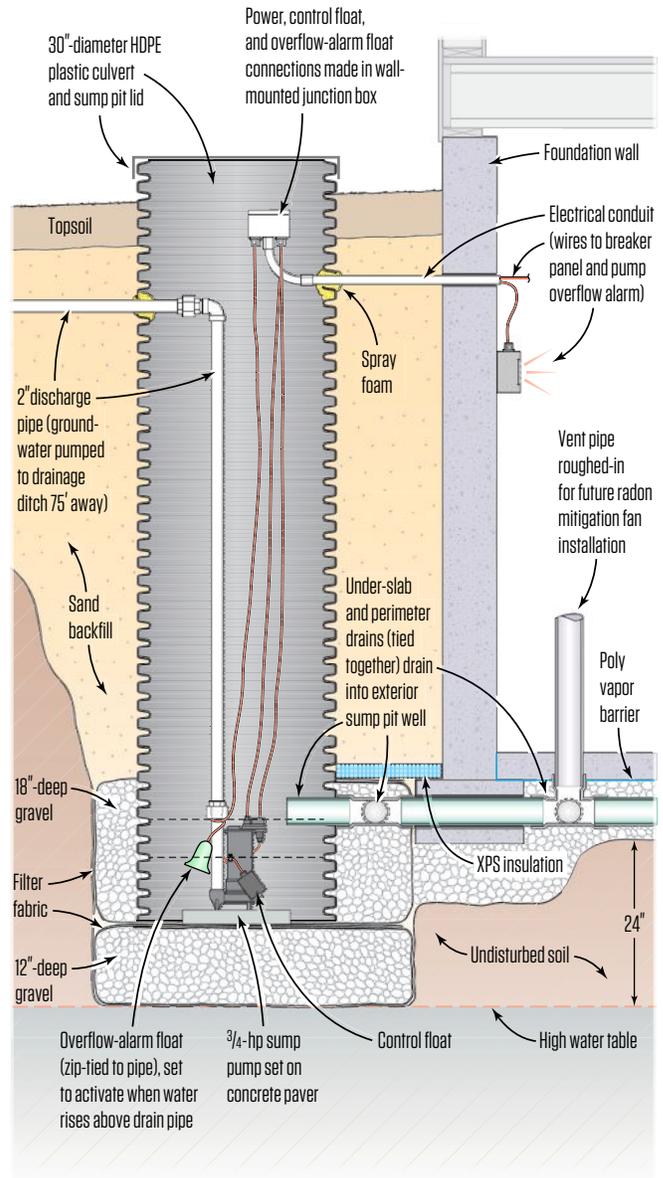
## Exterior Sump Pit

The foundation holes were dug 24 inches above the historic high water-table line while the bottom of the sump pits were set 18 inches below the top of the footing. Potential groundwater will be discharged into drainage swales 50 to 100 feet away from the development’s seven sump pit wells. Pump activation can be fine-tuned by adjusting the length of the float lines.

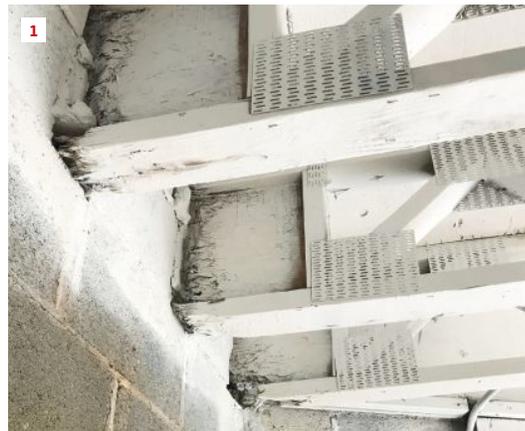
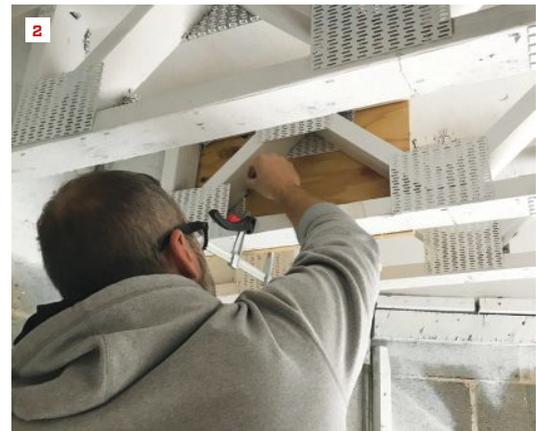
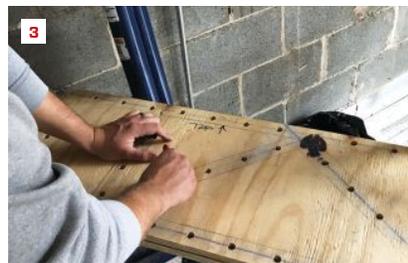
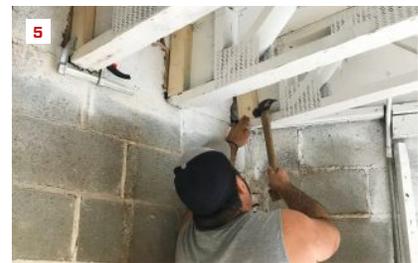
Removing water-damaged ceilings and walls revealed three trusses with rotted ends (1). To reinforce them, the author made plywood gussets. He traced the chord pattern onto a blank (2) and made a template to transfer the fastener layout (3, 4). Squash blocks stiffened the ends of the trusses (5).

**Damage from a roof leak.** We recently were called in to repair trusses on a townhouse that was built in the mid-1990s. The trusses supported a third-floor deck with a living space below. After seeing water damage on some interior drywall, the clients opened up the wall below the trusses. When they found extensive mold, they removed the rest of the drywall, exposing an adjacent CMU wall with pockets that supported the trusses. The ends of three of the trusses had rotted (1).

**Plywood gussets.** The first step was making the plywood gussets for the 15-inch-tall trusses. We cut blanks 15 by 36 inches out of 3/4-inch plywood with the grain running in the long direction. To ensure that we met the nailing schedule on all of the gussets, I made a fastener template by clamping one of the blanks to the side of a truss and tracing the outline of the truss chords (2). Then I plotted out the fastener locations and drilled a 1/2-inch-diameter hole at each location, big enough for a marking pen. With that pattern, we were able to quickly transfer the exact fastener locations to each of the six gussets (3, 4).

Before attaching the gussets, we inserted the 2x4 squash blocks as specified by the engineer (5). We then clamped the gussets to the trusses and drove nails at each fastener location, using a palm nailer (6). With the gussets in place, we spanned across the underside of the trusses with beams and lifted them using a four-point

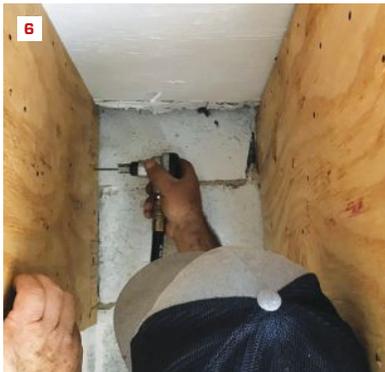
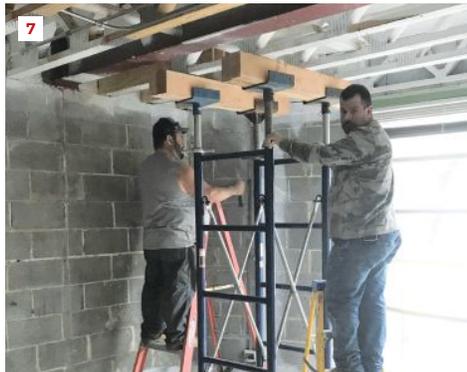
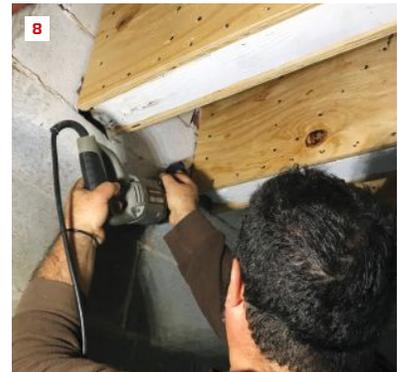
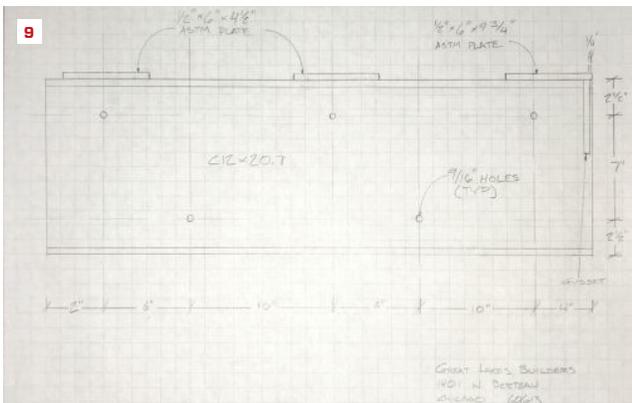
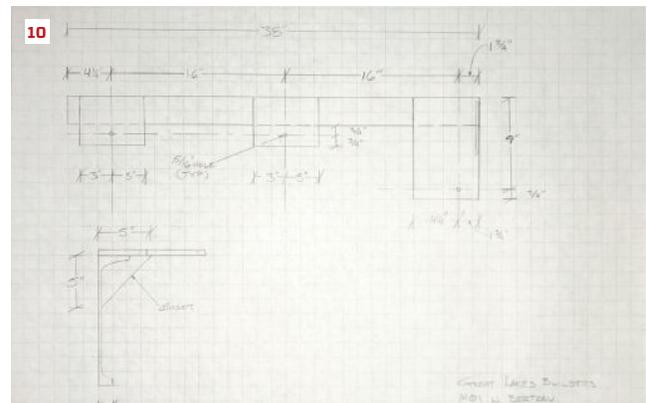
A palm nailer was used to drive the specified fasteners at each location to attach the gussets to the ends of the trusses (6). The crew used screw jacks and beams to lift the trusses to their original height (7), then cut away the rotted wood with a reciprocating saw (8). With an engineer's guidance, the author drew the support-beam elevation (9), plan, and section (10).

screw jack assembly (7). When the trusses were at the proper height, we cut the rotted part off the ends with a reciprocating saw (8).

information, I drew up the beam with the supports, the gussets, and the fastener locations and sent the drawings to the engineer (9, 10). After getting his approval, I gave the drawings to my steel fabricator, and he made up the support beam with the welded support plates (11). The drawings were pretty basic, but doing them gave me control over exactly how the beam would turn out, and it saved me the expense of hiring someone to draw the beam.

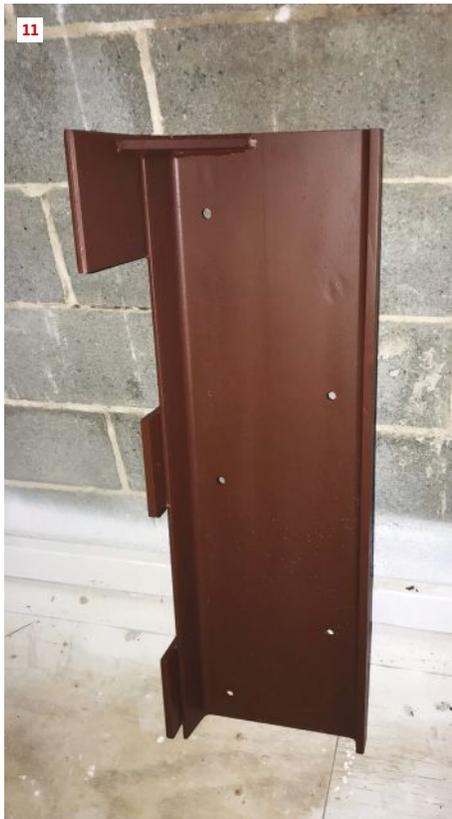
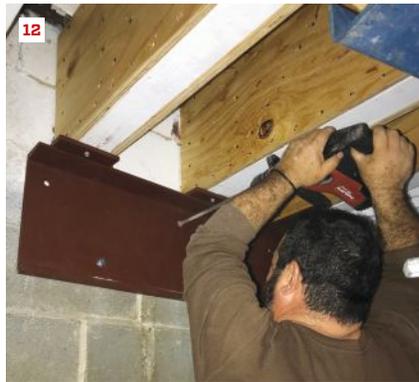
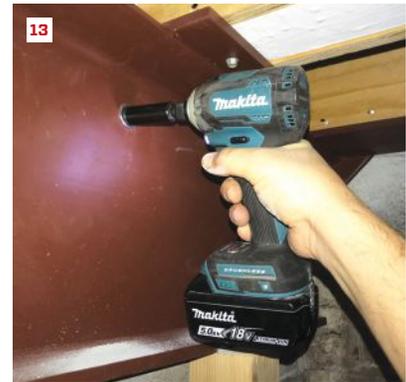
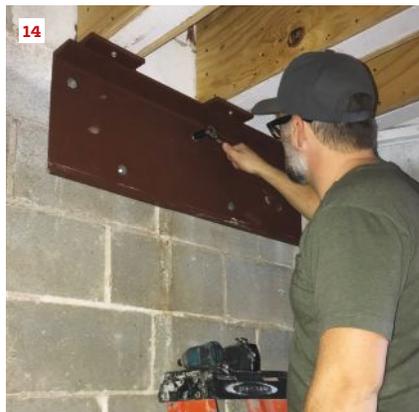
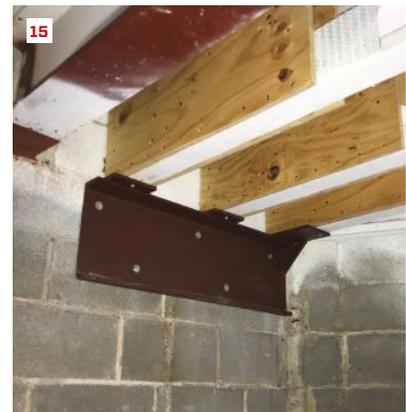
The author's approved drawings guided the fabrication of the support beam (11). With the beam lag-bolted to the trusses, the crew drilled holes for the anchors (12). The anchors were first snugged with an impact driver (13), and then given their final torque with a ratchet wrench (14). The final assembly will be concealed in the wall after the finishes are applied (15).

**Installing the steel.** The steel support beam arrived painted with a rust-resistant finish. Two crew members lifted the beam and held it in place under the trusses while I drove 1/4-inch lags into the trusses through holes drilled in the support plates. The lags held the beam in place temporarily while we fastened the vertical part of the beam to the CMU wall. At this point, the trusses were already at their final elevation, but to make sure that they wouldn't drop a bit when we removed our temporary supports, we jacked a 4x4 post under the channel to keep it snug against the trusses.

With the steel channel held firmly in place, we drilled holes for the sleeve anchors (12). After drilling the holes, we blew the dust and debris out of them and tapped the anchors into place. It is important not to overtighten sleeve anchors, so we first tightened them with an impact driver until they snugged up (13), then finished torquing the sleeve bolts by hand with a ratchet wrench (14). After removing the temporary supports under the trusses, we cleaned the jobsite thoroughly (we always try to leave the place cleaner than it was when we arrived). Our job as the structural repair crew was finished and the site was ready for the restoration crew to come in and reconstruct the interior finish (15).

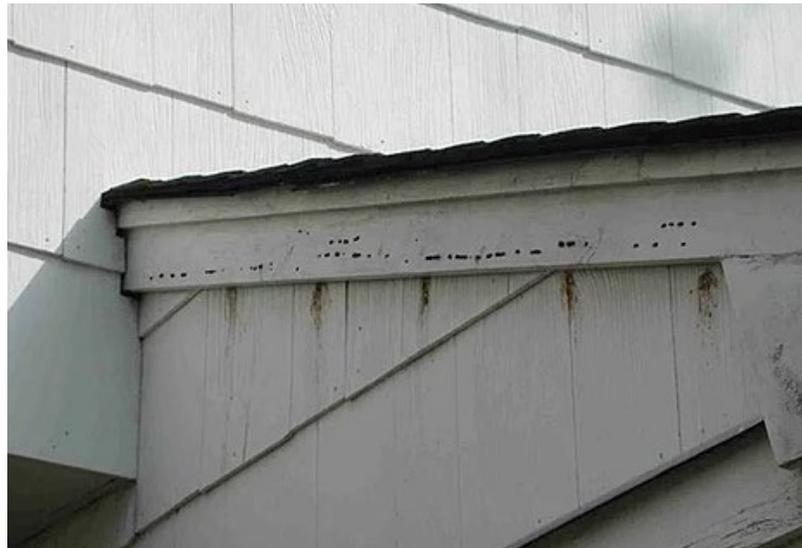
*Woodpecker damage on a fascia board and carpenter bee staining on a home.*

When carpenter bees nest, they typically nest behind fascia boards along a roofline on a home. If woodpeckers are searching for the carpenter eggs, they can leave damage along the fascia boards (eaves) as they peck into it for the eggs.

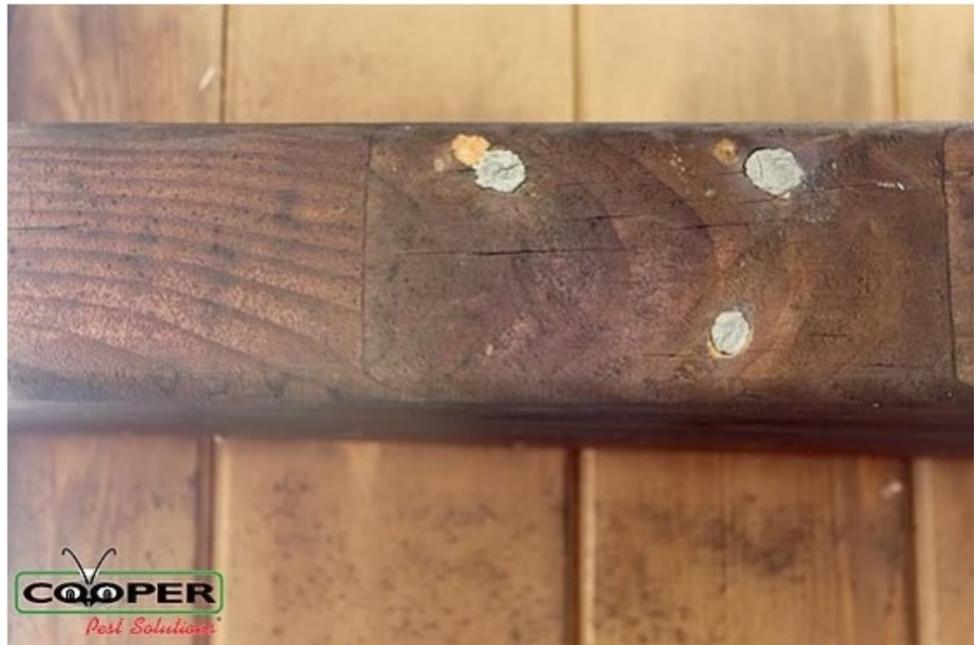
*Carpenter Bee holes filled by a professional pest control technician.*

- Your pest control technician may also use a cork, putty or caulking compound to plug the holes so that the bees are unable to return to the tunnels for future nesting. This is typically done during July or the summer months once all the active bees have left the nest and prior to the overwintering bees returning.
