CAHI MONTHLY NEWS

September 2020 Volume 13, Issue 09

Beam-Line Replacement

Rock-Solid Stair Posts

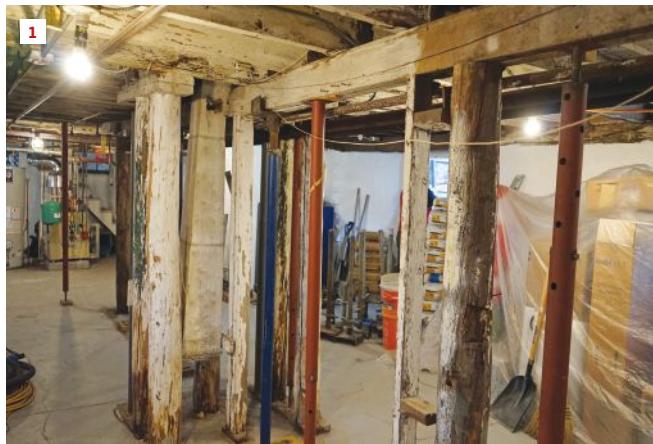
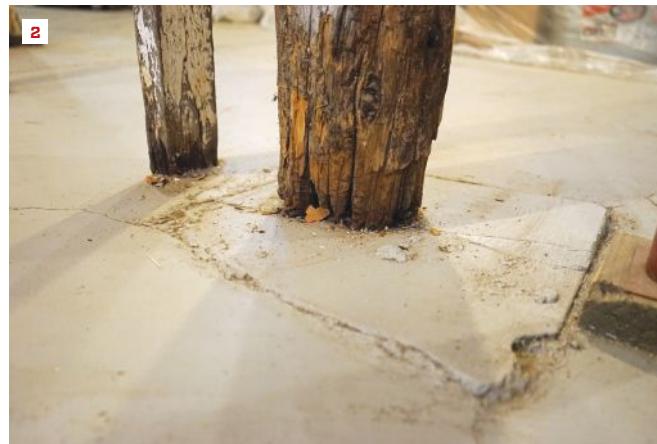
Here's the condition of the existing beam line we found when arriving at the job. This photo (1) shows the original wood posts clustered around the chimney location. Over time, steel "jack posts" (red), which should be considered temporary and do not meet code, had been added. The original posts, showing signs of deterioration from wicking ground moisture (2), were supported on brick footings, over which a thin "rat slab" had been poured at some point to cover the original dirt floor.

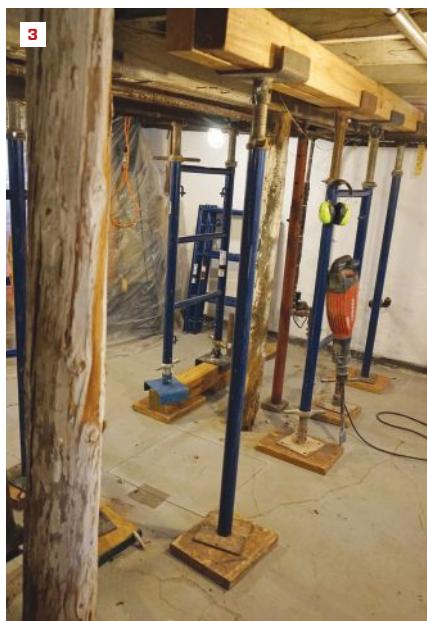
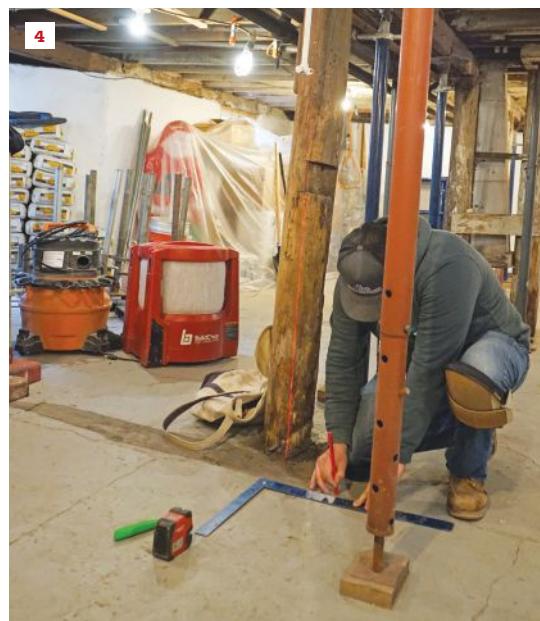
To temporarily support the load, we added two lines of heavy-duty shoring running parallel to the beam line (3). In this case, we were not jacking the floor, only supporting the floor at the existing elevation. Before installing the shoring, we measured where our new footings would be placed, keeping the shoring lines out of the way. Once the shoring was in place, I began to lay out the footing locations, using a laser to reference the centerline of the main beam (4).

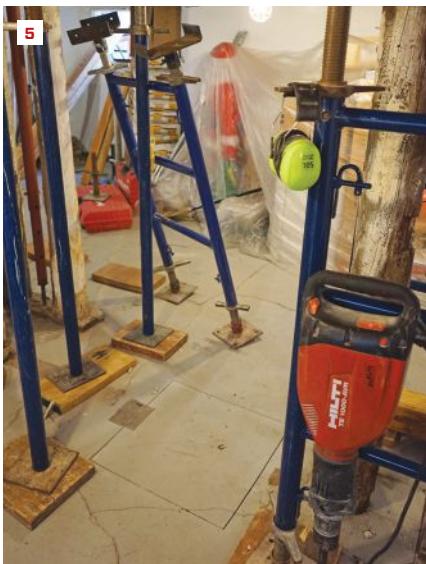
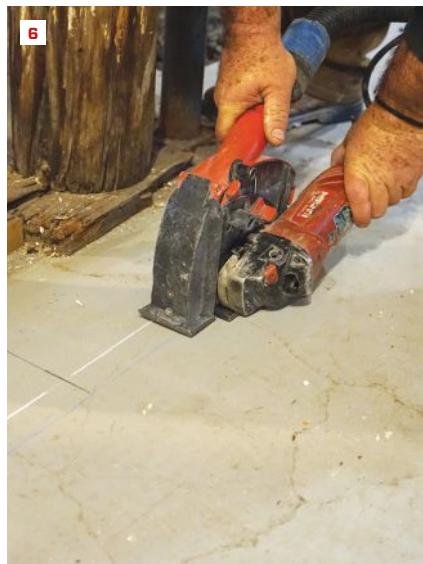
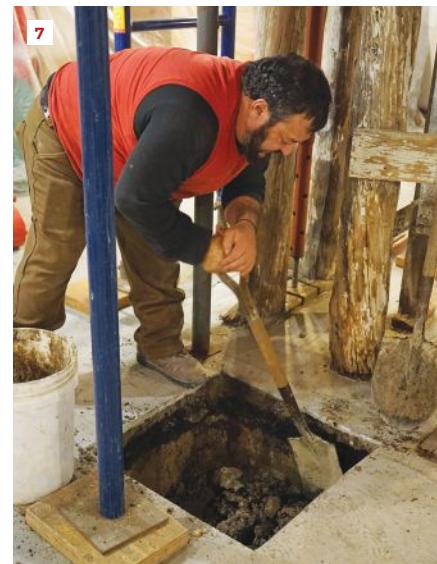
With the beam line marked and the footing locations defined, the crew cut through the slab to place new footings (5). We cut through the existing slab, which varied in thickness from $\frac{3}{4}$ inch to $1\frac{1}{2}$ inches, with a small grinder outfitted with a vacuum shroud (6). Once the perimeter of each footing was cut, we broke the slab out and dug the footing holes to a depth of about 15 inches (7).

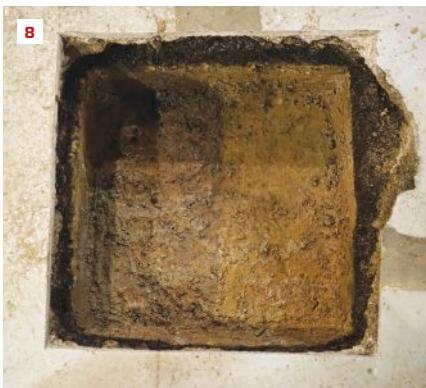
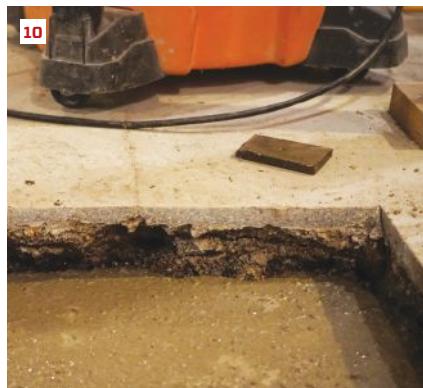
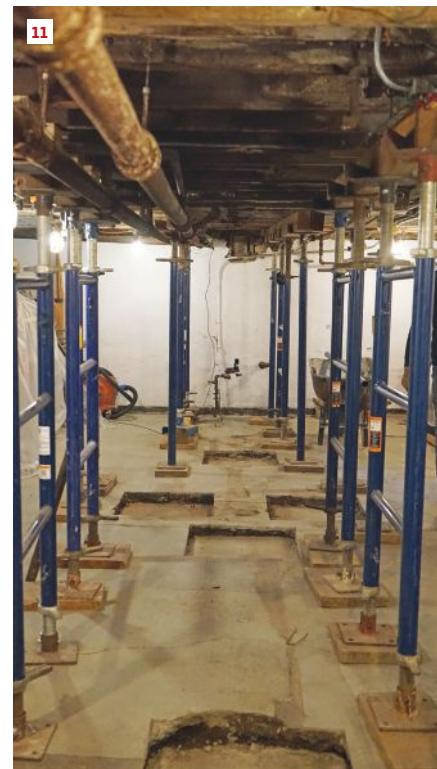
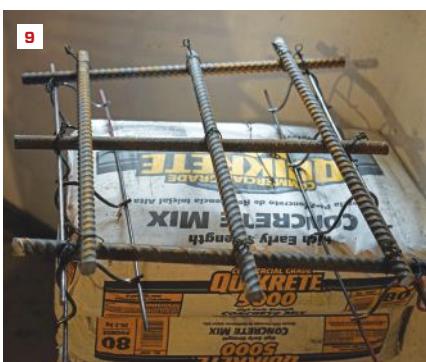
For each squared-off footing hole (8), we wired together a grid of #5 rebar (specified by the engineer), including rebar chairs (9) that held the grid 3 inches above the bottom of the hole. We poured each footing to a depth of 12 inches, well below the slab elevation (10), allowing us to finish out as shown on page 44. We used a "high early" Quikrete 5000 mix, which rapidly cured to 3,000 psi in a few days (11).

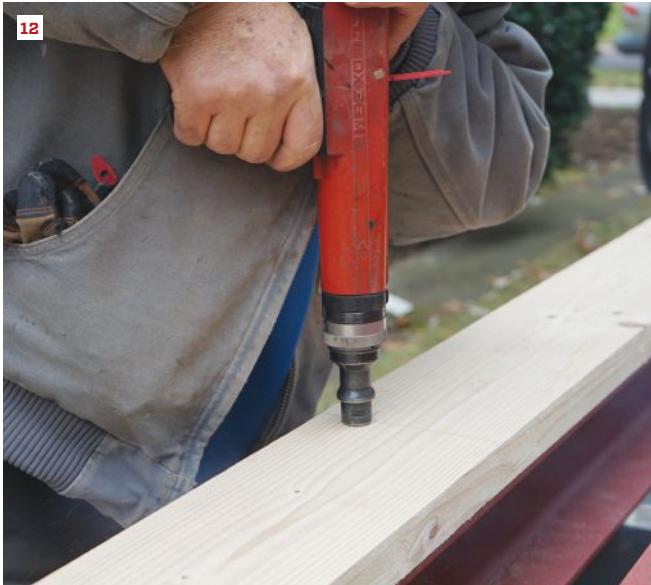
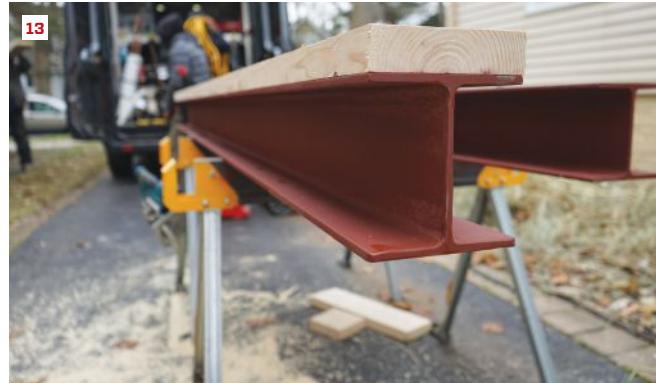
While the footings were curing, we prepared the steel I-beams, pinning a wood plate (12) to the top of each beam section (13). This 2-by nailer allowed us to mechanically fasten the beam to the joists, which would keep the joists from rotating. It also allowed us to adjust the elevation of the beam by mortising the plate rather than by removing material from the existing joists.

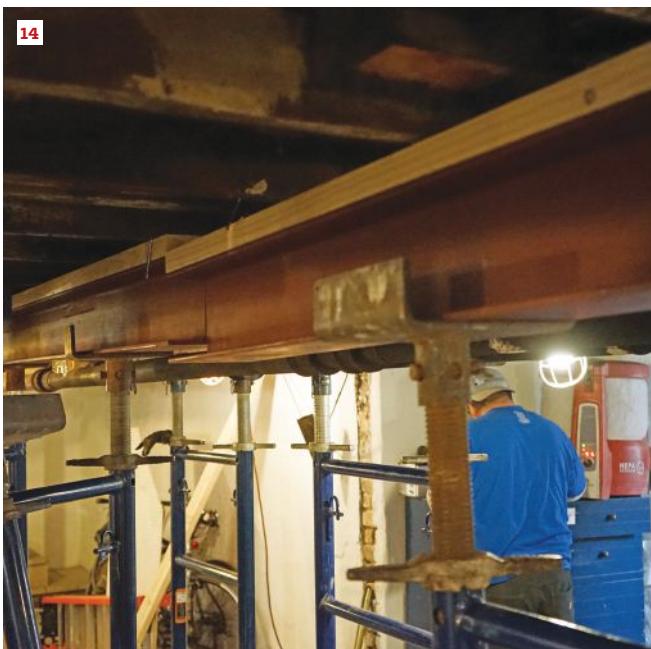
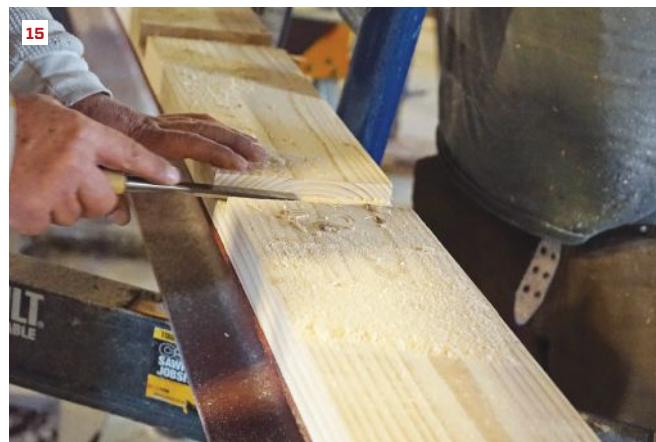
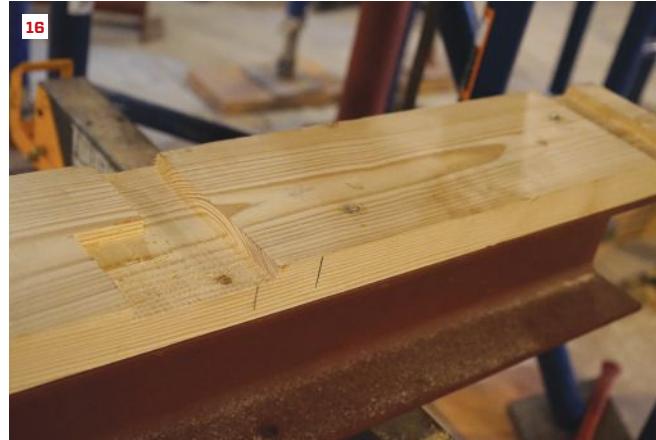
We rough-fit the beams (14) to mark the joist locations on the plate and measured the depth of the mortises we needed to cut. Each mortise was a different depth to accommodate the variation in the elevations of the joist bottoms (15, 16). On this job, the client did not want our work to cause any cosmetic damage to the finishes in the house above, so we were careful to support the floor at the existing elevation.

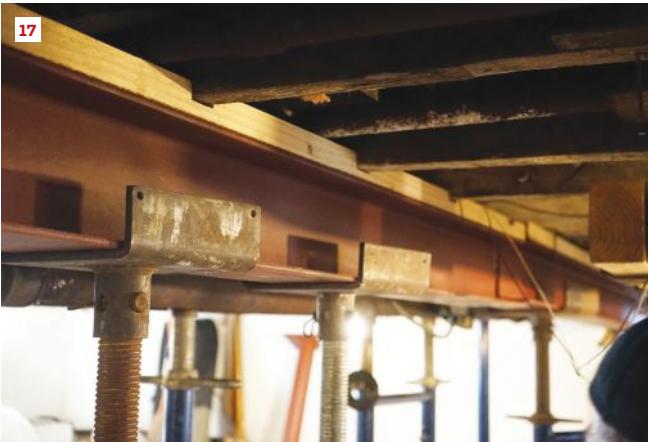
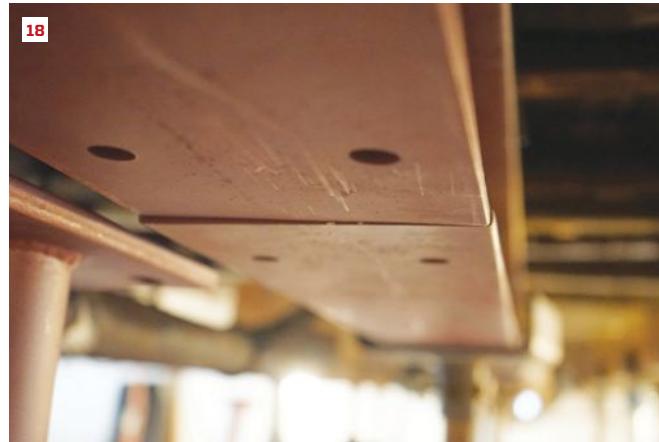
With the mortises cut, the variation in the bottom elevation of the joists was apparent (17). Such variation in joist size is common in older homes. When the house was framed, lumber dimensions varied more than we typically see today, and the carpenters were only concerned with having the tops of the joists at the same height. Once the mortises were cut, the beam sections aligned to within $\frac{1}{16}$ inch or so; they would be pulled into perfect alignment when the post was bolted in place (18).

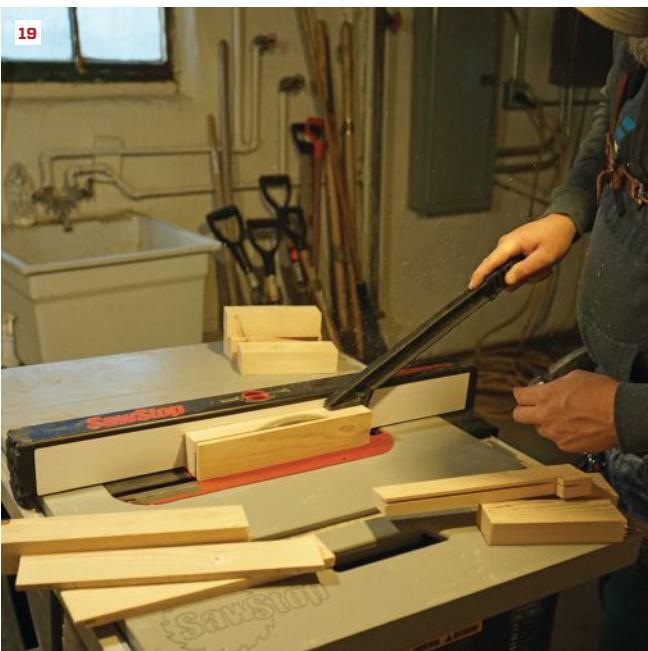
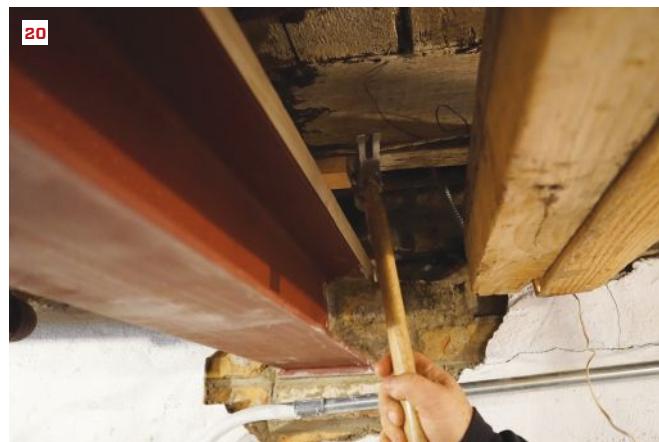
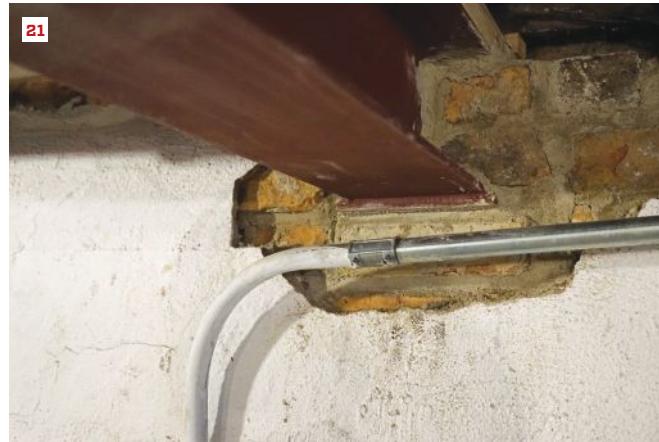
The bottom of some joists would be higher than the 2-by plate. For those, we cut shims (19) that we pounded into place where needed for firm bearing (20). One end of the new beam had to be grouted into a pocket in the foundation (21). This required enlarging the original beam pocket for the new steel beam, including a 7x7x $\frac{1}{2}$ -inch setting plate specified by the engineer to spread the load at the foundation.

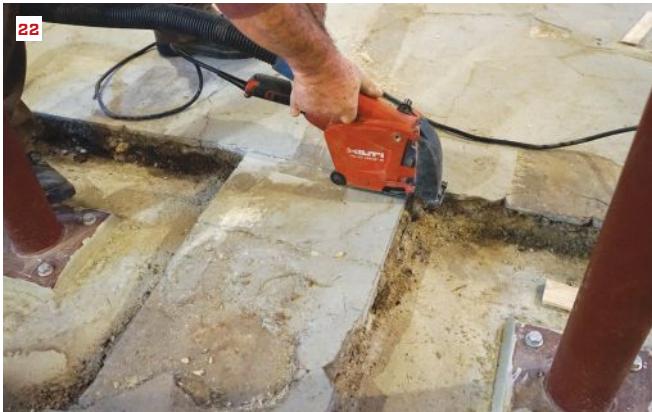
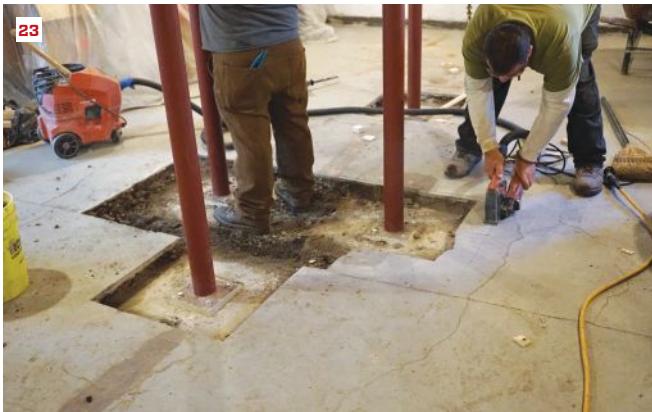
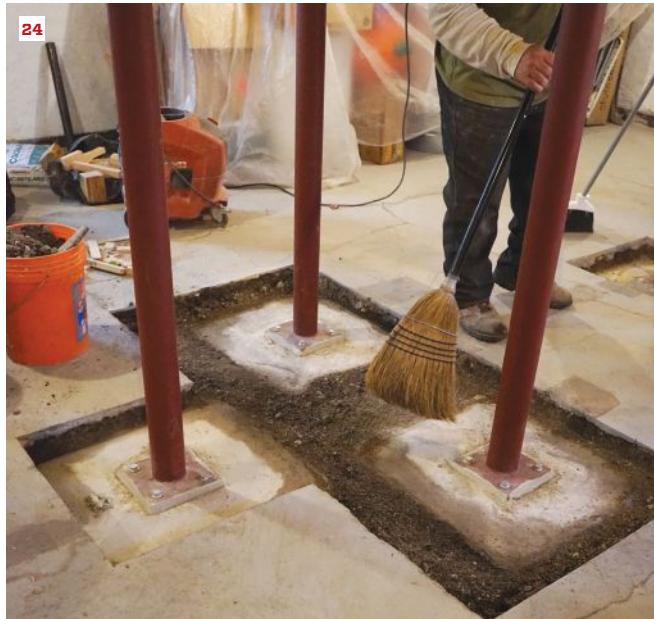
With the post base plates bolted to the new footing, the crew focused on cutting away the slab (22, 23) in order to join the footing area of the three posts supporting the chimney and midspan. Once the old slab was removed, the footings were broomed clean in preparation for a new pour (24). The goal here was a clean fit and finish of the new work, with the post bases recessed below the surface of the existing slab.

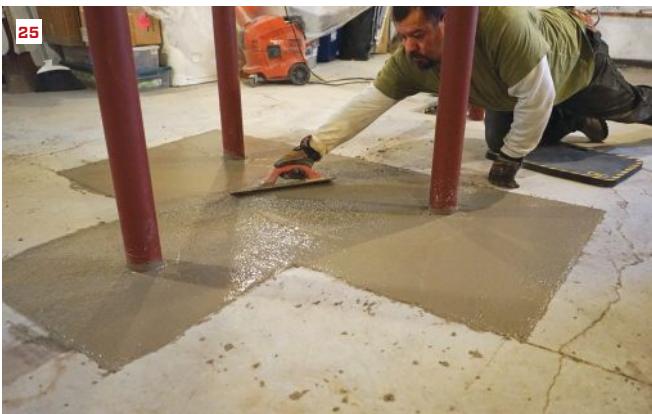
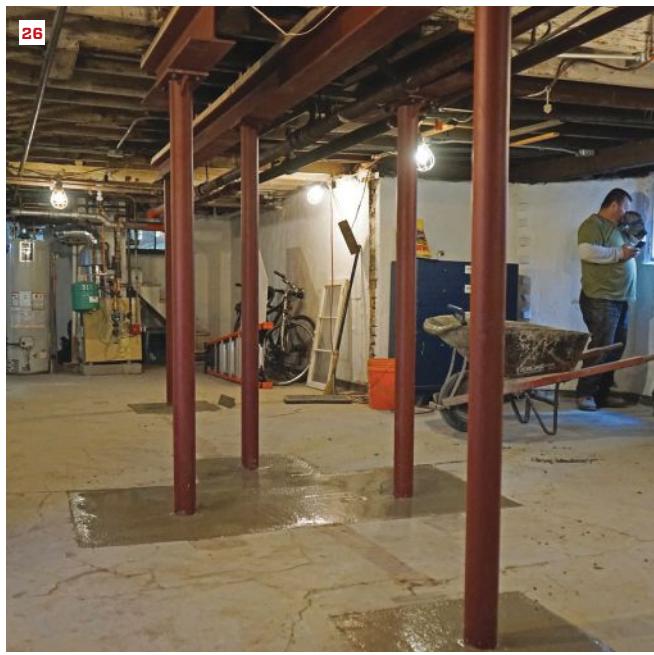
The slab area around the two end posts was also widened, then all three areas were covered with a new, thicker (3-inch) slab. After the surface was finished (25), the result was clean—better than the existing slab (26). While the structural elements of our new work are of critical importance to us, in the end, what the customer will see is how clean it looks. And there is no doubt on this point here.

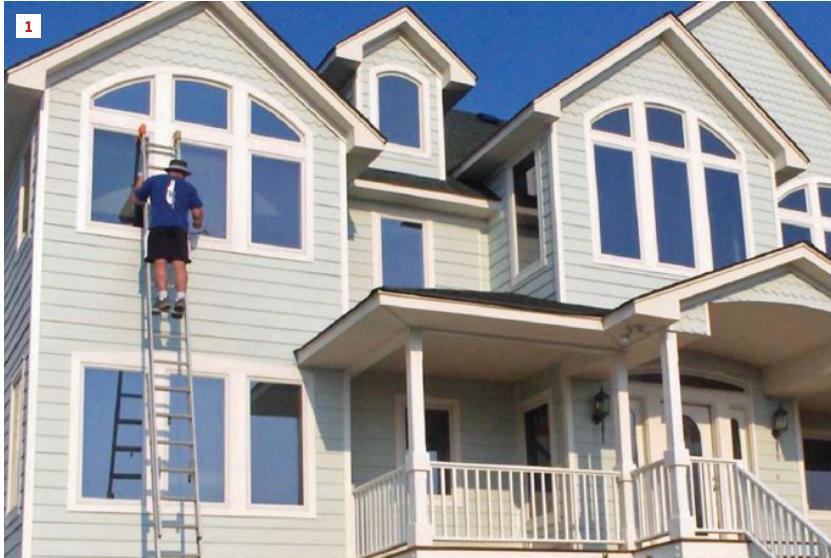
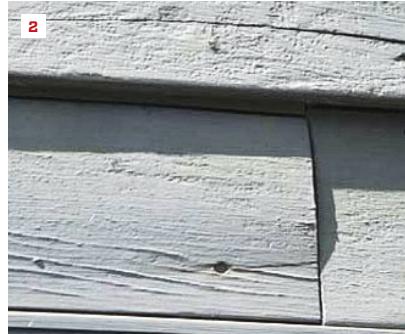
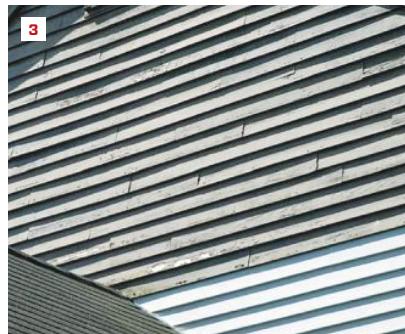
While the painters' work affects how good the paint job looks (1), what happens before they arrive affects how well the job performs over time. Bowed and buckled clapboards are often caused by interior moisture driving through siding that has not been back-primed (2, 3).

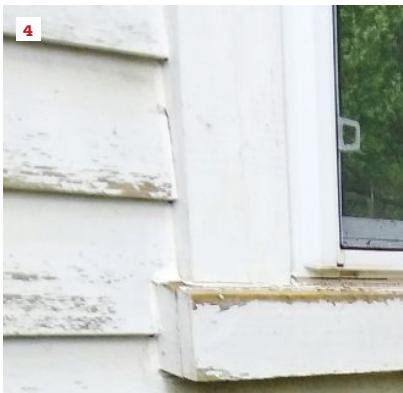
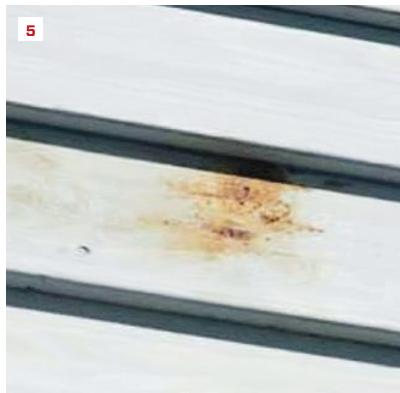
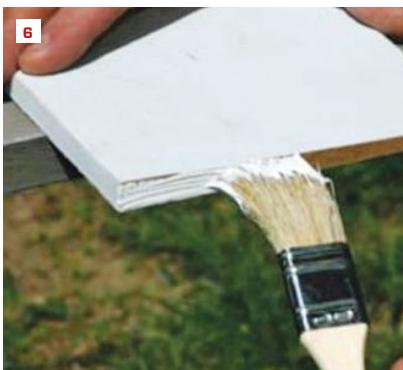
Unprimed siding won't hold paint for long. This paint job on a new addition (4) is less than five years old. Factory-installed primer is better than no primer, but it won't block the bleed-through of extractive oils in cedar (5). An additional coat of acrylic primer is needed before the finish coat. All field cuts need to be primed before installation of all siding and trim (6).

If you use unprimed material, you should prime it yourself before you nail it up. That includes priming the back face. Although it doesn't face the weather, the back of a board is often attacked by moisture coming from within the house. Back-primed wood can resist that moisture, but wood that hasn't been primed on the back will curl or cup. That unbalanced movement stresses the nailed connections, and moisture migrating toward the outdoors also attacks the bond between the coating and the wood, causing early peeling or wear.

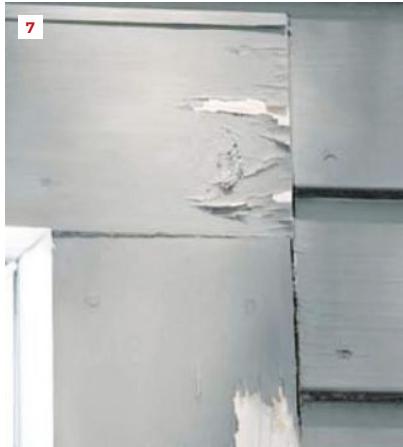
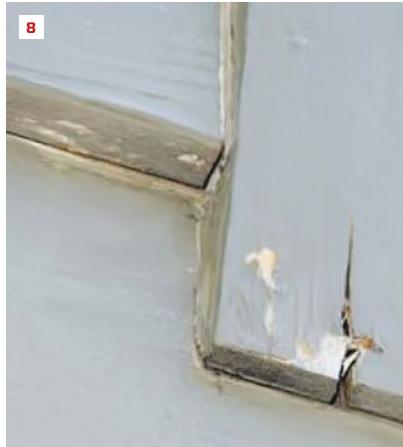
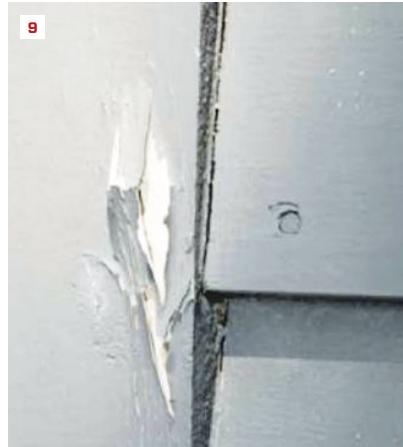
Here, carpenters have installed factory-primed window casing without sealing the ends. Failure has begun at unprimed ends (7), and in one case, water absorbed into an unprimed end has caused the wood to check (8). Not all of the failure is due to the carpenters, however. Stain was applied without any sanding or a second coat of primer, causing the finish to fail (9).

If you don't prime the cut ends, you're leaving open the part of the wood that is most open to moisture entering: the end grain. Nature intended wood to draw water into the end grain. In service, unprimed ends will absorb water and swell, and paint will start to come off the wood at that location first. If painters arrive to paint or stain a house that is sided with clapboards whose cut ends are unprimed, or trimmed out with boards whose ends are unprimed, there is very little they can do to address the issue. So it's up to the people installing that wood to make sure that the ends are primed.

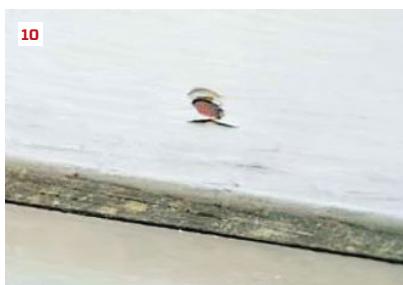
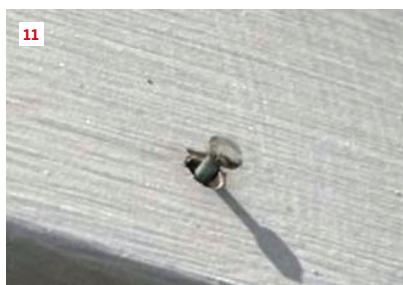
Water will collect and seep into the wood around an overdriven nail (10). Over time, smooth-shank nails will work their way proud of the surface (11) as siding changes in moisture content and temperature. Nails like this should be replaced with stainless steel, ring-shank nails.

from the material over time, leaving them standing proud. On repaint jobs, our prep crew usually has to pull a lot of nails that are high, and we always replace them with ring-shank nails (either hot-dipped galvanized or stainless steel). There's no good reason for a carpenter in new construction not to use ring-shank nails in the first place. I've never found a ring-shank nail that has worked its way high of the siding or trim.

Be careful to drive nails just flush with the top surface of the wood, or perhaps a hair lower. Good carpenters develop a feel for how to set the nails just right with the final tap of the hammer. But gun nails are harder to control, and carpenters may get in the habit of driving the nail heads into the wood. That's bad practice—it provides a place for water to pool and attack end grain, and it creates a surface condition that is hard for primer to seal.

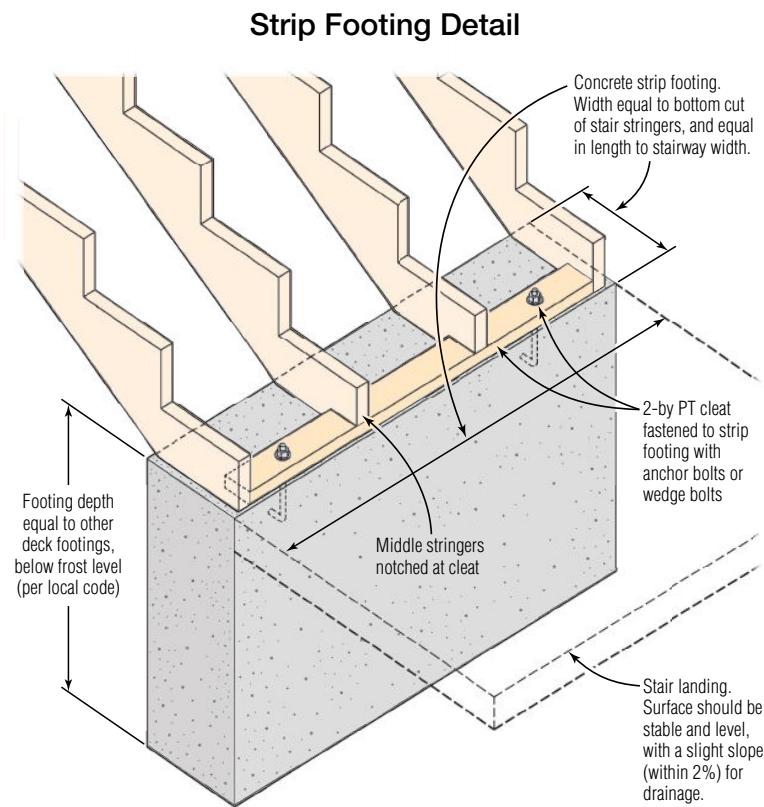
Instead of using individual concrete piers to support each stair stringer, the author prefers to dig and pour a monolithic strip footing, which is sized to extend below frost depth and fully support the stringers' seat cuts. The stair stringers are locked to the footing by a PT cleat anchored to the concrete.

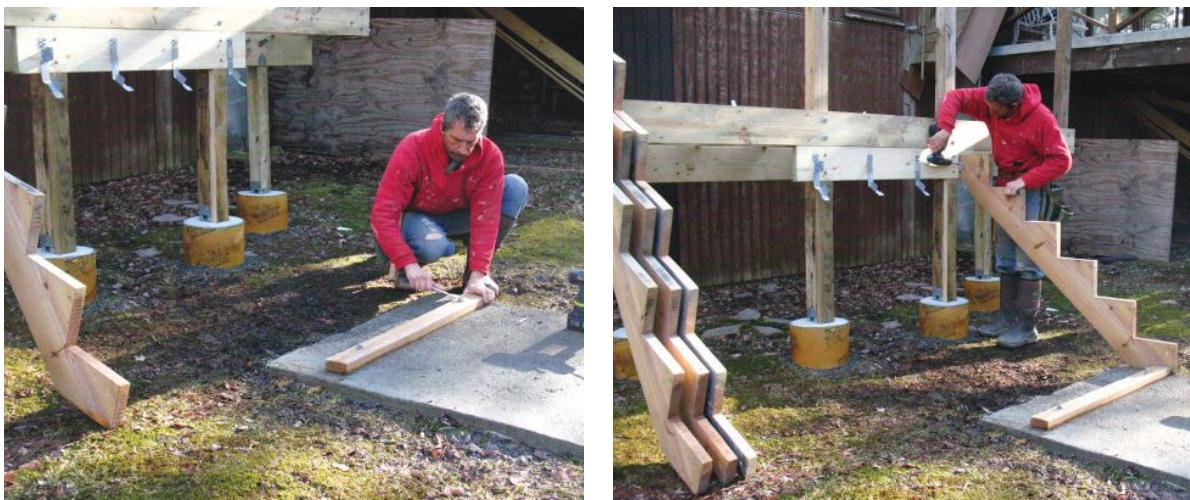
Figure 1. After pouring the concrete for the strip footing and stair landing, the author uses anchor bolts to connect a 2-by PT cleat to the footing (above left). When installing the end stringers, he fastens them to the cleat with structural screws (above right). The middle stringers will be notched to fit over the cleat.

To provide an anchor point for connecting the stringers to a footing or an integrated footing and landing, I secure a 2x4 (or larger) PT cleat to the concrete, either with cast-in-place HDG J bolts installed during the pour or with expansion anchors that can be installed after the concrete is cured. The 2-by has to align with the front end of the stringers, so it helps to cut the stringers before casting the footings and landing so that you know exactly where to dig. In that case, I install 1/2-inch-diameter generic HDGJ-type anchor bolts when I pour the footing. If for some reason I'm not certain of the stringer layout, the cleat can be fastened to the concrete with expansion anchors (either ITW Red Heads or

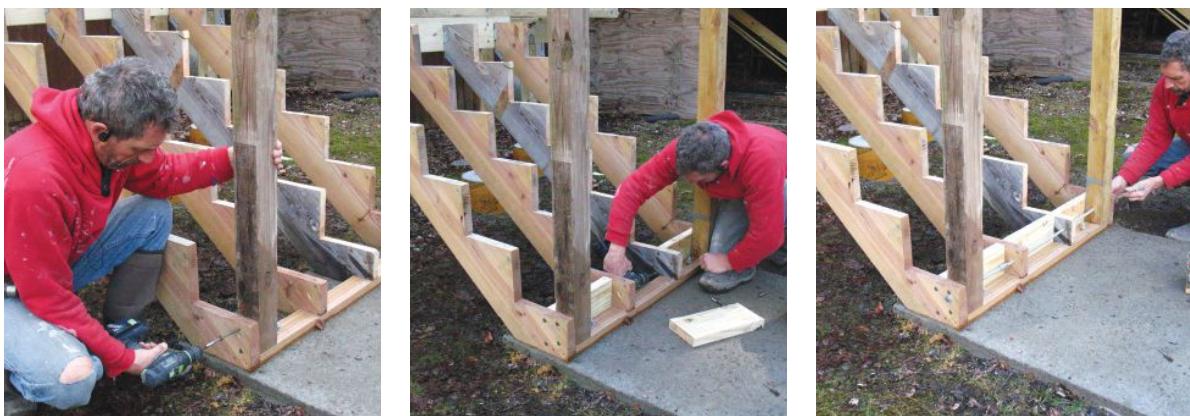
Figure 2. The author screws the guard posts to the stringers (above left), then installs a row of blocking that fits tightly between the stringers (above center). A 1/2-inch-diameter galvanized threaded rod that fits through prebored holes in the posts and stringers ties the assembly together (above right).

Once the stringers have been fastened to the footing cleat, the 4x4 PT guard posts can be mounted to the outer stringers. On the job shown here, I mounted the posts inside the stringers, but with this system, it is possible to mount them on the outside of the stringers. To hold the posts in place while I install blocking and the threaded rod, I fasten them to the stringers with a couple of 4 1/2-inch-long structural screws. I plumb them in line with the stringers; in the final step, I adjust the camber of the posts (**Figure 2**).

the height of the stringer from footing to tread cut. The blocks are positioned behind the guard posts in a straight line and fastened through each stringer with 5-inch structural screws about 1½ inches up from the bottom of the stringer and down from the tread cut. I also drive additional 4-inch screws through the back of the blocks into the 2-by cleat.

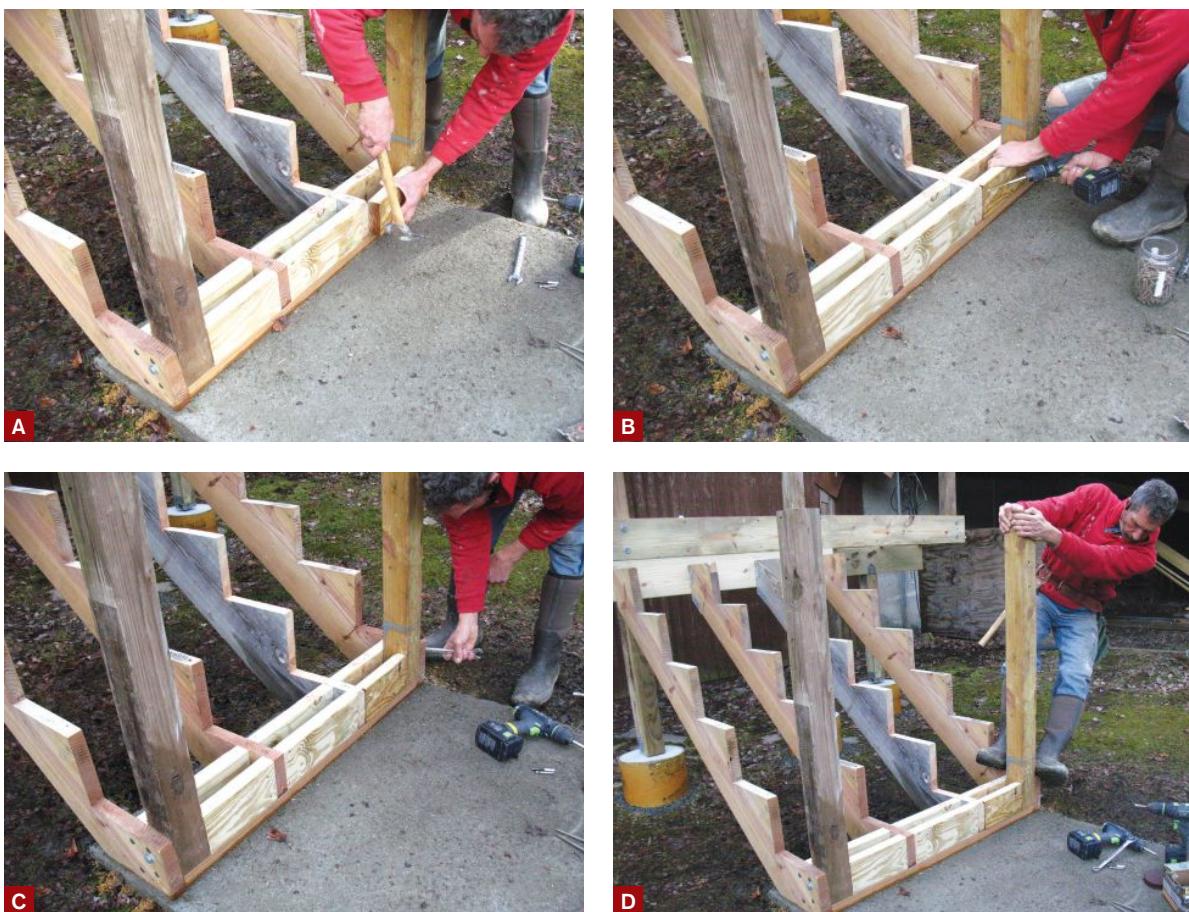
Figure 3. Next, the author installs a second row of blocking, aligned with the front of the stringers, to reinforce the assembly (A). After screwing the blocking to the stringers (B), the author tightens the rod nuts (C), and tests the assembly (D), making adjustments as needed with shims so that the posts are plumb.

Next, I install a second row of blocking aligned with the front of the risers and on top of the cleat, fastening the blocks with structural screws or framing screws. (When the posts are positioned outside the end stringers, the first blocks run from stringer to stringer, rather than from post to stringer, as on this job.) Another variation I've tried is to cut 1½ inches off the riser face of the intermediate

Finally, I tighten down the end nuts and trim off the excess rod, coating the cuts with a rust-prohibiting coating. Tightening the nuts can cause the posts to camber inward. Final adjustments can be made by loosening the nuts, inserting shims between the outer stringers and the blocks (or between the blocks and posts), and retightening.
