CAHI MONTHLY NEWS

July 2019 Volume 12, Issue 07

Inspecting Homes for Termites

Inspecting New Siding – Devil’s in the Details

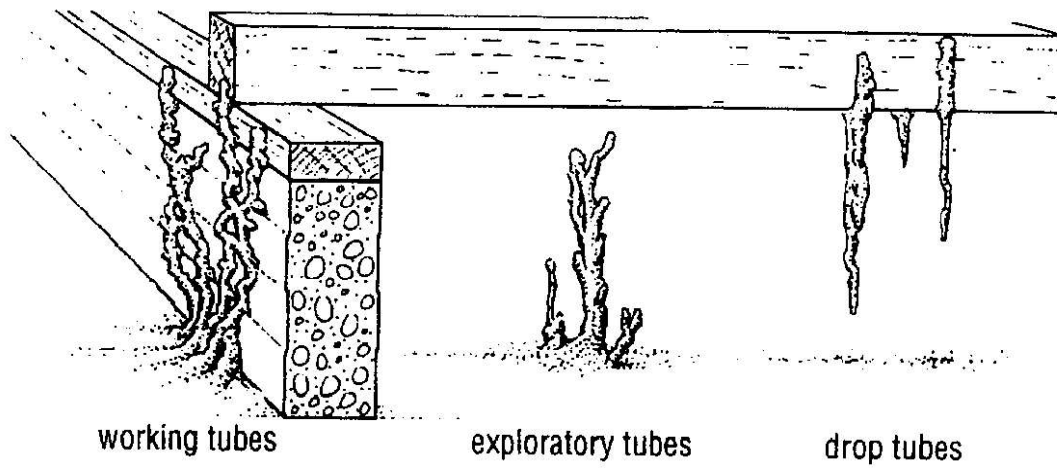
- Subterranean termites construct four types of tubes or tunnels. Working tubes (left) are constructed from nests in the soil to wooden structures; they may travel up concrete or stone foundations. Exploratory and migratory tubes (center) arise from the soil but do not connect to wood structures. Drop tubes (right) extend from wooden structures back to the soil.

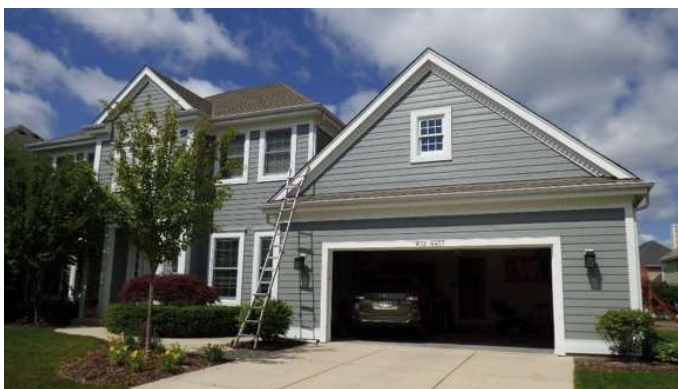
(Figure 1: Home with Cement Siding)

That brings us to replacement siding projects and inspecting siding and trim. Here’s an example from my personal experience. I recently worked with a homeowner whose 30-year-old home had a total siding replacement with fiber cement lap siding. Fiber cement is a great product and it performs well if installed according to the manufacturer’s instructions. This homeowner specifically chose a contractor certified by the siding manufacturer (See Figure 1: Home with Cement Siding). The contractor removed the old cedar and placed a new water-resistant barrier over the wall assembly. Workers replaced flashings at windows, doors, and horizontal trim. They also installed kick-out flashings. The new siding looked great until leaks occurred over the front entrance and over the garage door. Now the owner was concerned. He had paid extra to reframe the front entrance because of long-term water leaks.

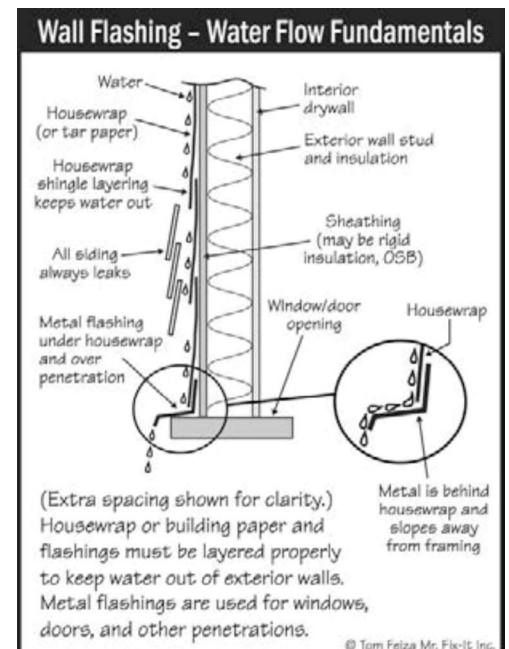
(Figure 8: Wall Flashing – Water Flow Fundamentals)

and flashings was too small. Some siding was improperly caulked to the flashing. (See Figure 8: Wall Flashing – Water Flow Fundamentals, and Figure 9: Metal Head / Cap Flashing Edge.)
